# **Field Evaluations of Epoxy-Coated Bars in Inland and Marine Bridges**

David McDonald, Ph.D., P.E.

Epoxy Interest Group of CRSI

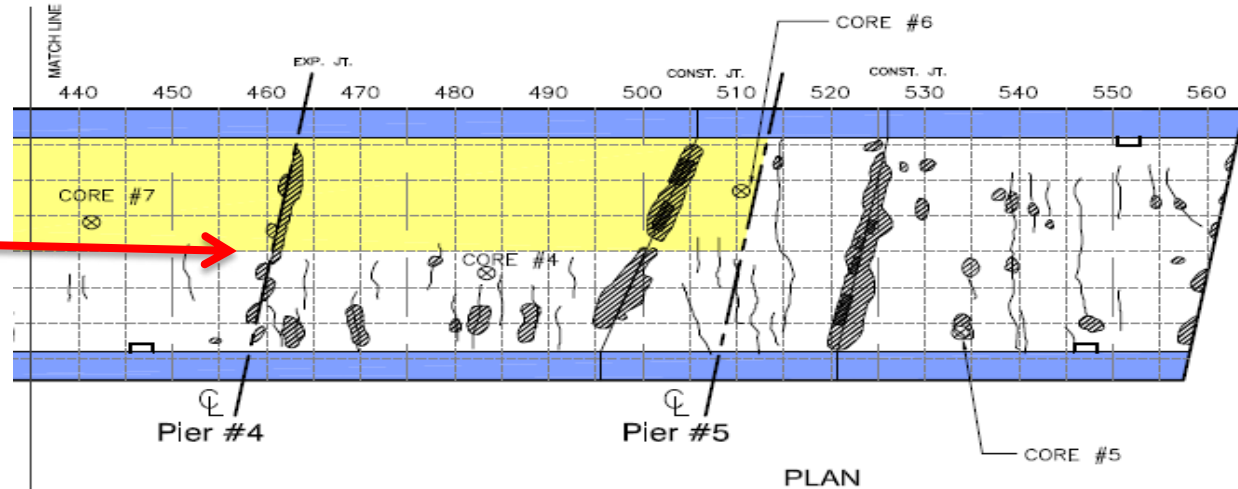
Black - Delaminated concrete after 17 years

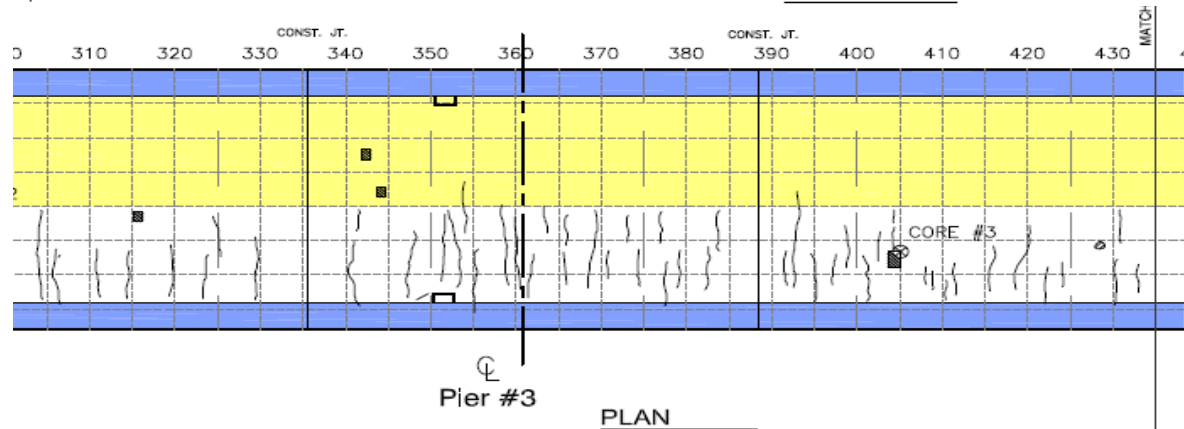
Epoxy - No delaminations after 34 years

Deck with both epoxy and black bar sections

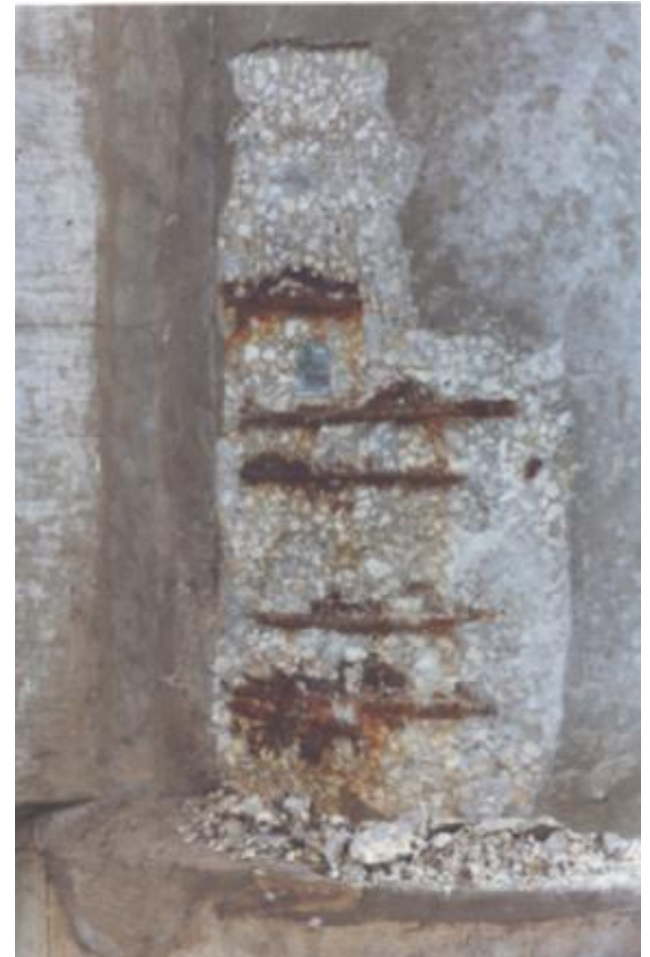
- Severe corrosion in five bridges
  - Built between 1978 and 1983
- Defects
  - Portions had very low cover
  - 2% allowable damage to the epoxy
  - Bare steel tie wires
  - High permeability concrete
