# Performance Of **WEST VIRGINIA BRIDGE DECKS**

*Constructed with Epoxy-Coated Reinforcing Bars*

**The full report titled “Condition Survey Of Older West Virginia Bridge Decks Constructed With Epoxy-coated Reinforcing Bars” is available from [www.epoxyinterestgroup.org](http://www.epoxyinterestgroup.org).**

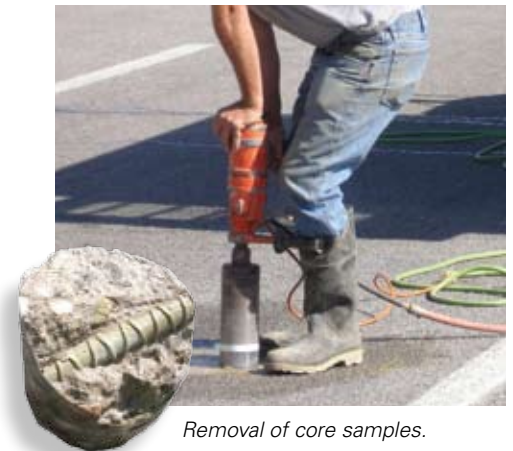
*Removal of core samples.*

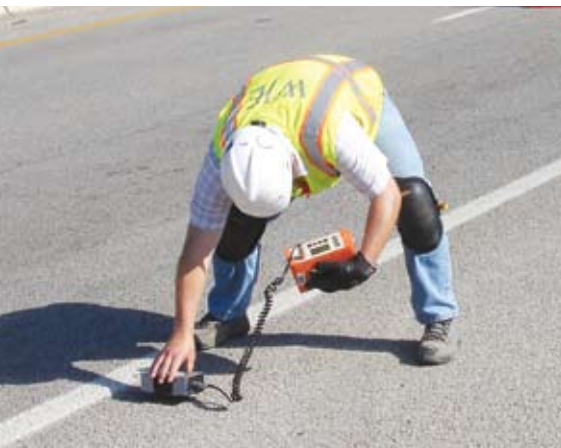
*Measuring concrete cover over reinforcing bars.*

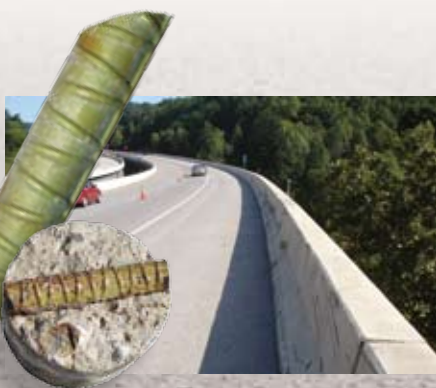
**BRIDGE NO. 2668 N** – This bridge carries I-79 and consists of seven spans supported on steel girders. The bridge deck contains epoxy-coated reinforcing steel in both top and bottom mats and was topped with an anti-icing and anti-skid epoxy-based overlay in 2008.

The delamination survey identified a few small delaminations away from the expansion joints totaling less than 10 sq ft in the 12444 sq ft that was surveyed. Examination of the deck from be-

low revealed extensive transverse cracking. No corrosion-related deterioration was visible on the deck soffit. Electrical continuity testing was performed indicating that the bar segments are not electrically connected but that the overall resistance is somewhat lower than fully isolated bars.

Chloride values at the bar depth ranged from 0.009 to 0.117 percent by weight of concrete in uncracked cores. Visual inspection of bars found that one of the 11 extracted bars exhibited active corrosion, but this core was taken at a crack and only partially recovered; therefore chloride analysis was not performed. The epoxy coating thickness varied widely in this bridge. Most of the samples bars had a thickness of 9 to 15 mils; however, one bar had a coating thickness of only 3.5 mils. This bar was sampled at a lap and may represent an end of a bar.

**Bridge No. 2668 N**  
Coated bars in top and bottom mat.

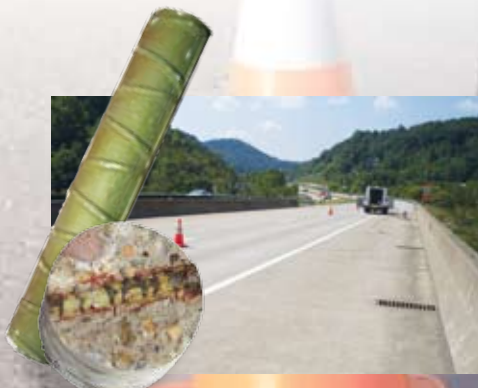
**BRIDGE NOS. 2672 N, 2672 S** – The decks of Bridges 2672 N and 2672 S are similar in design and consist of three spans on concrete girders, carrying I-79. The bridge decks contain epoxy-coated reinforcing steel in the top mat and black bar in the bottom mat. Minor delaminations, 2 sq ft in size or less and some associated spalls and patching were identified in these decks and totaled less than 10 sq ft in the 8400 sq ft that was surveyed. The majority of these were associated with construction joints separating the deck placements over the piers. According to the design drawings, this joint was to be keyed and edged with  $\frac{1}{4}$  in. edging tool then filled with a “hot-poured elastic-type construction joint sealer.” Similar construction joint details are given for the other bridge decks that were investigated.

Transverse cracks were also present throughout the decks. Spalling at an uncoated bottom reinforcing bar in Bridge No. 2672 N was visible in one location and incipient spalling and staining related to corrosion of uncoated bottom bars was visible at a number locations on the soffit of both of these decks, particularly adjacent to the construction joints.

DC resistance between top bar segments indicated that the top bar segments measured were generally electrically discontinuous. Chloride values at the bar depth ranged from 0.009 to 0.039 percent by weight of concrete in uncracked cores and from 0.054 to 0.222 percent by weight of concrete in the cracked cores. Two of the 7 bars from Bridge No. 2672 N and one of the 7 bars from Bridge No. 2672 S were obtained with indications of active corrosion. The calculated chloride concentration at the bar depth for the corroding bars

was 0.182, 0.132 and 0.222 percent by weight of concrete, respectively, or approximately 4 to 6 $\frac{1}{2}$  times higher than the chloride threshold for uncoated black steel (about 0.035 percent by weight of concrete). The coating thickness was less than 7 mils in all three cases, and a crack was present over each of these bars.

**Bridge No. 2672 S**  
Coated bars in top mat only.

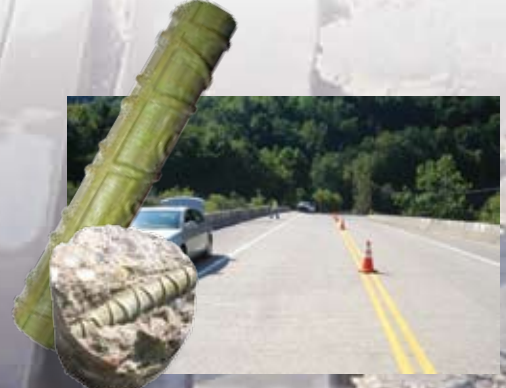
**BRIDGE NO. 2673** – Bridge No. 2673 is an overpass over I-79 and sees significantly less traffic than other bridges included in this study. This bridge deck has five spans on steel girders and contains epoxy-coated reinforcing steel in the top and black uncoated bars in the bottom mat. Despite the lower traffic, the condition of the deck was similar in nature to the other decks. The largest delamination identified was approximately 5 sq ft in size and transverse cracking was present throughout and particularly concentrated in Span 4. A total of 5 sq ft of delamination was found in the 16,618 sq ft surveyed.

Relatively fewer cracks were observed on the deck soffit compared with other decks; however, signs of corrosion staining were visible at the construction joints. DC resistance between top bar segments varied depending on location and ranged significantly from 0.1 to 3600 Kohm.

Chloride values at the bar depth ranged from 0.079 to 0.165 percent by weight of concrete in uncracked cores and 0.204 percent by weight of concrete for the single cracked core. The bar segment at the cracked location was undergoing active corrosion. While no delamination was occurring at this bar, a delamination was present approximately 2 ft. away following the crack along the same bar.

**Bridge No. 2673**  
Coated bars in top mat only.

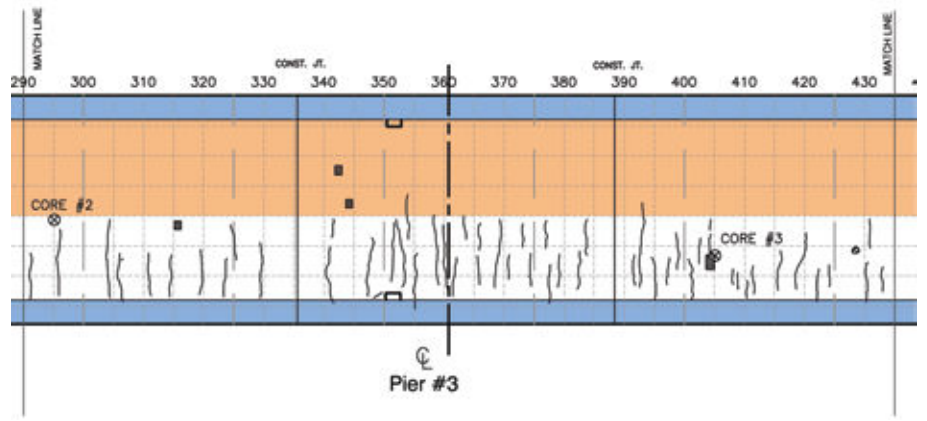
The frequency of transverse cracking was higher in this bridge than any of the other decks examined. However, despite the presence of these cracks throughout the bridge, essentially no reinforcing corrosion-related deterioration was observed in Spans 1-4, which are reinforced with epoxy-coated reinforcing steel. All the deterioration that was detected on this bridge occurred in Spans 5-6, with more than 5% of the surface area of Spans 5-6 exhibiting repairs, spalling or delaminations.

Map of deck of Bridge 2930 containing epoxy-coated bars showing cracks.

ment. Chloride values at the bar depth ranged from 0.041 to 0.165 percent by weight of concrete in uncracked concrete. No cracks were found in the spans containing epoxy-coated bars. The measured coating thickness on all bars taken from Spans 1-4 ranged from 8–15.8 mil and none of these epoxy-coated reinforcing steel segments exhibited evidence of corrosion.

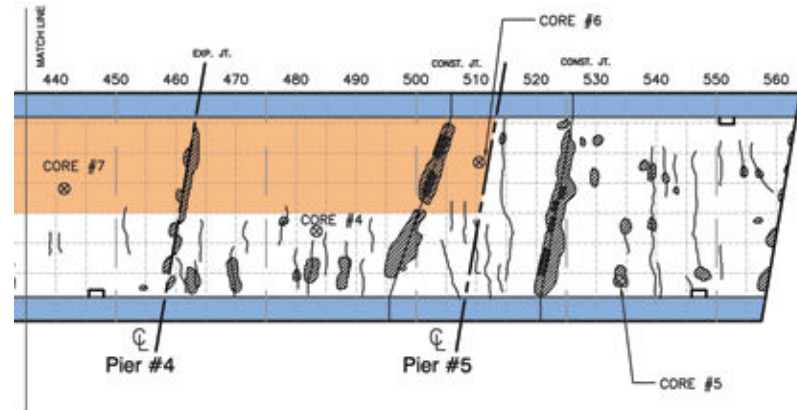
According to WV DOT, some repairs were performed on this deck in 1998. These repairs took one of two forms. The first consisted of conventional patches, which are most prevalent at spalls concentrated in Span 5-6. In addition, a number of small (less than 1 sq ft), uniform, isolated, essentially square repairs were observed throughout the spans. The reason for these smaller isolated repairs is uncertain, though given their size they do not appear to be related to reinforcing corrosion.

Map of deck of bridge 2930 containing black bars showing delaminations & cracks.

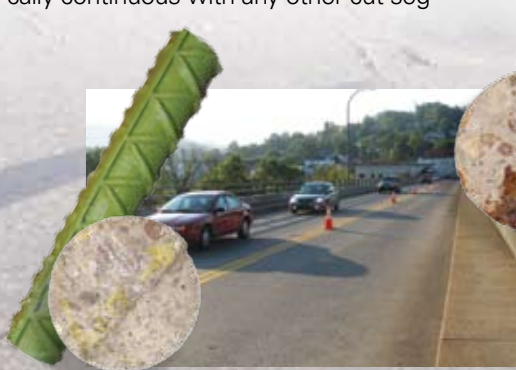
Bridge No. 2930, Spans 1-4  
Coated bars in top and bottom mat.

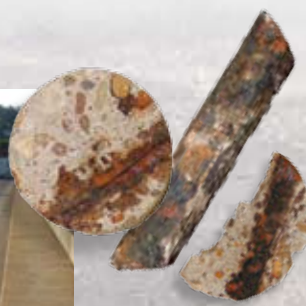
Bridge No. 2930, Spans 5-6  
Black bar in top and bottom mat.

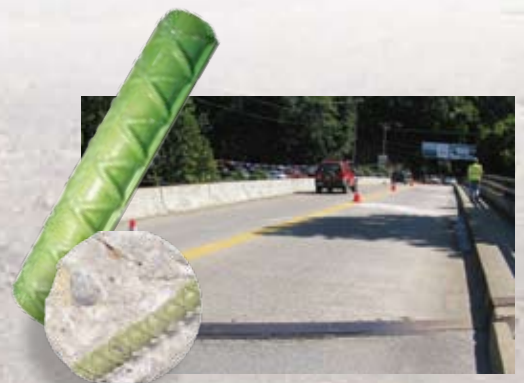
**BRIDGE NO. 2953** – Bridge No. 2953 is an urban bridge in Clarksburg, WV. This deck is three spans on steel girders and stay-in-place forms. This bridge deck contains epoxy-coated reinforcing steel in both the top and bottom mats. No corrosion related deterioration was observed in this deck.

The DC electrical resistance between epoxy-coated reinforcing steel bar samples cut during coring was typically very high on this bridge, which indicated that the bars in this bridge are essentially electrically isolated by the reinforcing coating.

Chloride values at the bar depth ranged from 0.082 to 0.165 percent by weight of concrete in uncracked cores and 0.263 percent by weight of concrete in the cracked cores. The coating thicknesses on these bar segments ranged from 8.0 to 11.9 mil and none of these epoxy-coated reinforcing steel segments exhibited evidence of corrosion.

Bridge No. 2953  
Coated bars in top and bottom mat.

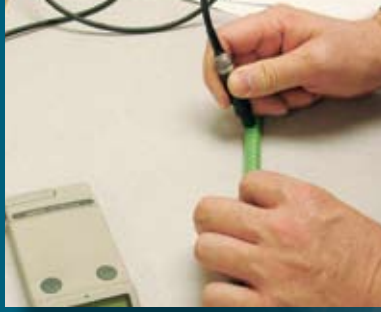
Epoxy-coating thickness test.

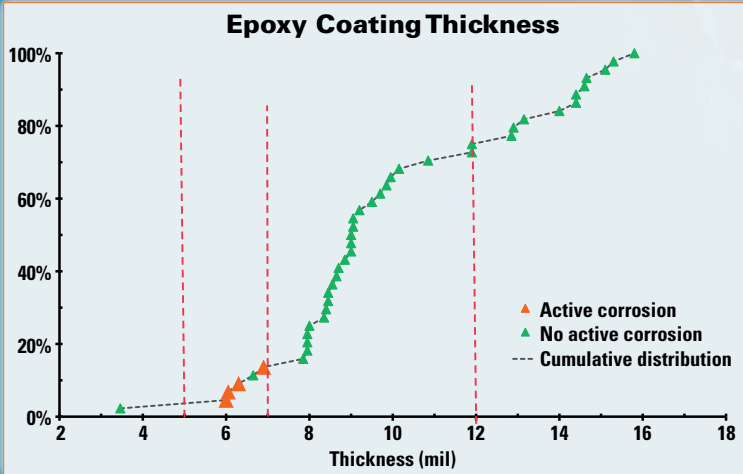
Coating thickness strongly correlated to corrosion, with all four bar segments judged to be experiencing active corrosion having a coating thickness of less than 7 mils, which would be unacceptable or marginally acceptable by current standards.

Distribution plot of epoxy coating thickness on bars in cores sampled from all bridges.

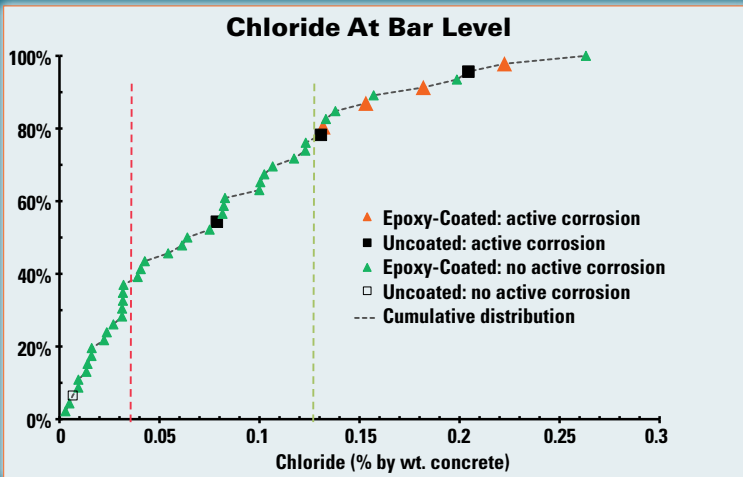
The distribution of chloride values for both the epoxy-coated reinforcing steel segments was evaluated. The only segment of black bar not undergoing active corrosion is at a location where the chloride concentration is less than the commonly issued black bar threshold of 0.035 percent by weight of concrete. For the coated bars, 22 epoxy-coated reinforcing steel segments without active corrosion had a chloride concentration of greater than this threshold. The chloride concentrations at the four actively corroding epoxy-coated reinforcing steel segments are greater than 0.13 percent by weight of concrete or about 4 times the black bar threshold. Furthermore, five other epoxy-coated reinforcing steel segments exposed to chloride concentrations greater than 0.13 percent by weight of concrete were not actively corroding, with the greatest at 0.263 percent by weight of concrete. This suggests that the epoxy coating provides a significant level of protection to chloride-induced corrosion of the reinforcing steel.

Distribution plot of chloride concentration at bar depth from all bridges.

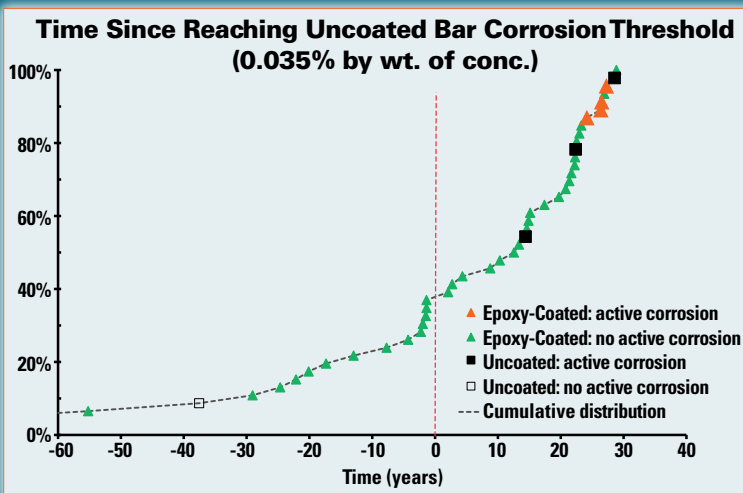
It was further found that the epoxy-coated reinforcing steel segments exhibiting active corrosion are among those bar segments that have been exposed to chloride concentrations above the black bar threshold for the longest period of time, exceeding 20 years in all four cases. Some epoxy-coated reinforcing steel segments have been exposed to chloride concentrations longer than 20 years without active corrosion.

Distribution of time since reaching black bar corrosion threshold (0.035 percent by weight of concrete).
