**CONDITION SURVEY AND SERVICE LIFE  
PREDICTION OF FOUR MARINE BRIDGE  
SUBSTRUCTURES CONTAINING EPOXY-COATED  
REINFORCING BARS**

**Final Report**

9 January 2007

**Wiss, Janney, Elstner Associates, Inc.**

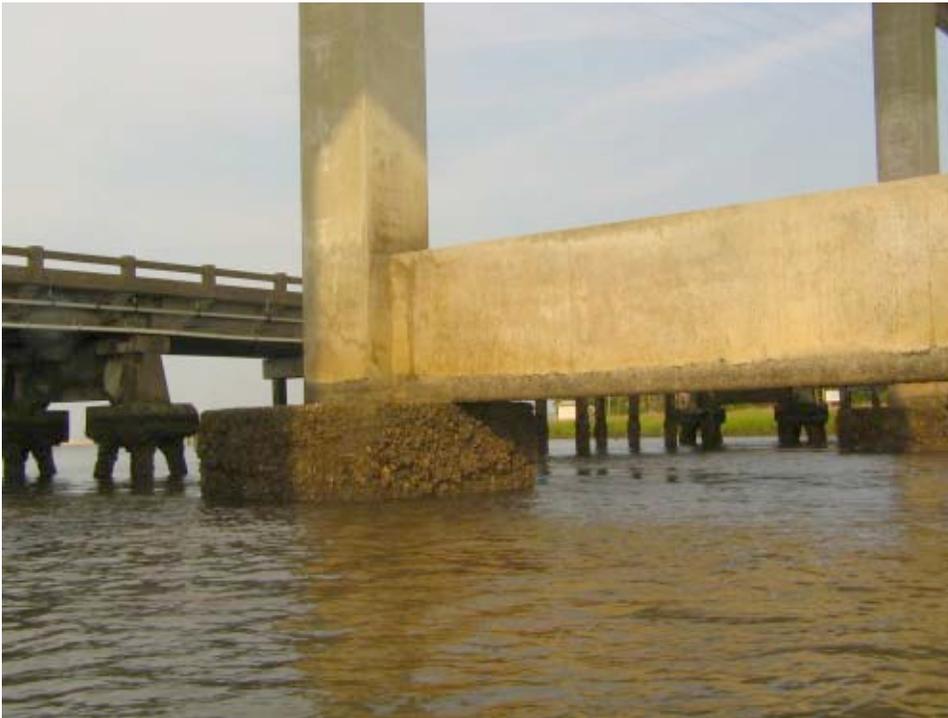
The columns and strut walls of the MacKay River Bridge were in good condition and no spalling was observed. Occasional vertical cracks, attributed to thermal or shrinkage cracking, were observed on the strut walls. With the exception of the south column of Bent 15, which had several cracks, the columns were generally crack-free. Isolated spots of corrosion product on the concrete surface were observed and attributed to exposed steel chair tips. The pile caps were completely covered with barnacles on the sides and partially covered on the top. Figures 4 through 7 show the surface condition of several representative bents.

*Figure 4. Surface condition of the MacKay River Bridge Bents: east face of Bent 12.*

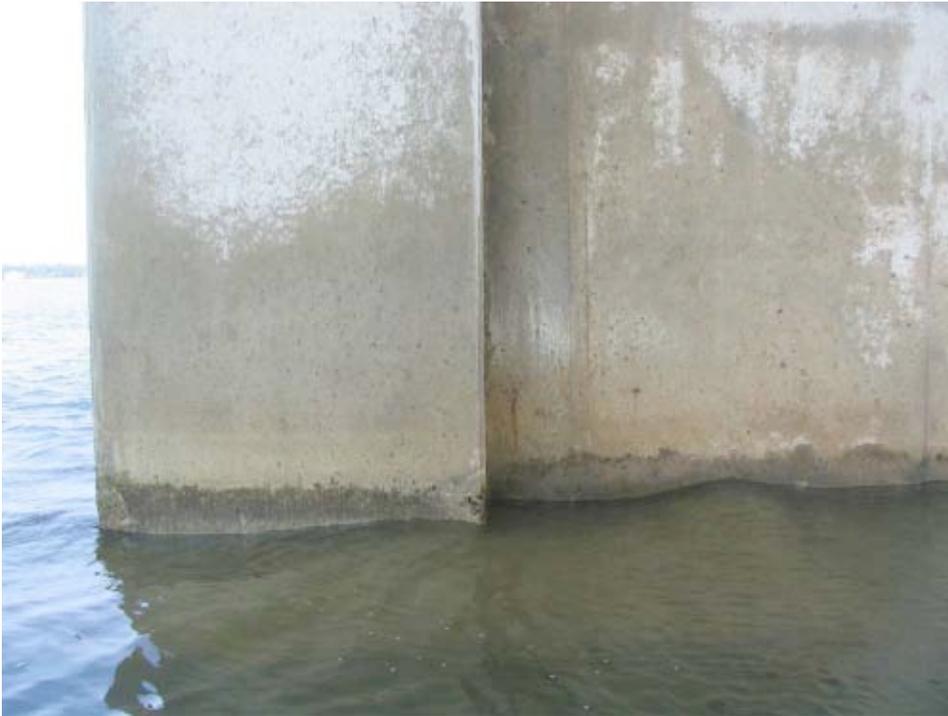
*Figure 5. Surface condition of the MacKay River Bridge Bents: west face of the North column of Bent 9 and adjacent strut wall.*

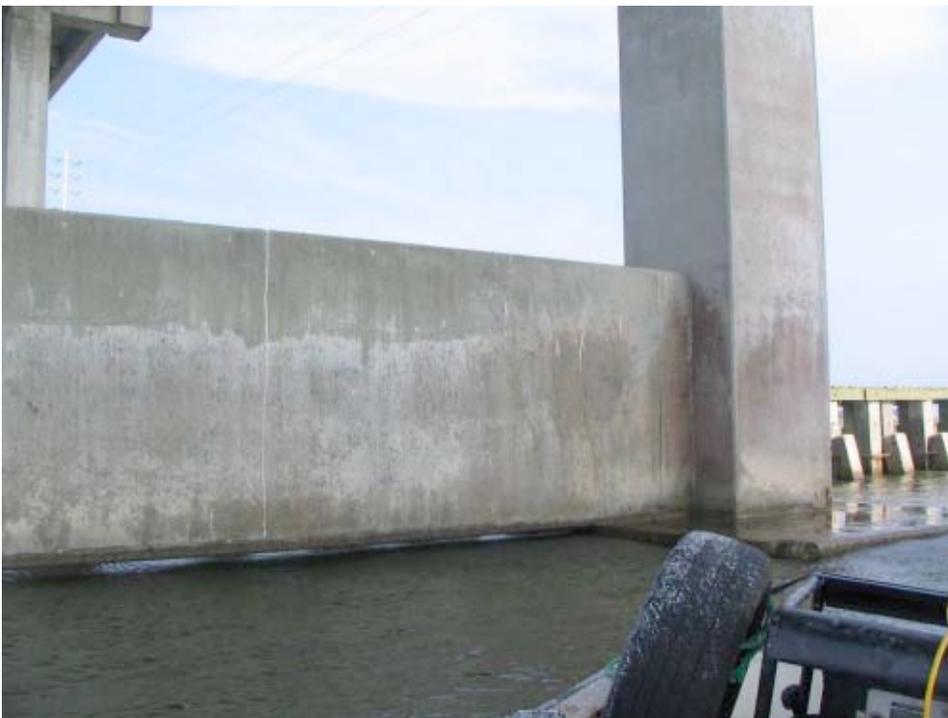
*Figure 6. Surface condition of the MacKay River Bridge Bents: west side of Bent 14 (some vertical cracks are visible on the strut wall).*

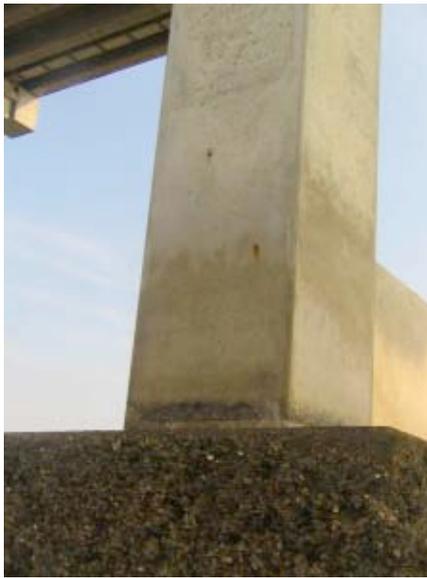
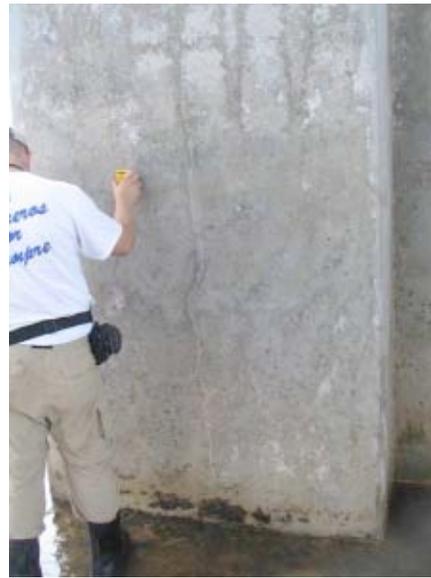
*Figure 7. Surface condition of the MacKay River Bridge Bents: a) south face of the south column of Bent 17; b) east face of the south column of Bent 15 (A long vertical crack is highlighted with white crayon).*

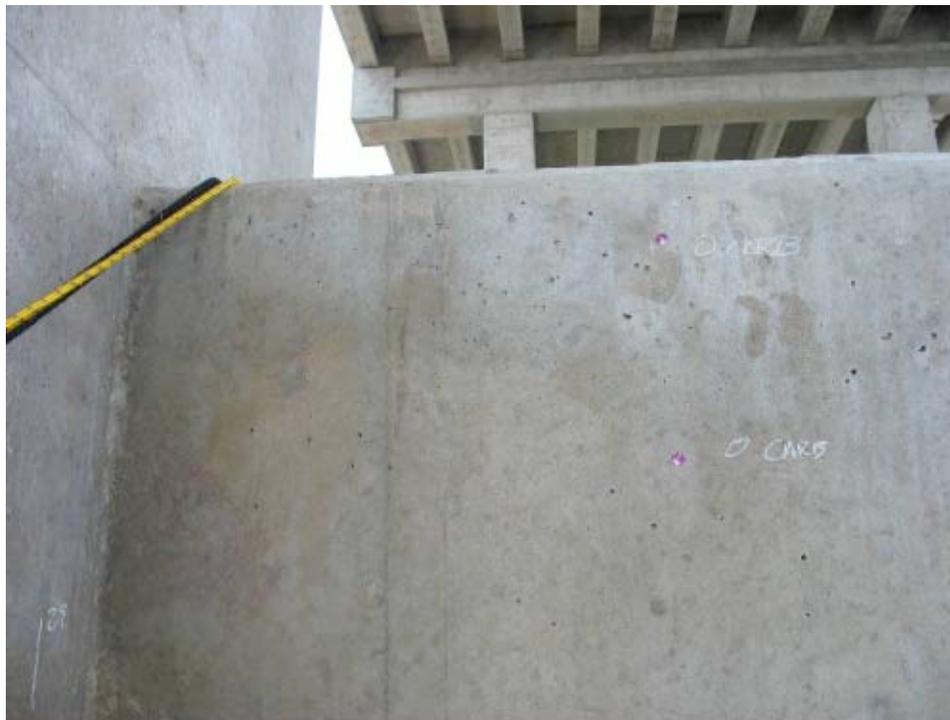
No delaminations were detected by sounding and none of the concrete cores, including one taken on a crack, showed any signs of delamination or other damage related to reinforcement corrosion. Carbonation tests, as illustrated in Figure 8, showed no detectable carbonation.

*Figure 8. Carbonation test holes on the strut wall of the MacKay River Bridge, Bent 17.*

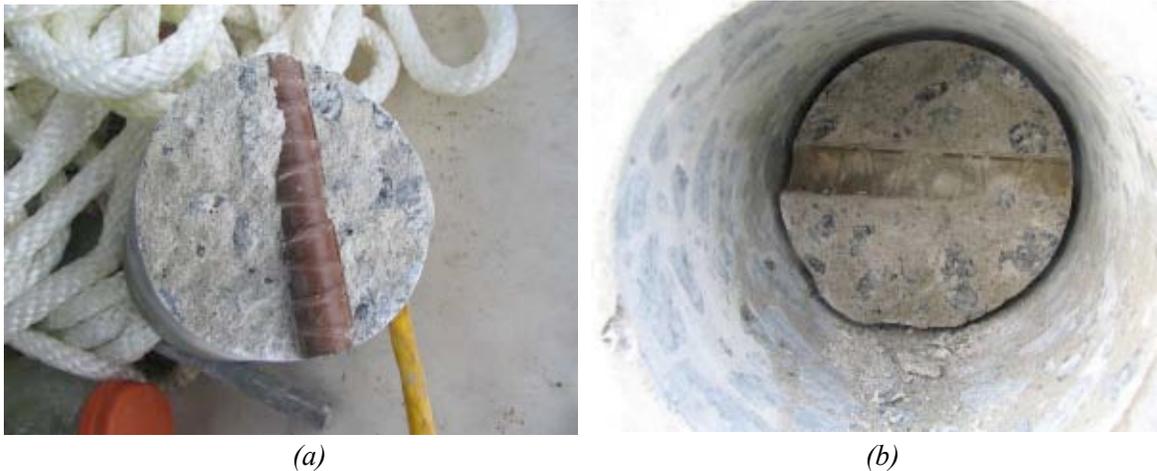
*Figure 12. Condition of the bar contained in the MacKay River Bridge Core 17-5 (54 in. above high tide, bar-level chloride concentration is 0.023 wt%).*

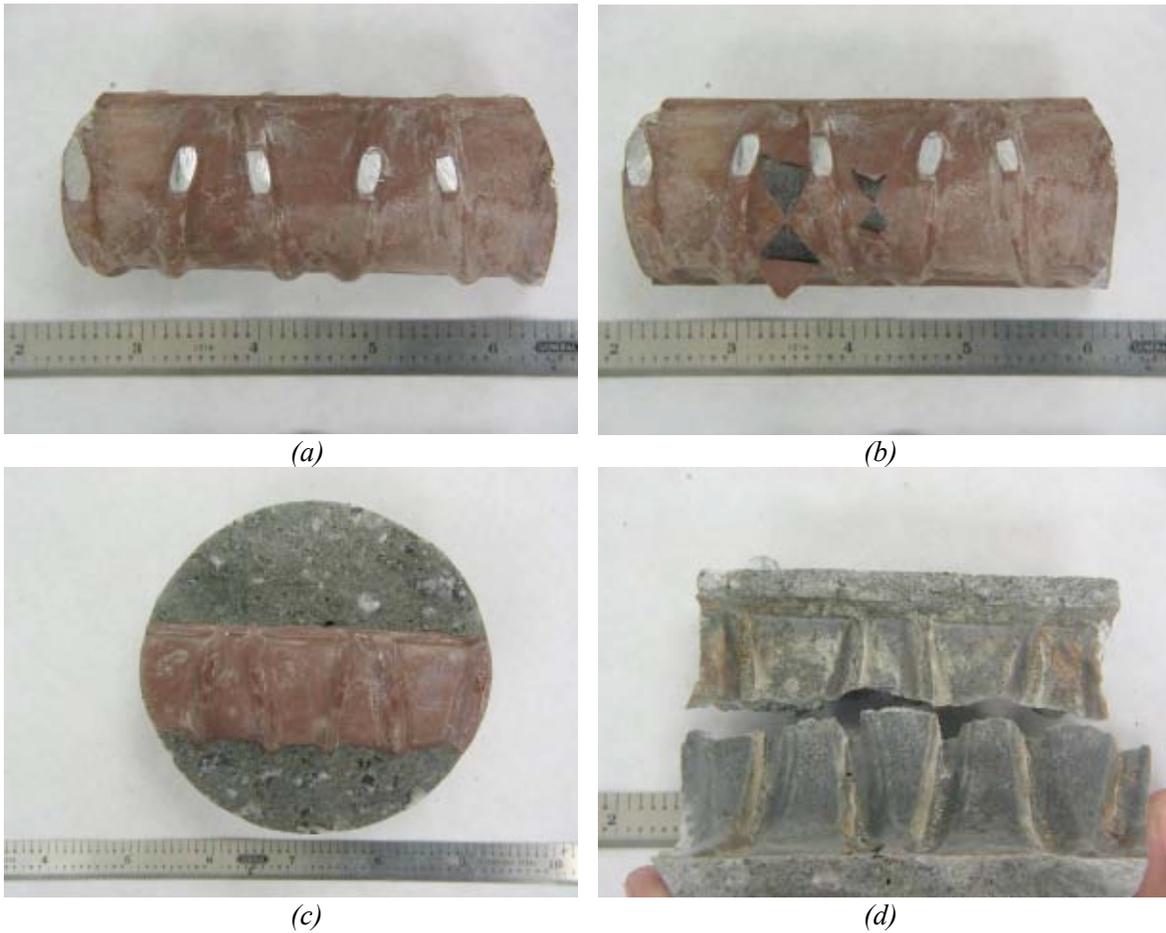
*Figure 13. Condition of the bar contained in the MacKay River Bridge Core 15-1 (22 in. above high tide, a vertical crack on top of the bar, bar-level chloride concentration is 0.079 wt%): a) top surface (coating damaged during concrete slicing in laboratory); b) adhesion test result (rating=5); c) bottom surface (no corrosion); d) bar imprint of top surface (no corrosion stains).*

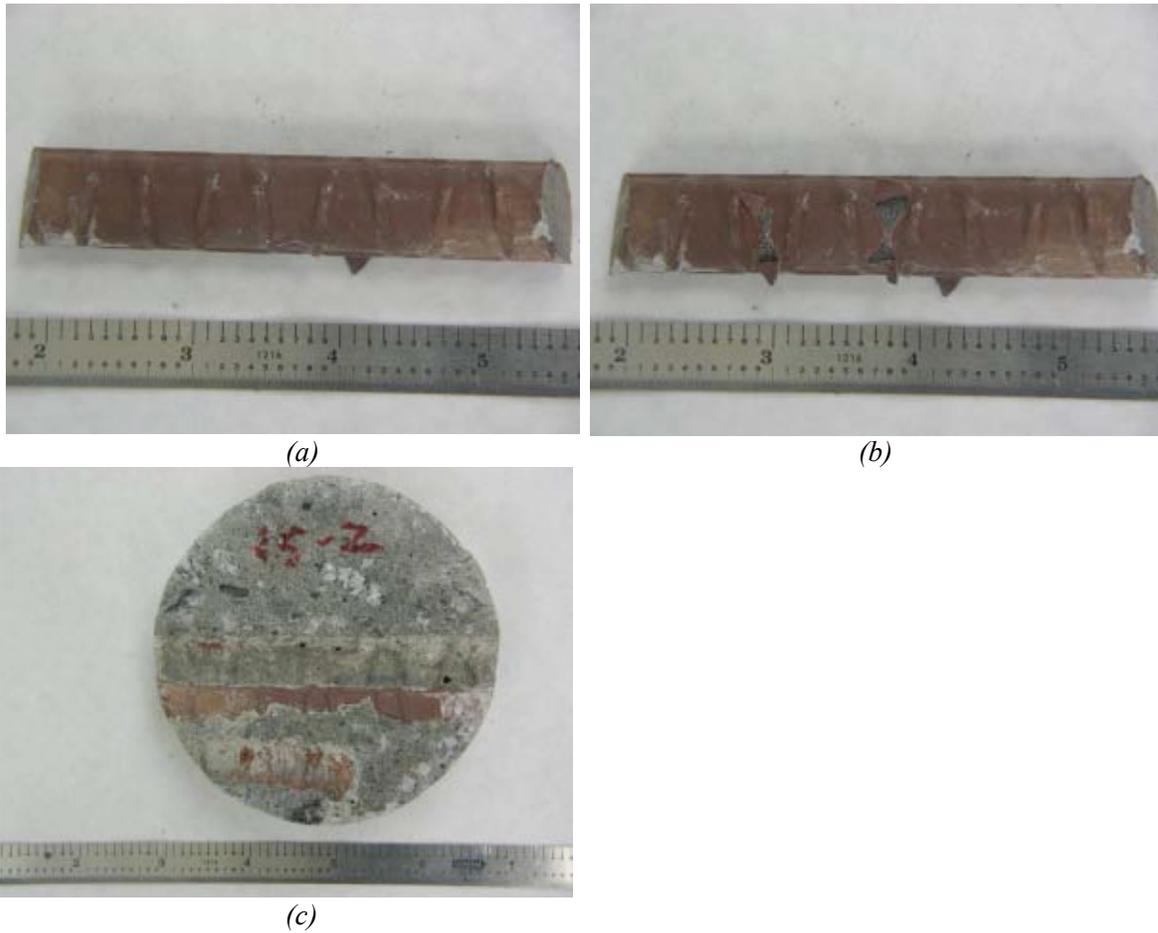
Figure 14. Condition of the bar from MacKay River Bridge Core 15-2 (2 in. above high tide, bar-level chloride concentration is 0.079 wt%): a) surface condition; b) adhesion test result (rating=5); c) bar imprints (no corrosion stains).

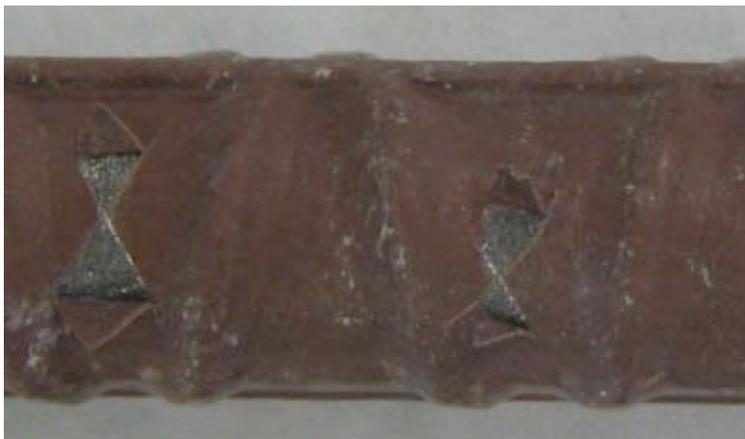
Figure 15. Condition of steel under coating of the MacKay River Bridge Core 12-4 (62 in. above high tide, bar-level chloride concentration is 0.002 wt%).

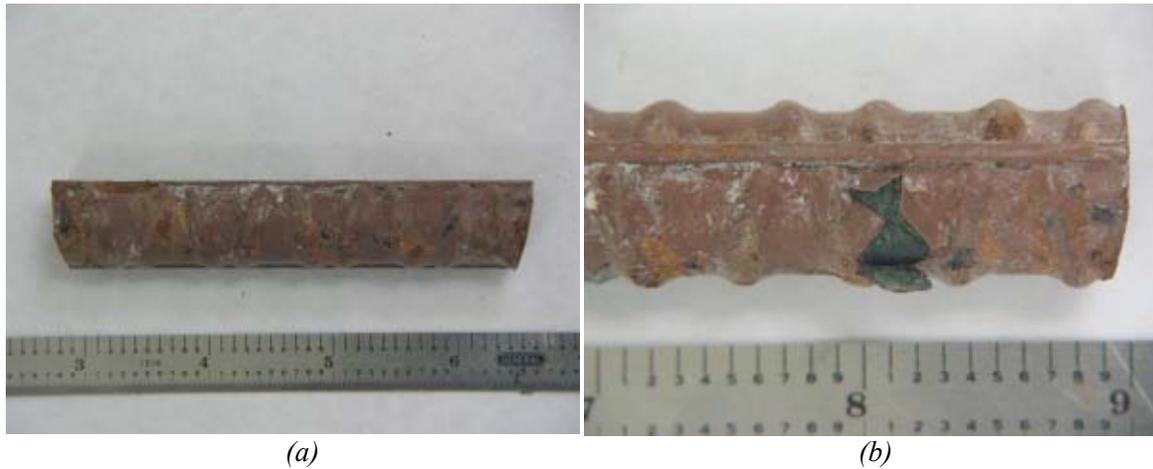
The bar from Core 12-1 has approximately 5% coating damage and significant corrosion staining was present on the coating surface. This damaged bar was judged to be actively corroding, although there was no significant section loss. The chloride concentration at this bar was 0.251 wt%.

*Figure 16. Condition of the Bar contained in the MacKay River Bridge Core 12-1 (tidal zone, bar-level chloride concentration is 0.251 wt%): a) top surface showing corrosion staining; b) adhesion test result (rating=5).*

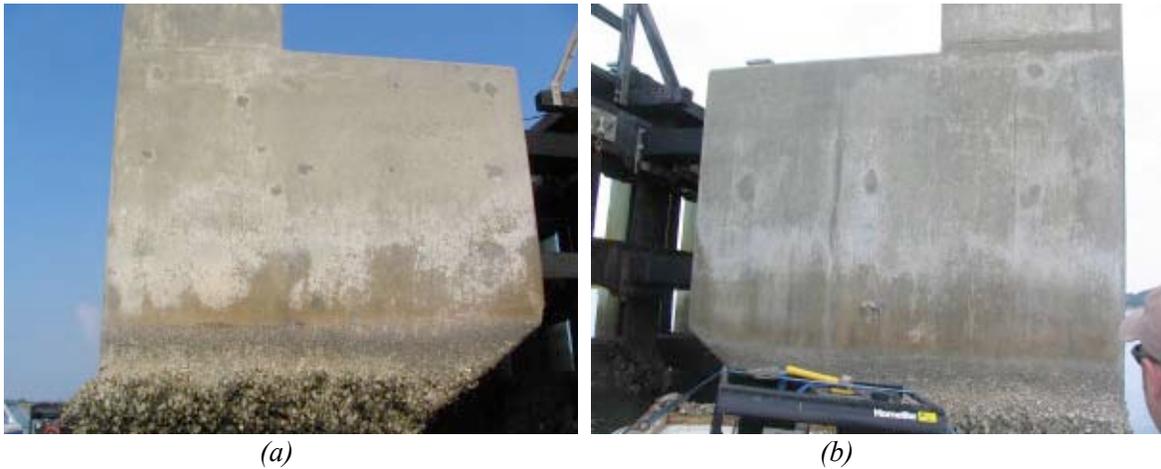
The bents accessible by boat, Bents 7 to 12, were visually inspected. In general, the bents (pile caps, haunches and columns) are in good condition. Figure 18 shows the overall condition of the east faces of Bents 9 and 10. Some isolated corrosion stains that likely formed due to exposed steel chair tips were observed. In addition, some minor cracks, attributed to thermal or shrinkage cracking, were observed on the top surface of pile caps of Bents 7, 8, and 12, as well as on the columns of Bent 12.

Figure 18. Condition of the Ocean Isle Bridge bents: a) east face of Bent 9; b) east face of Bent 10.

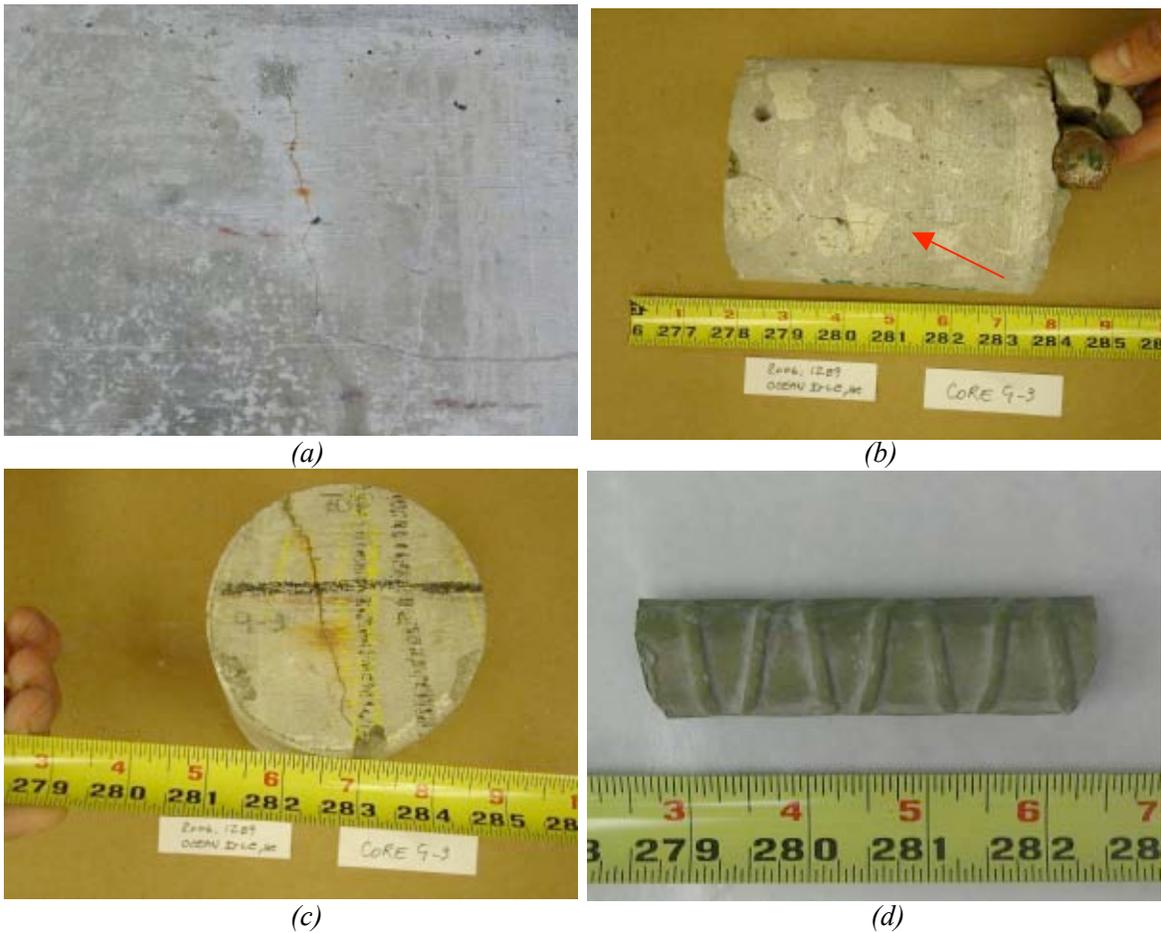
In addition, two significant cracks (maximum width of 15 mils) with a total combined length of 65 in. were observed on the south face of Bent 9. A corrosion stain was visible on one of these cracks, through which Core 9-3 was taken. As shown in Figure 19, a No. 8 epoxy-coated bar free of any active corrosion

was found in this core at a depth of 4.9 in., but the crack that extended through the core did not originate from the reinforcing steel.

Figure 19. A core extracted from a cracked zone on Bent 9 in the Ocean Isle Bridge: a) a crack in concrete; b) the core showing side view of crack; c) external surface condition of the core; d) the epoxy-coated bar segment contained in the core was corrosion-free. Bar-level chloride concentration is 0.009 wt%.

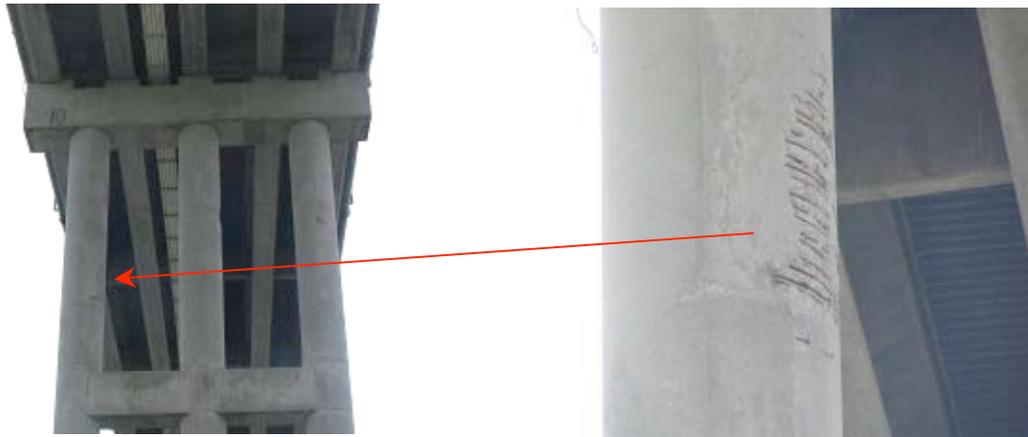
In contrast to the general good condition of the areas of the substructure reinforced with epoxy-coated bar, the columns near the bridge deck (far above high tide) have developed several spalls due to inadequate cover over apparently uncoated spiral reinforcement, as illustrated in Figure 20.

Figure 20. Several columns in the Ocean Isle Bridge developed spalls (far above high tide) due to inadequate cover over uncoated bar spirals.

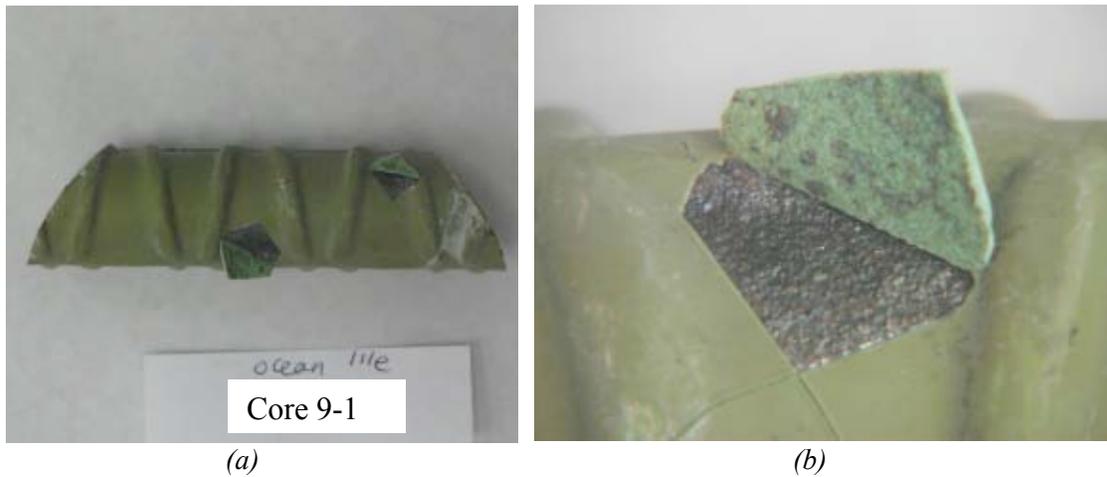
Figure 22. Typical condition of corrosion-free epoxy-coated bar extracted from the Ocean Isle Bridge: a) overall appearance; b) undercoating steel often has a dark color but is corrosion-free. The bar is from Core 9-1, 10 in. below high tide. Bar-level chloride concentration is 0.056 wt%.

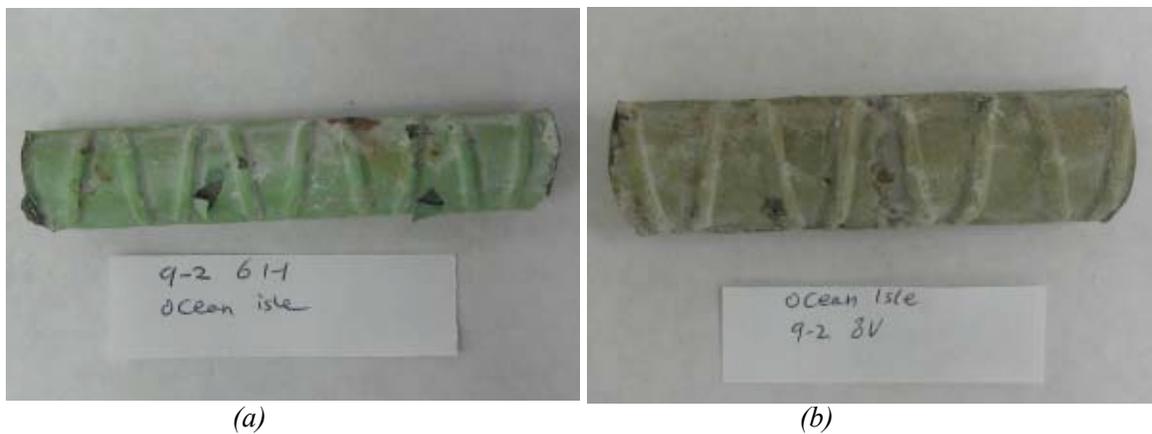
Figure 23. Two bars contained in Core 9-2 from the Ocean Isle Bridge show corrosion staining: a) a horizontal No. 6 bar with a cover of 4.75 in. Bar-level chloride concentration is 0.199 wt%; b) a vertical No. 8 bar with a cover of 5.1 in. and bar-level chloride concentration is 0.183 wt%.

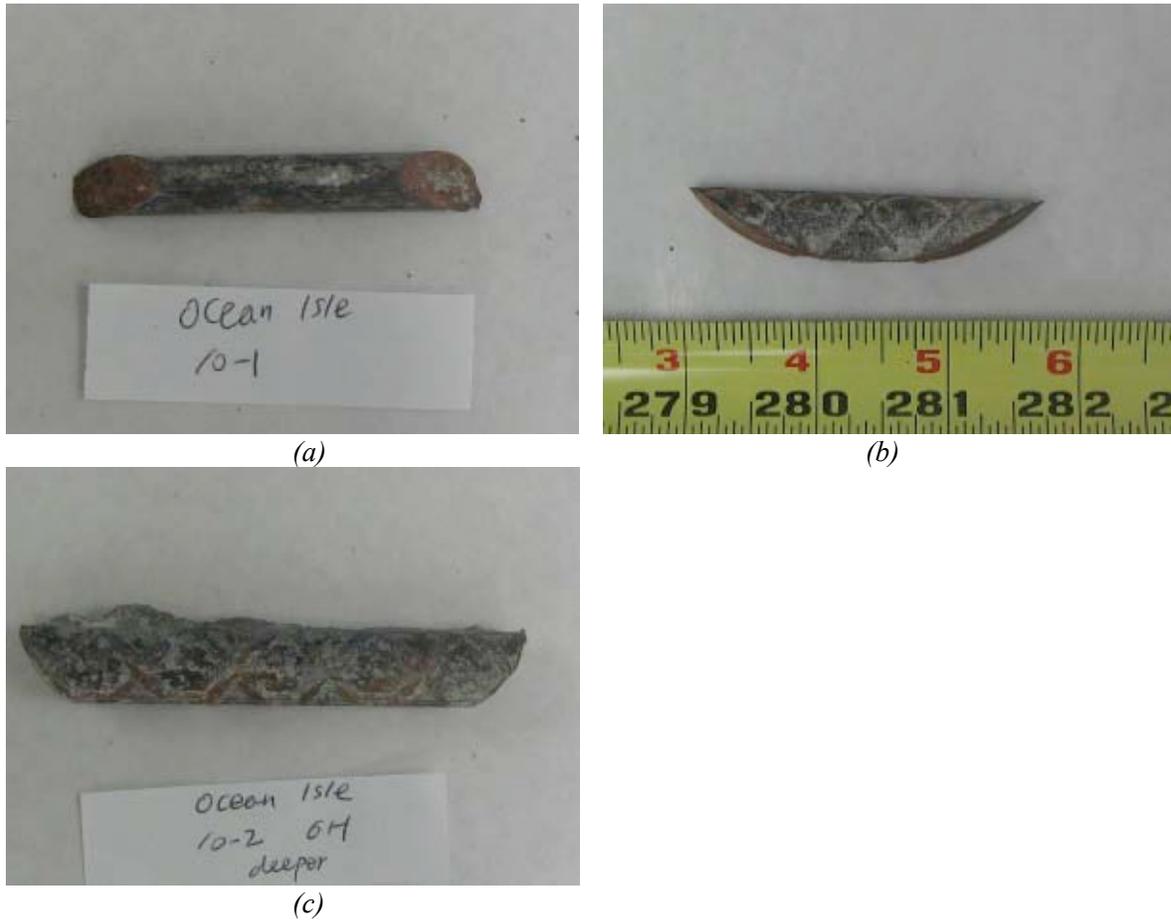
*Figure 24. Uncoated bars from the Ocean Isle Bridge: a) a No. 3 round bar from Core 10-1, bar cover is 4.3 in. and bar-level chloride concentration is 0.021 wt%; b) a No. 4 deformed bar from Core 10-3, cover is 4.125 in. and bar-level chloride concentration is 0.009 wt%; c) a No. 4 deformed bar from Core 10-3, cover is 4.5 in. and bar-level chloride concentration is 0.007 wt%.*

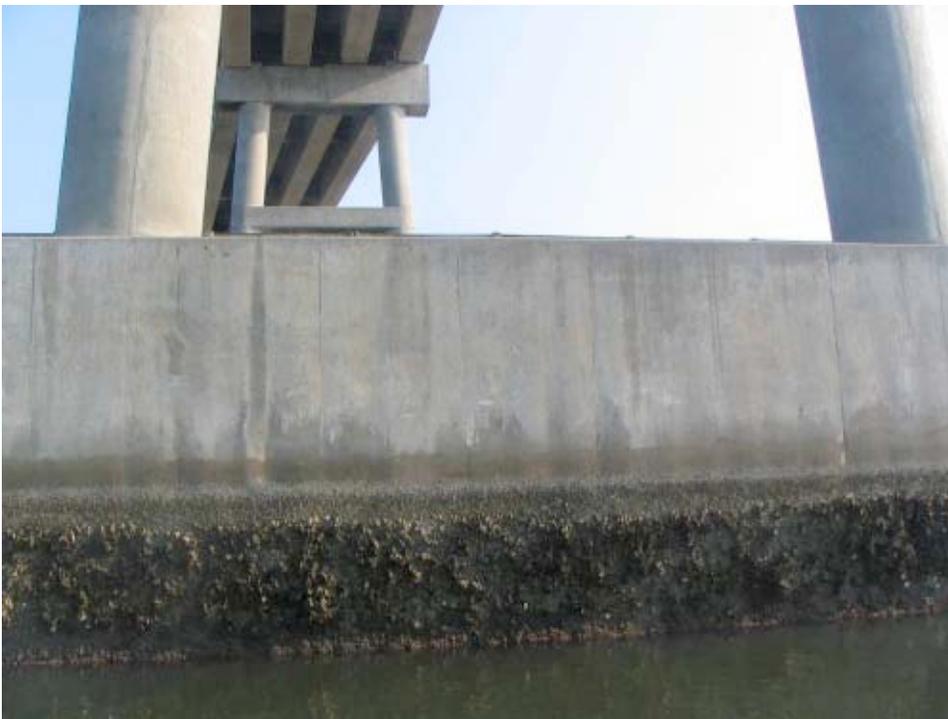
*Figure 26. Surface condition of the Holden Beach Bridge Bents: the south face of Bent 11.*

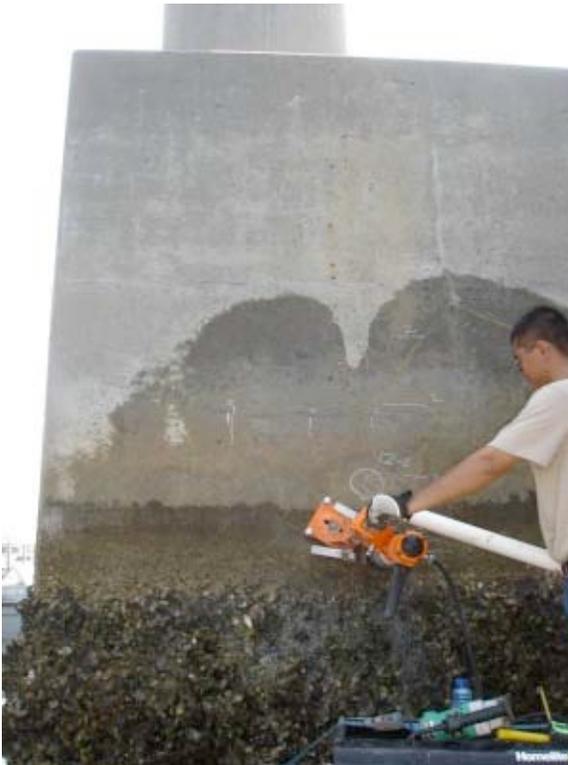
*Figure 27. Surface condition of the Holden Beach Bridge Bents: the west face of Bent 12. Cracks are highlighted with yellow crayon.*

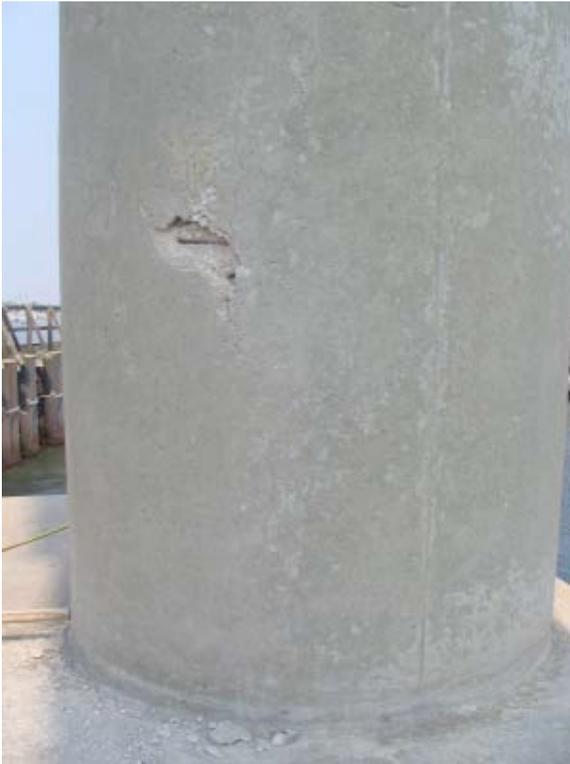
Figure 28. A spalled area observed on the east column of Bent 11 of the Holden Beach Bridge. The spall is about 10 ft. above high tide, and concrete cover for the uncoated bar is approximately 1 in.

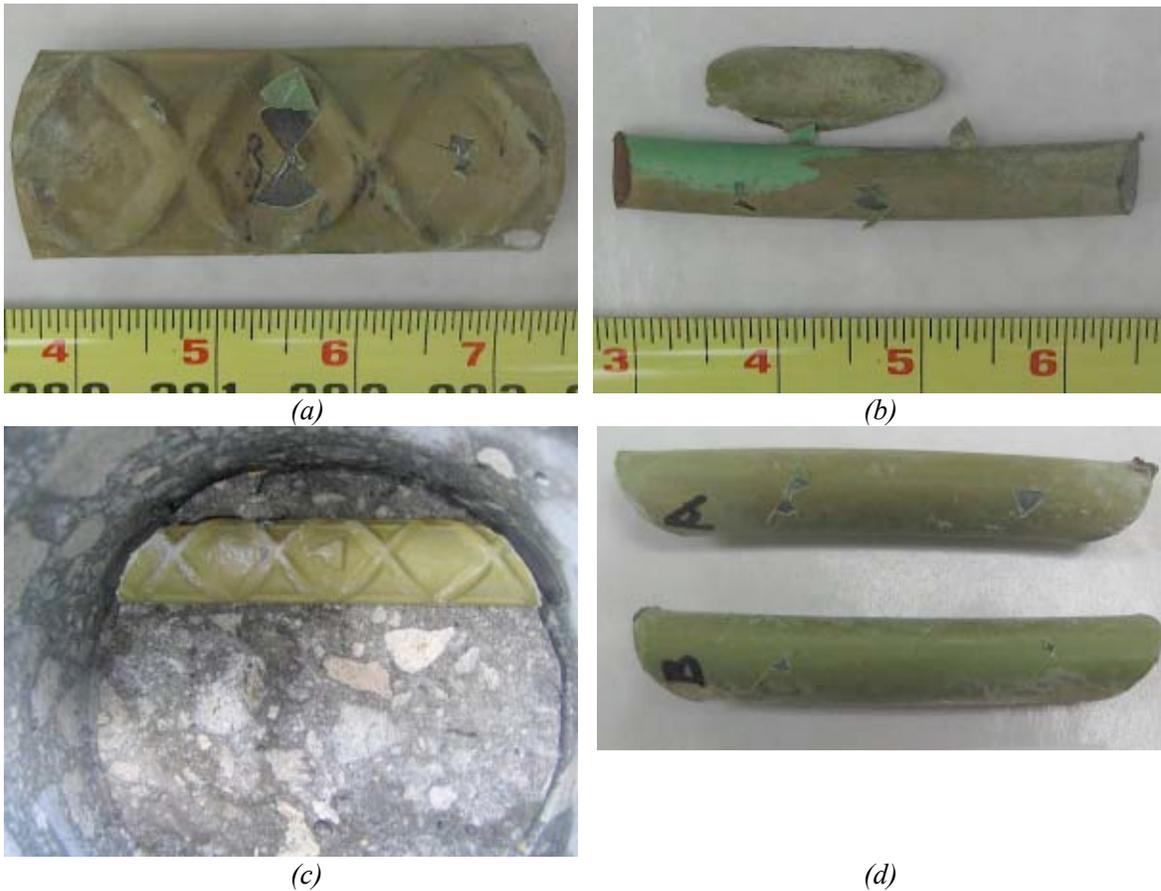
*Figure 30. Condition of bars extracted from the Holden Beach Bridge: a) a bar from Core 10-2, from the top of the strut wall of Bent 10 (14 in. above high tide). Bar-level chloride is 0.039 wt%; b) a bar from Core 10-3, from the west column of Bent 10 (26 in. above high tide). Bar-level chloride concentration is 0.100 wt%; c) a bar from Core 12-5, from the north face of Bent 12 (at high tide line). Bar-level chloride concentration is 0.068 wt%; d) two bars from Core 10-5, from the west column of Bent 10 (62 in. above high tide). Bar-level chloride concentration is 0.008 wt%.*

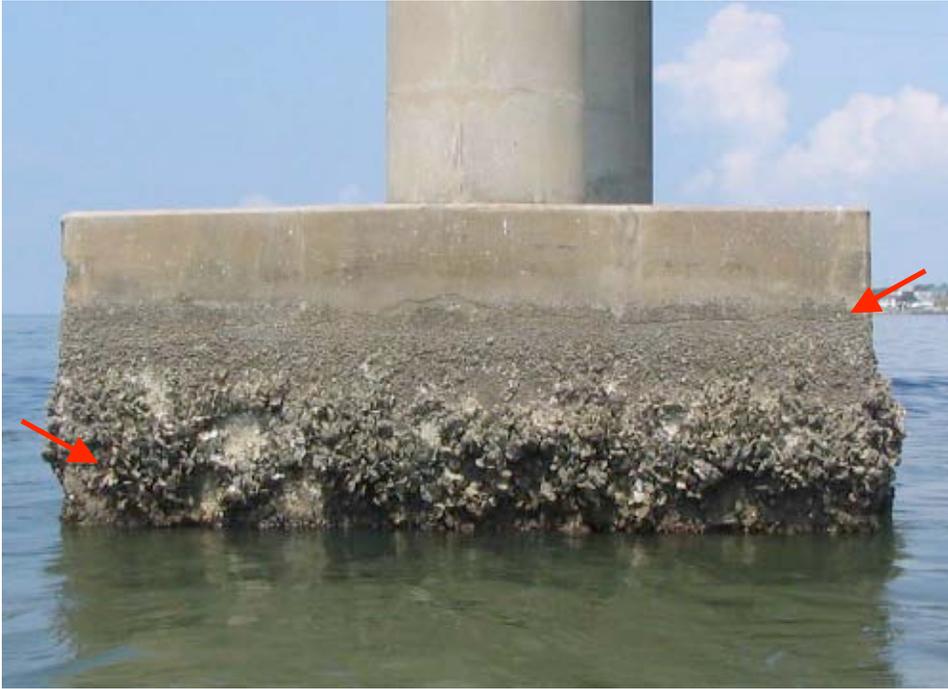
*Figure 33. Surface condition of the Atlantic Beach Bridge Bents: the pile cap of Bent 38 has two horizontal cracks (highlighted by arrows).*

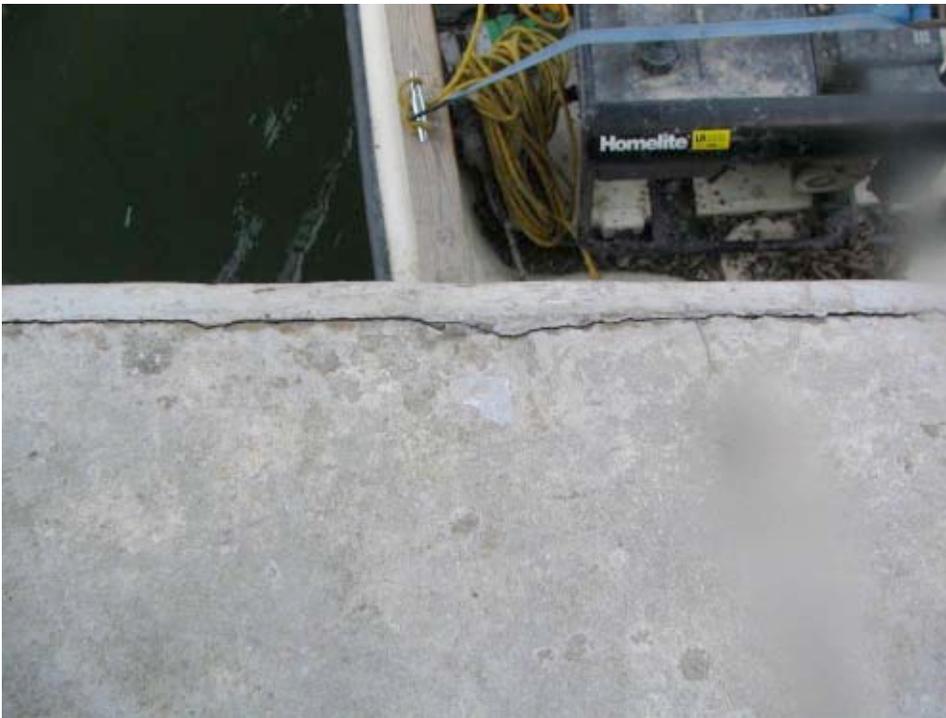
*Figure 34. Surface condition of the Atlantic Beach Bridge Bents: a delamination observed on the top of the pile cap of Bent 36. The delaminated concrete has a thickness of approximately 1 in.*

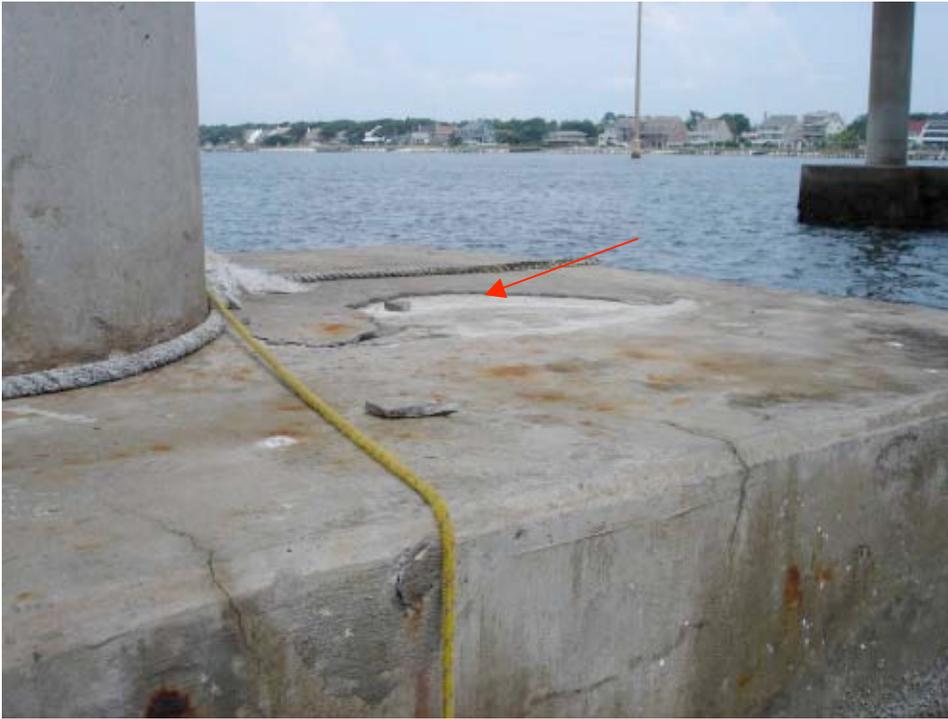
Figure 35. Surface condition of the Atlantic Beach Bridge Bents: a delaminated area and several cracks were found on the top surface of the east pile cap of the Bent 34. The delaminated area has very thin cover (approximately 1/2 in.) and appears to be a secondary concrete placement (overlay).

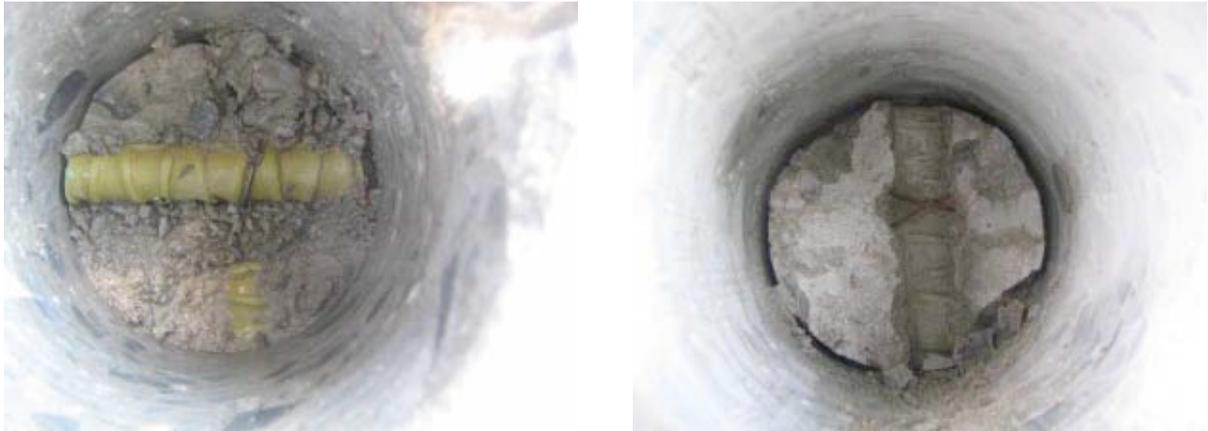
Figure 37. Condition of epoxy-coated bar extracted from the Atlantic Beach Bridge: 1) Core 34-4; 2) Core 31-8, bar imprint with no sign of active corrosion, uncoated steel ties were used.

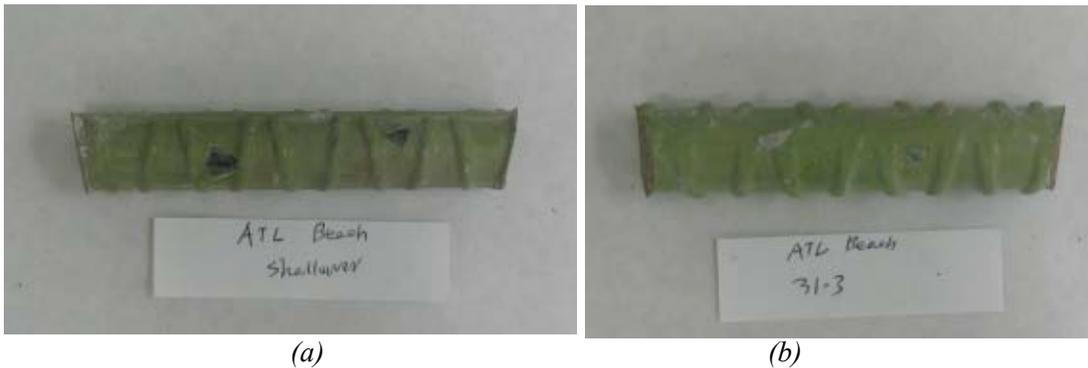
Figure 38. Surface condition and adhesion test results of bars extracted from the Atlantic Beach Bridge: a) a bar from Core 31-4, poor adhesion; b) a bar from Core 31-3, good adhesion. Bar-level chloride concentrations were both 0.003 wt%.
