CONDITION SURVEY OF OLDER WEST VIRGINIA BRIDGE DECKS CONSTRUCTED WITH EPOXY- COATED REINFORCING BARS

Final Report

December 22, 2009

Wiss, Janney, Elstner Associates, Inc.

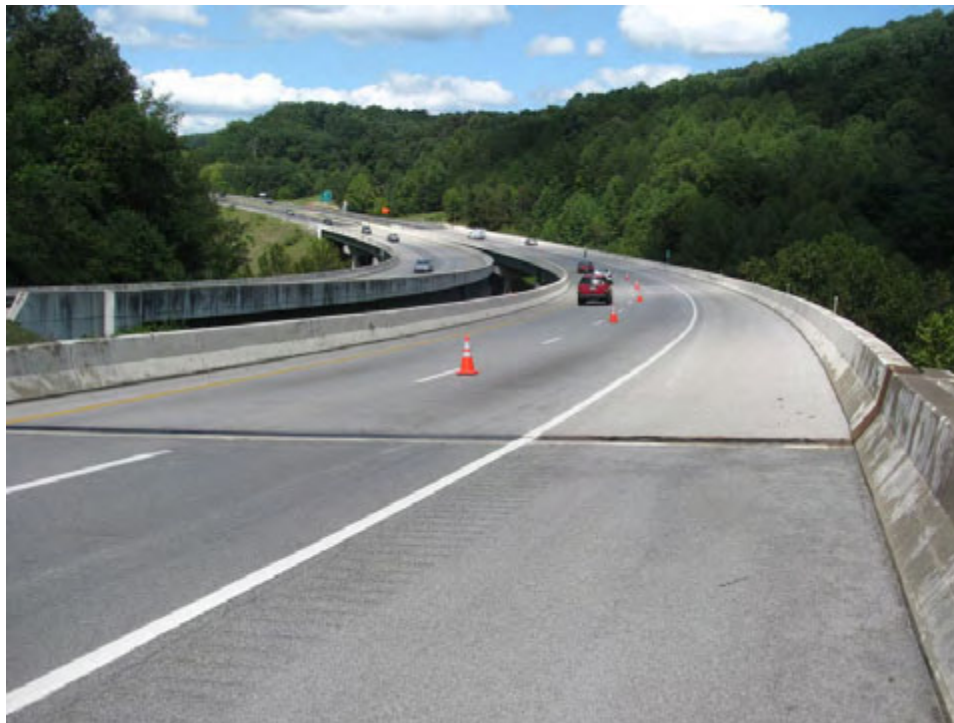
Figure 8. Bridge No. 2668N

The deck of Bridge No. 2668N is curved, carries I-79, and consists of seven spans supported on steel girders. The average measured cover was 2.7 in. The bridge deck contains ECR in both top and bottom mats. The deck is pictured in Figure 8. This deck was topped with an anti-icing and anti-skid epoxy-based overlay in 2008. This polymer overlay is visible on the core shown as Figure 9. The deck did not show any corrosion related distress at the time the overlay was placed. Since the overlay was installed so recently, this deck was included because it was felt the chloride penetration and conditions of the bars would not have been significantly affected in the year since this overlay was installed.

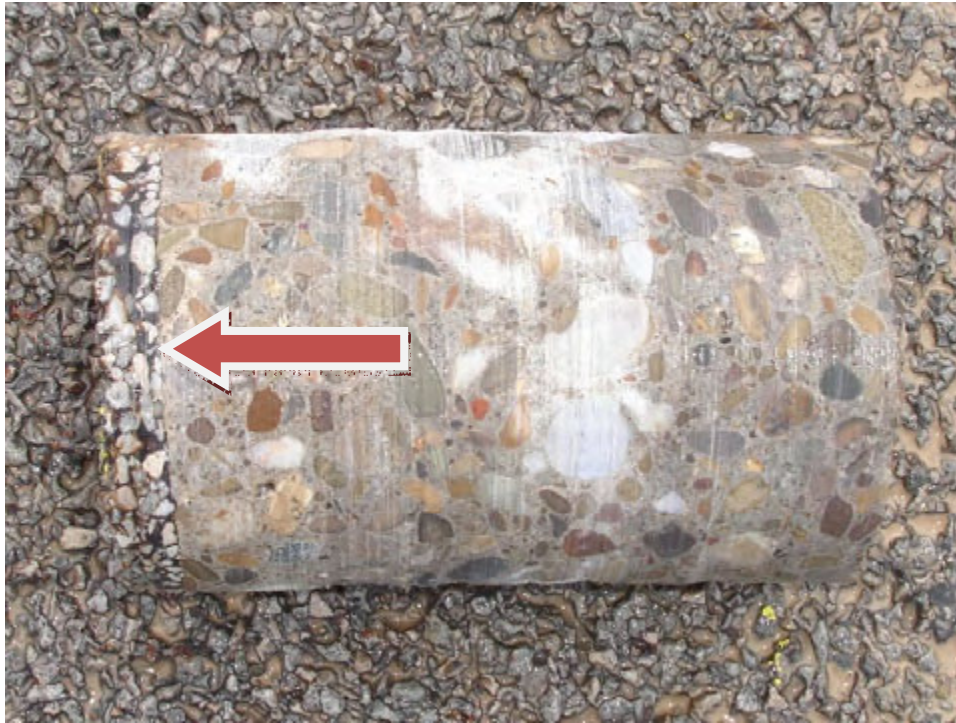
Figure 9. Thin polymer overlay visible on top (left) of core from Bridge No. 2668N.

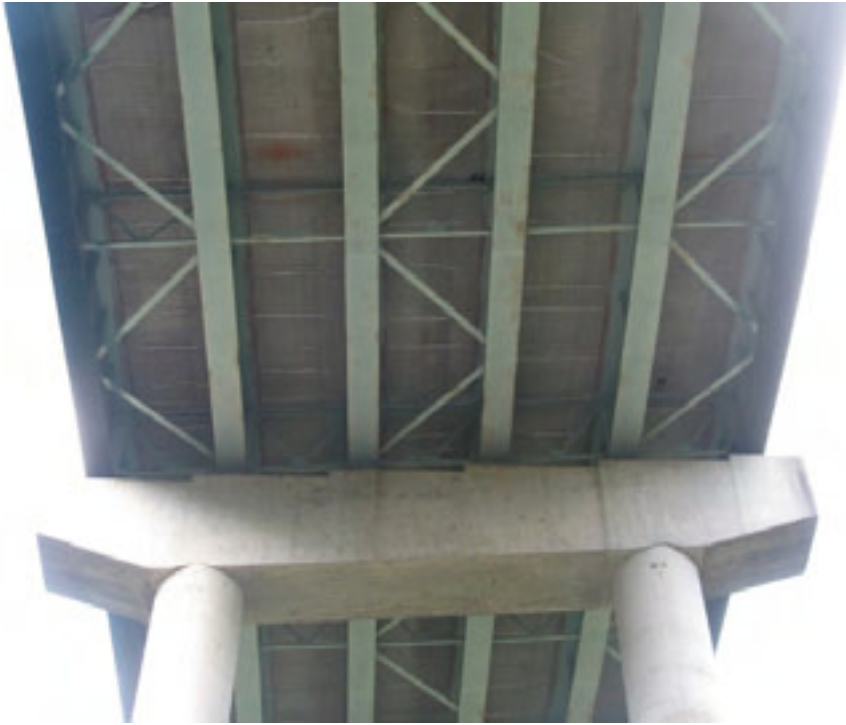
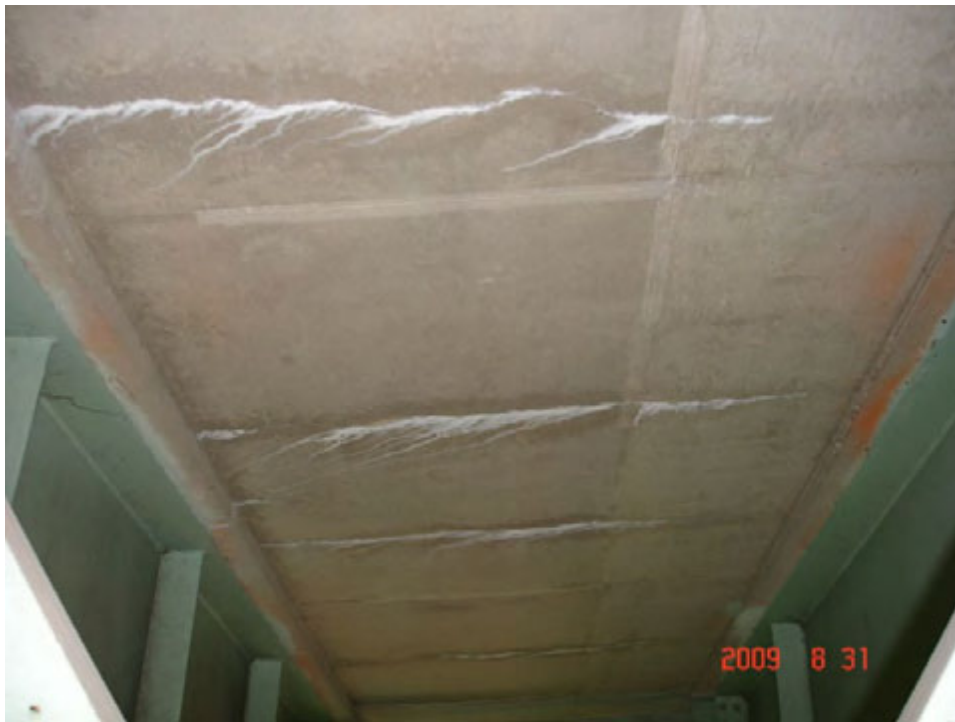
The delamination survey identified few small delaminations away from the expansion joints. Of the 12,444 ft² evaluated, only 9 ft² (0.07 percent) of delamination was identified. Sounding could not determine if the delaminations were due to a lack of bond between the thin polymer overlay and the deck or due to concrete deck delaminations. Since the overlay was present, cracks in the deck could not be located visually. However, a core (4T) taken in a delaminated area did include a vertical crack and a delamination at the top bar level. Examination of the deck from below revealed extensive transverse cracking (Figure 10). No corrosion-related deterioration was observed on the deck soffit.

Figure 10. Transverse cracking on underside of Bridge No. 2668N.

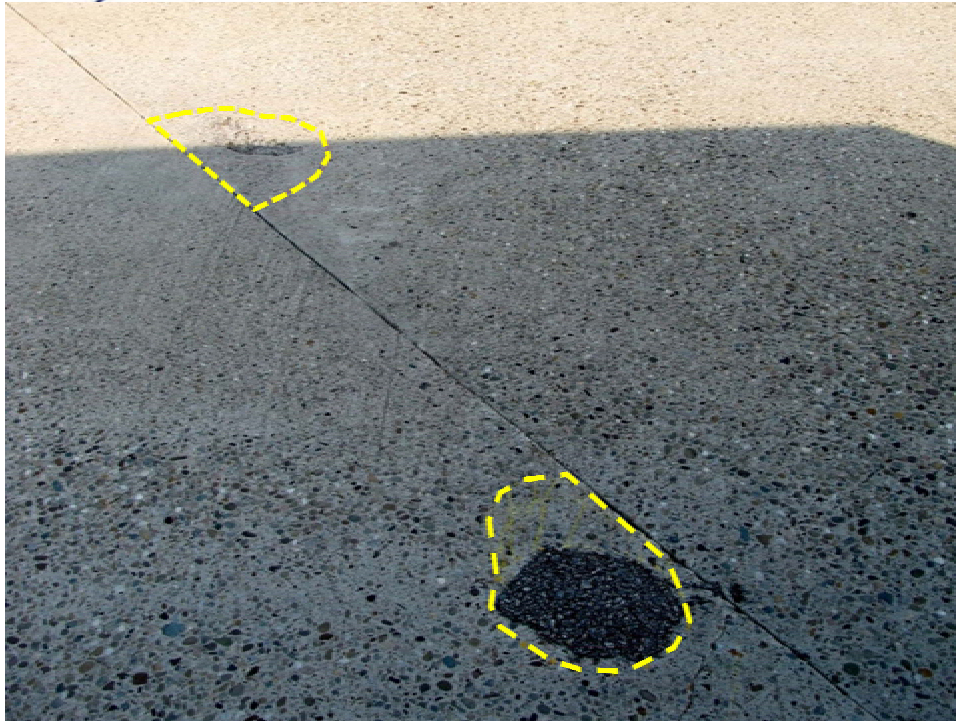
Delaminations 2 ft² in size or less and some associated spalls and patching were identified in these decks (Figure 13). A total of 8,544 ft² was surveyed between these two decks, and only 9 sf (0.10 percent) of delamination was identified. The majority of these were associated with construction joints separating the deck placements over the piers. According to the design drawings, this joint was to be keyed and edged with 1/4-in. edging tool then filled with a “hot-poured elastic-type construction joint sealer”. Similar construction joint details are given for the other bridge decks that were investigated.

Figure 13. Patch and spall at construction joint on Bridge No. 2672N. Delaminations are highlighted by yellow dashed lines.

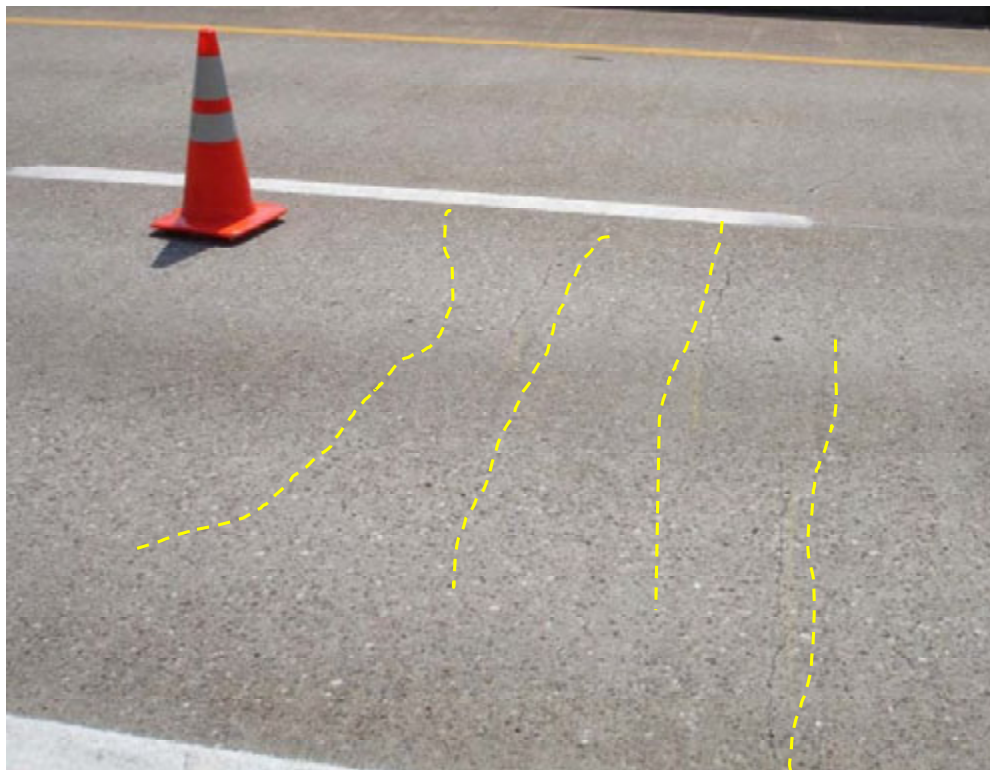
Transverse cracks were also present throughout the decks (Figure 14). These cracks are typical of early-age, transverse deck cracks that were likely caused by concrete drying shrinkage and thermal contraction (Krauss P. D., 1996) and not by corrosion of the reinforcing bars (Figure 15). Such cracking was common on all decks inspected as part of this study. This transverse cracking was also visible on the underside of these decks. Spalling at an uncoated bottom reinforcing bar in Bridge No. 2672N was visible in one location (see Figure 16), and incipient spalling and staining related to corrosion of uncoated bottom bars was visible at a number locations on the soffit of both of these decks, particularly adjacent to the construction joints.

Figure 14. Transverse cracking in Bridge No. 2672S. Cracks are highlighted by yellow dashed lines.

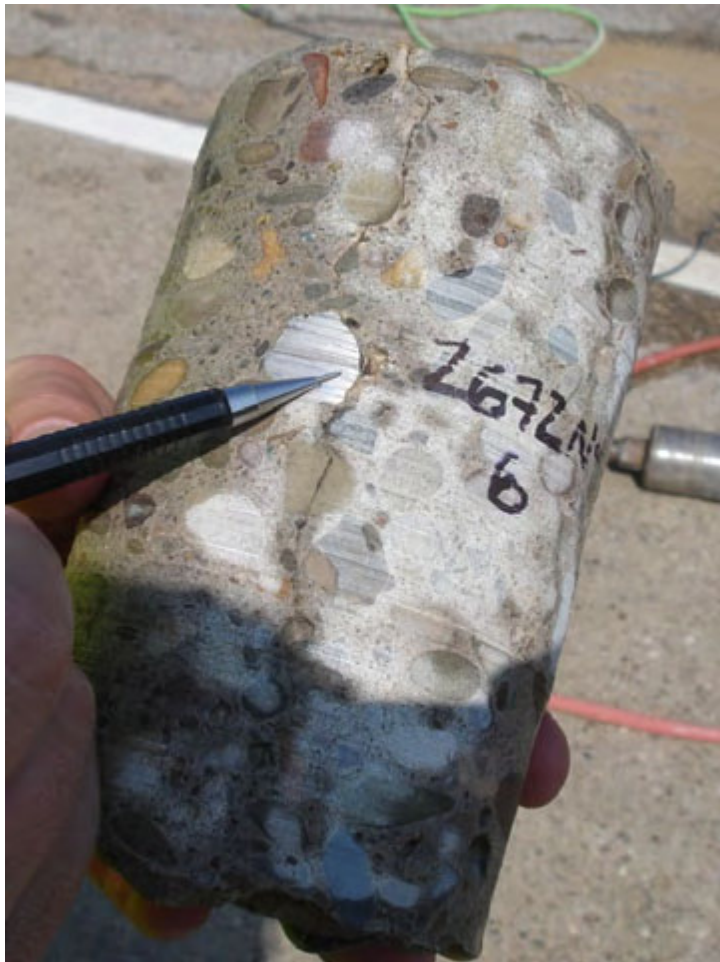
Figure 15. Transverse cracking core 6 from Bridge No. 2672N.

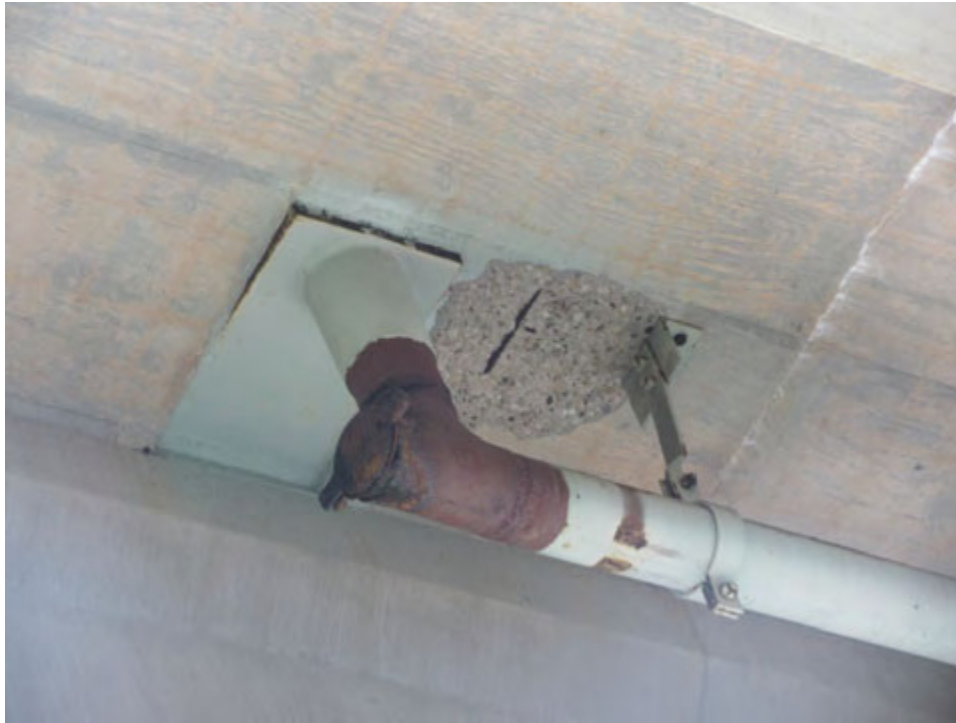
Figure 16. Spall due to corrosion of uncoated bottom bar in Bridge No. 2672N.

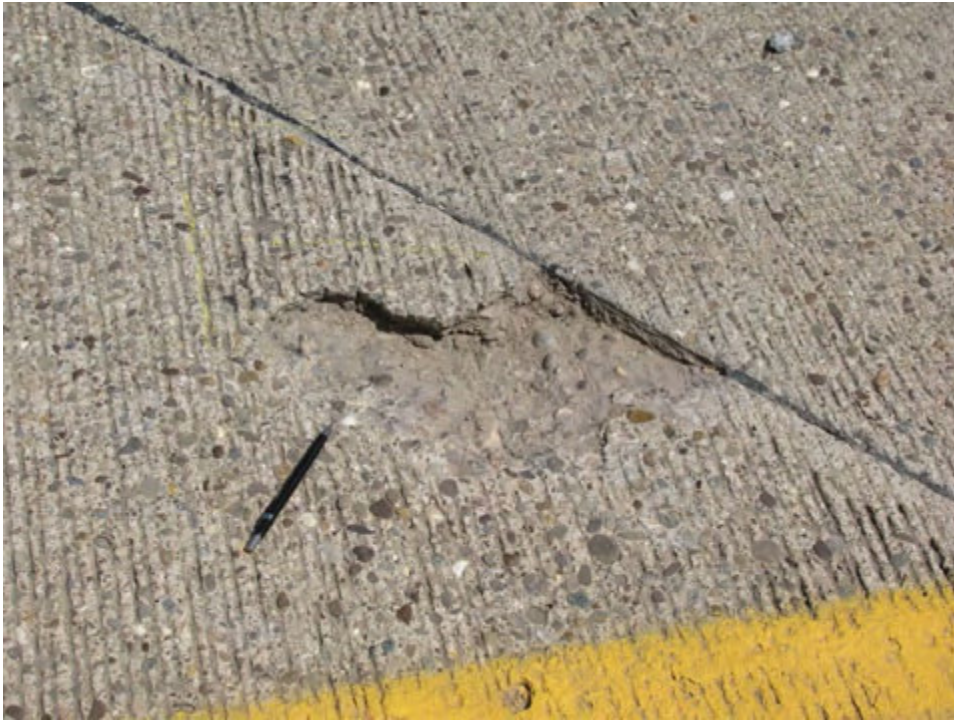
Figure 18. Spall at construction joint on Bridge No. 2673.

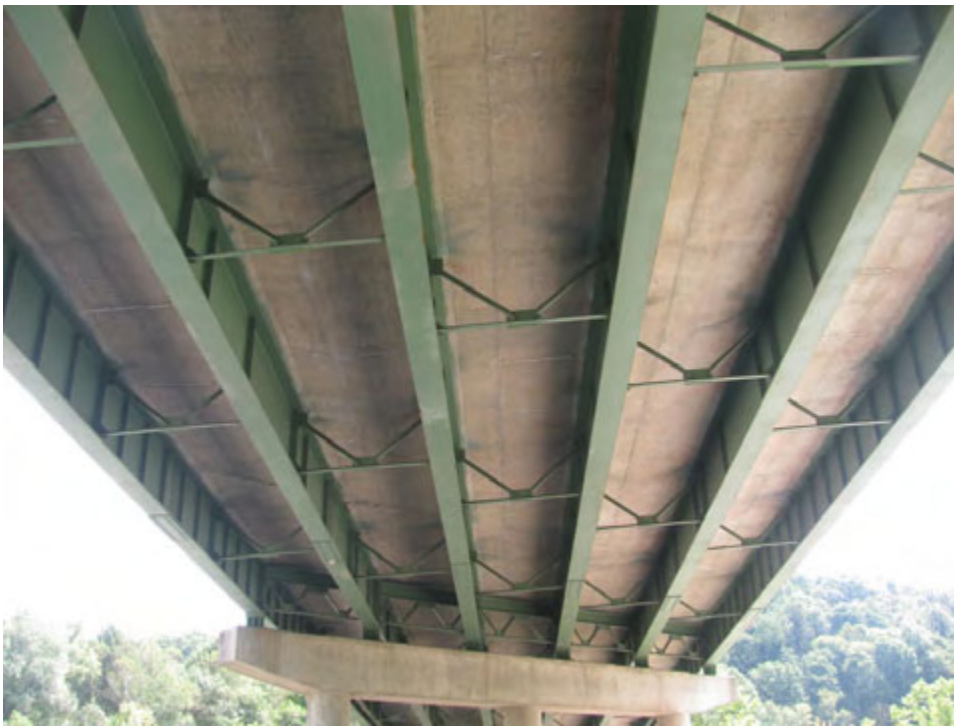
Relatively fewer cracks were observed on the deck soffit (Figure 19). However, signs of corrosion staining were visible at the construction joints, but no spalls were observed on the underside of the deck.

Figure 19. Underside of Bridge No. 2673.

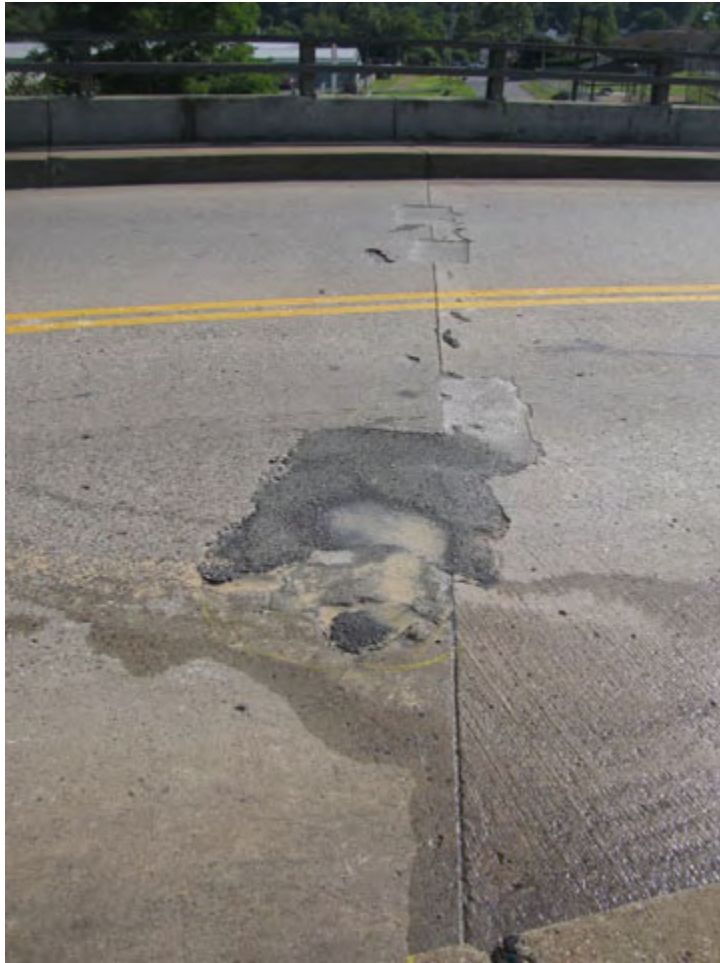
Figure 23. Repair on Span 5 of Bridge No. 2930.

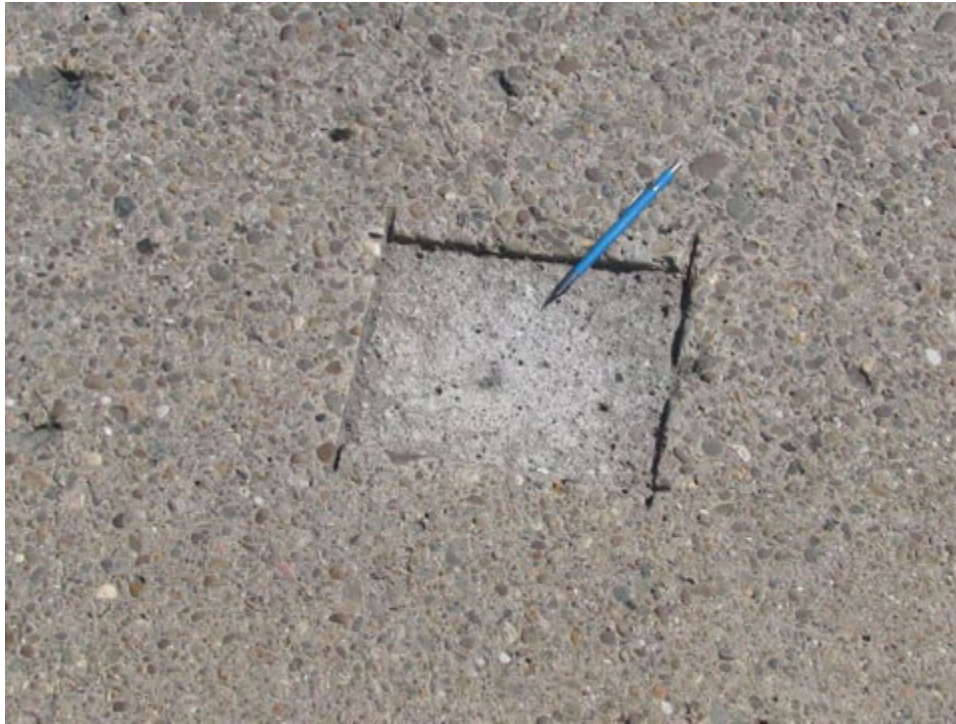
Figure 24. Isolated repairs on Bridge No. 2930.

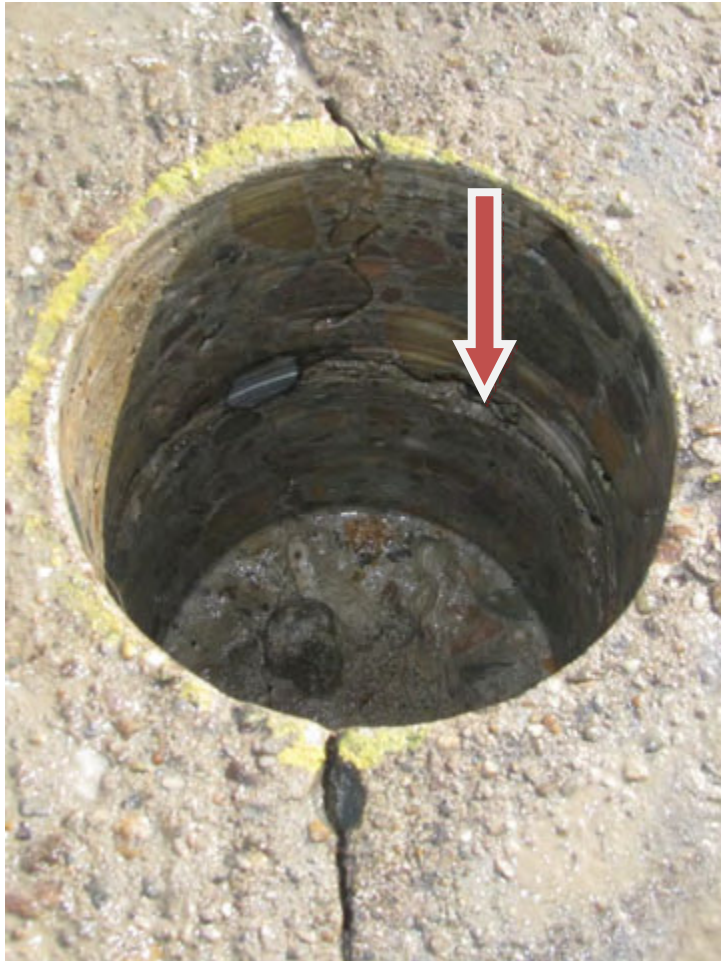
Figure 25. Delamination at bar level caused by corrosion of uncoated black bar in Bridge No. 2930.

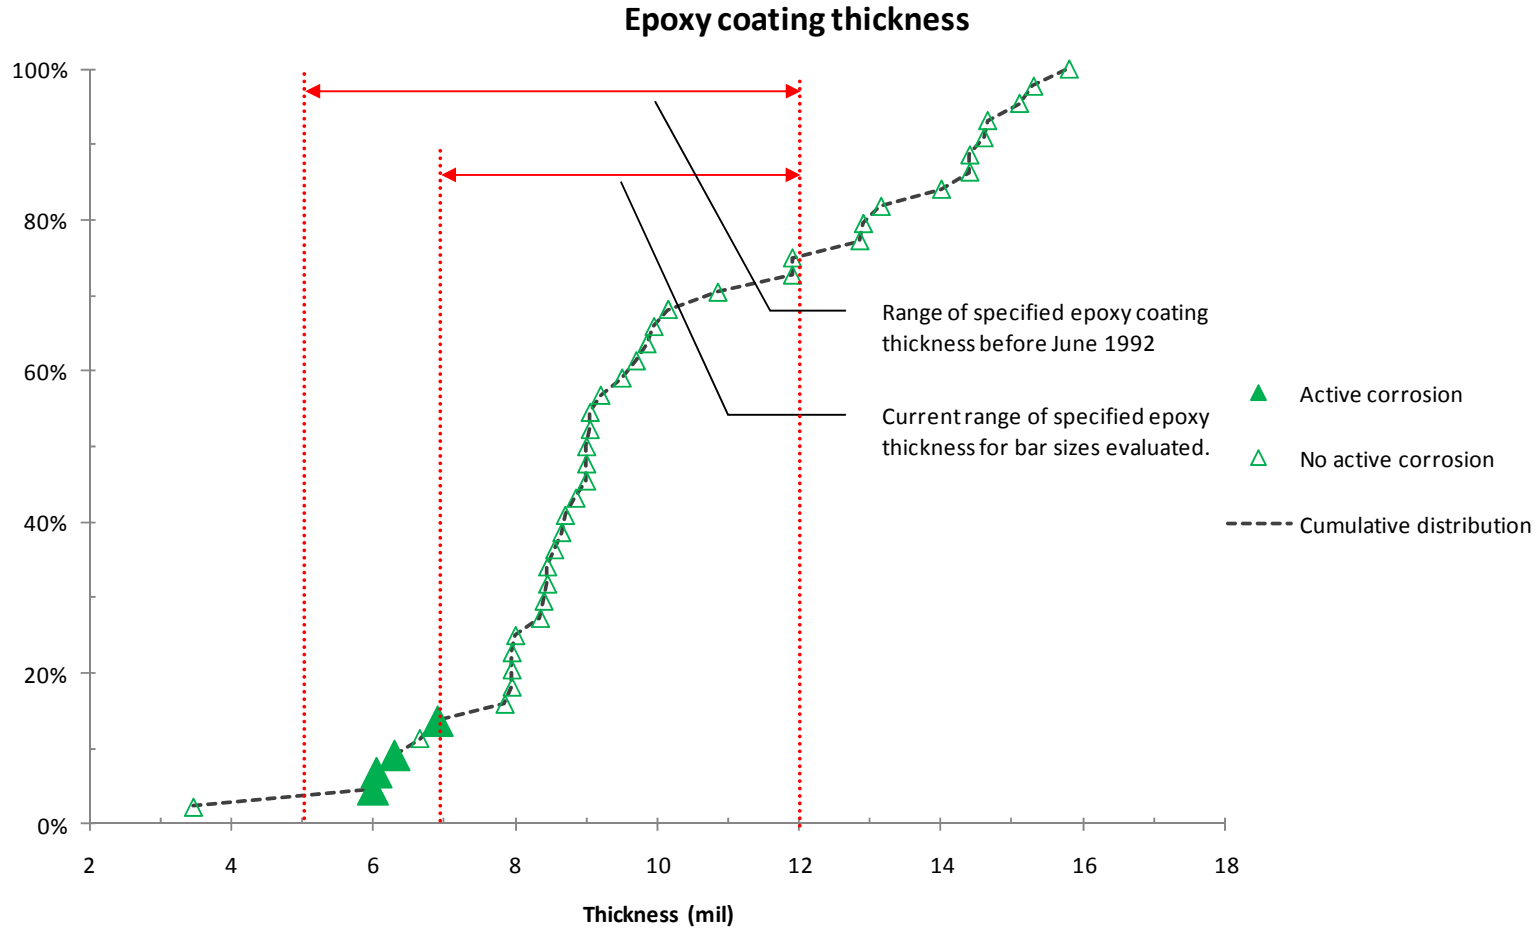
Figure 30. Distribution plot of epoxy coating thickness on bars in cores sampled from all bridges. Note actively corroding bars have thinner coatings.

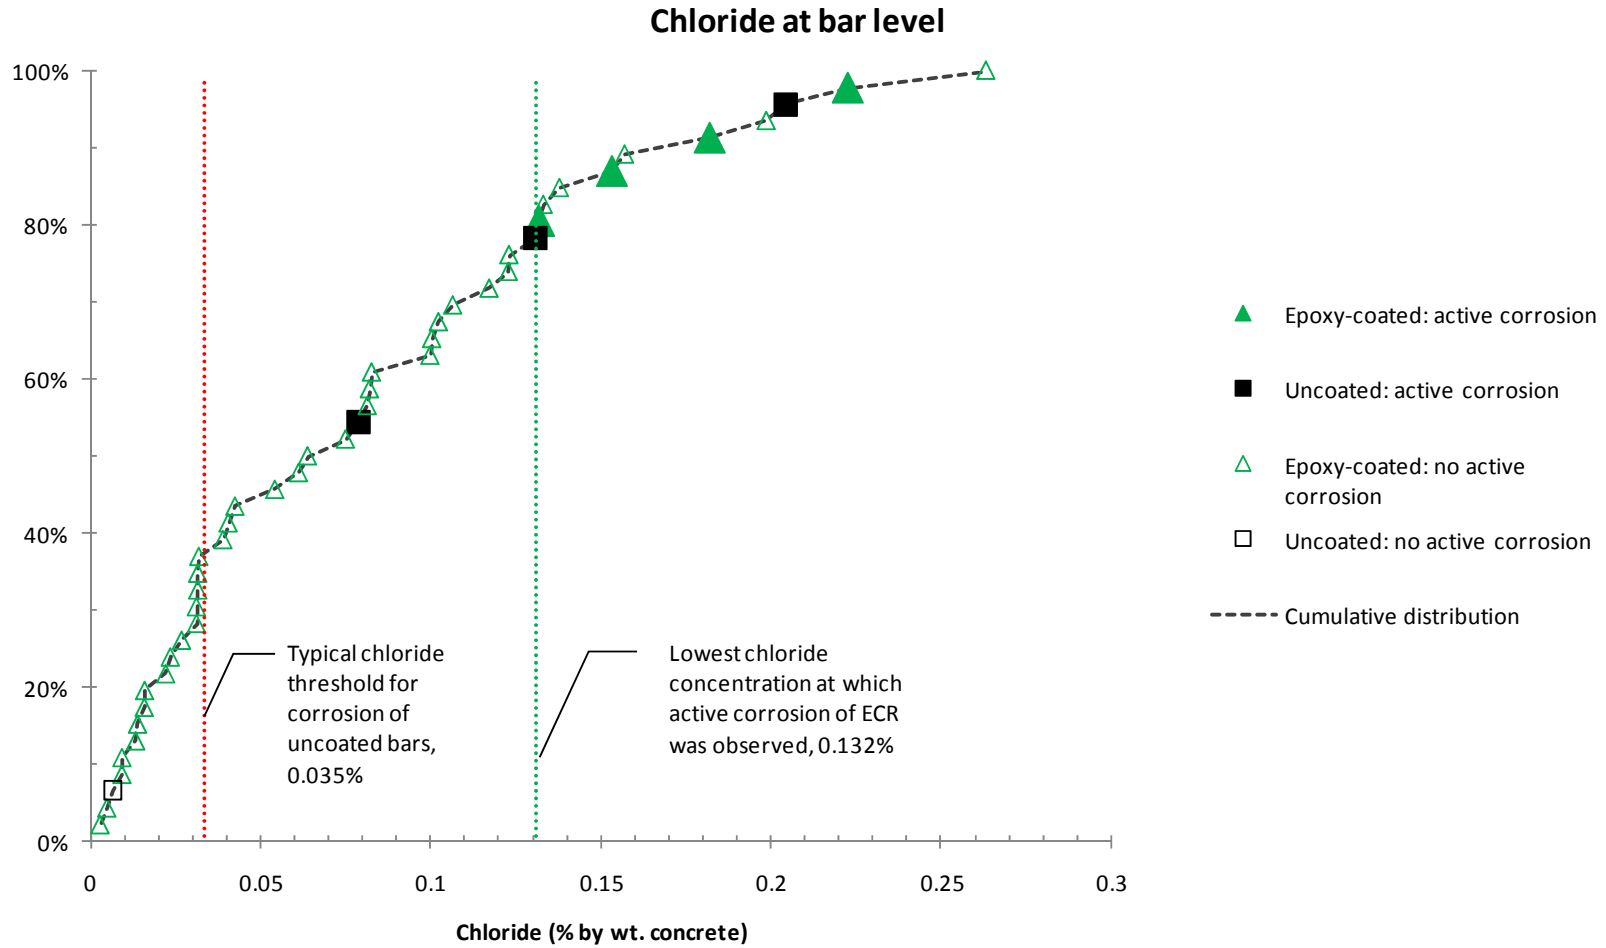
Figure 31. Distribution plot of chloride concentration at bar depth from all bridges. Note that all uncoated bars above uncoated-bar chloride threshold are actively corroding while the uncoated bar below this threshold is not corroding.
