**DESIGN AND CONSTRUCTION  
OF THE ST. ANTHONY FALLS BRIDGE (I-35W)  
TOM DEHAVEN - FIGG**

# BRIDGE DESCRIPTION

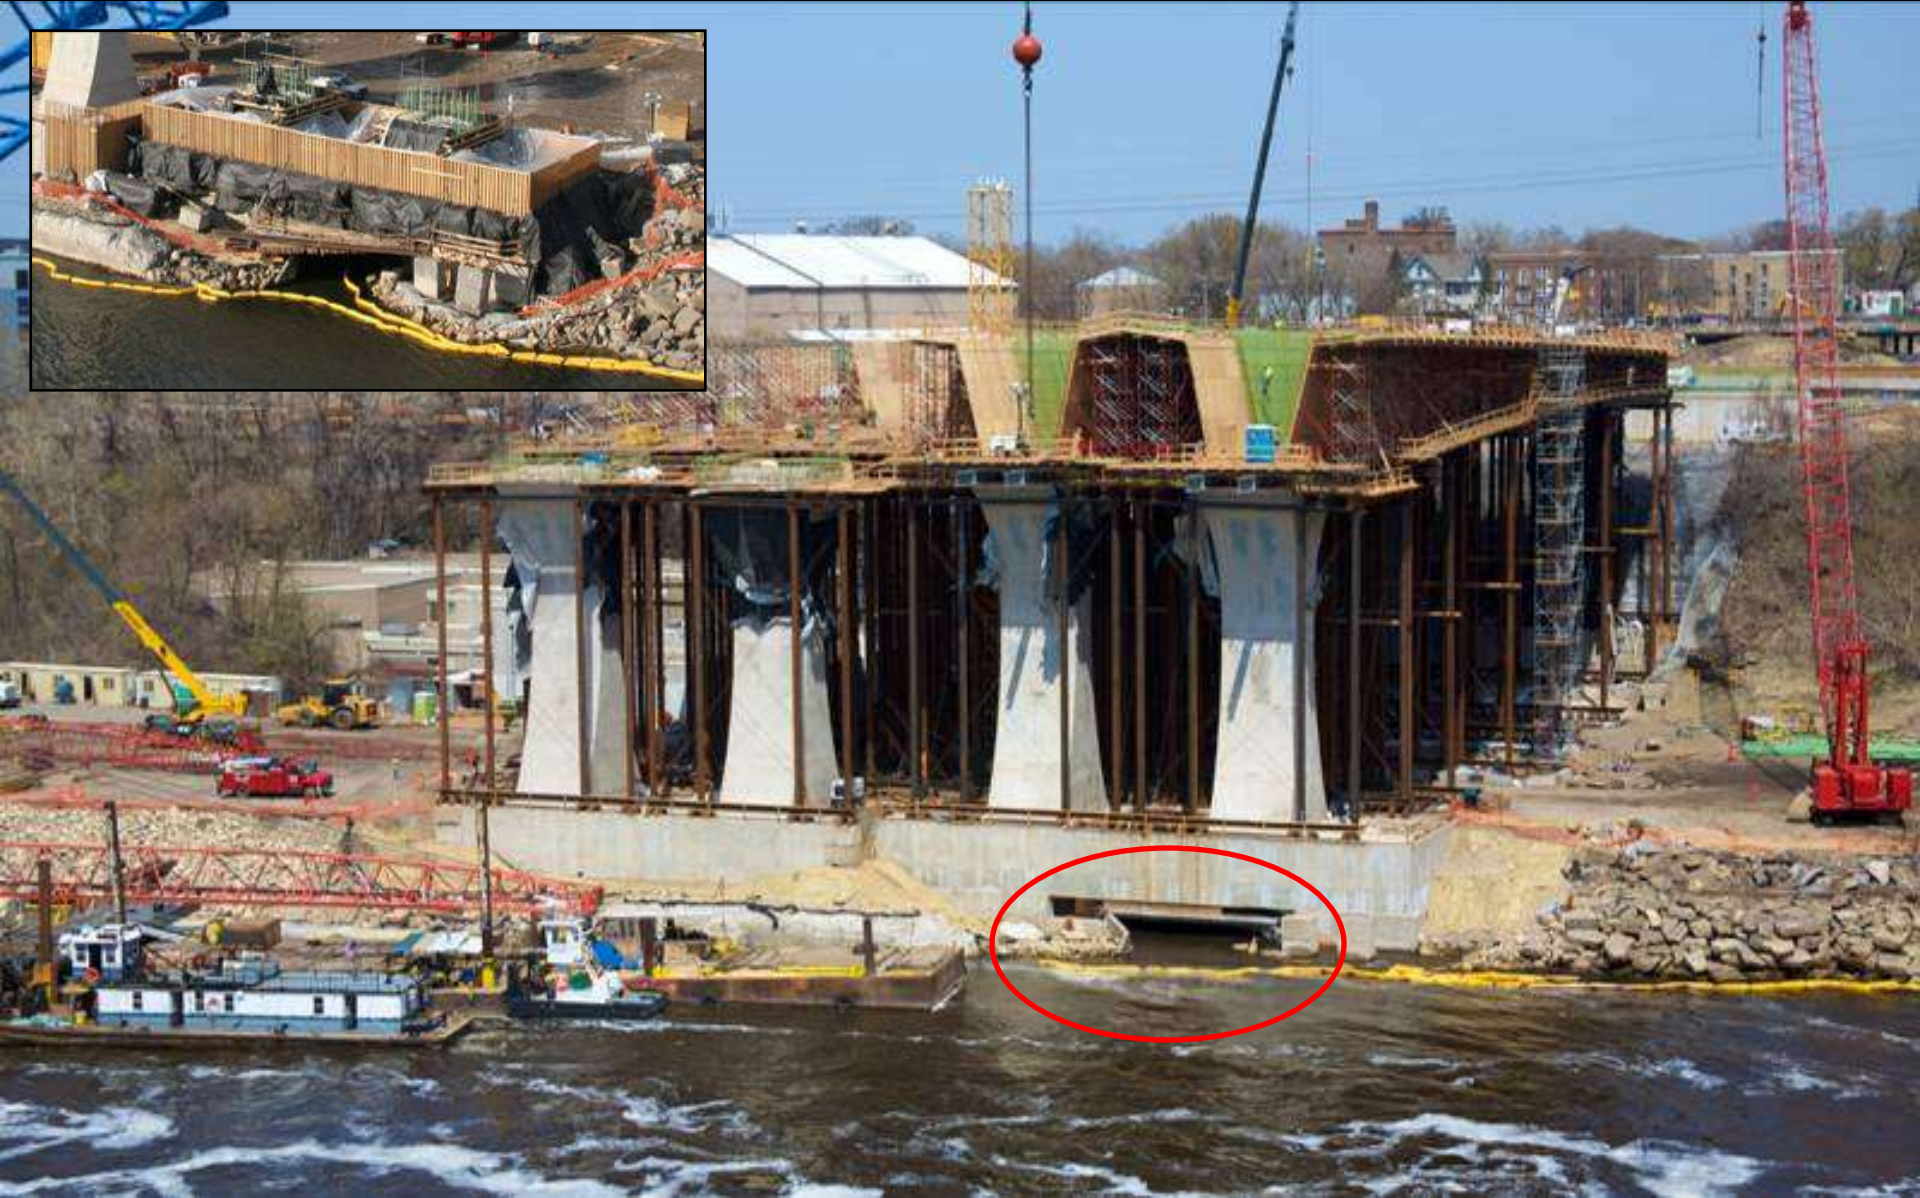
## MAIN PIER FOOTINGS

Span extensive storm drains  
Some locations straddle existing foundations

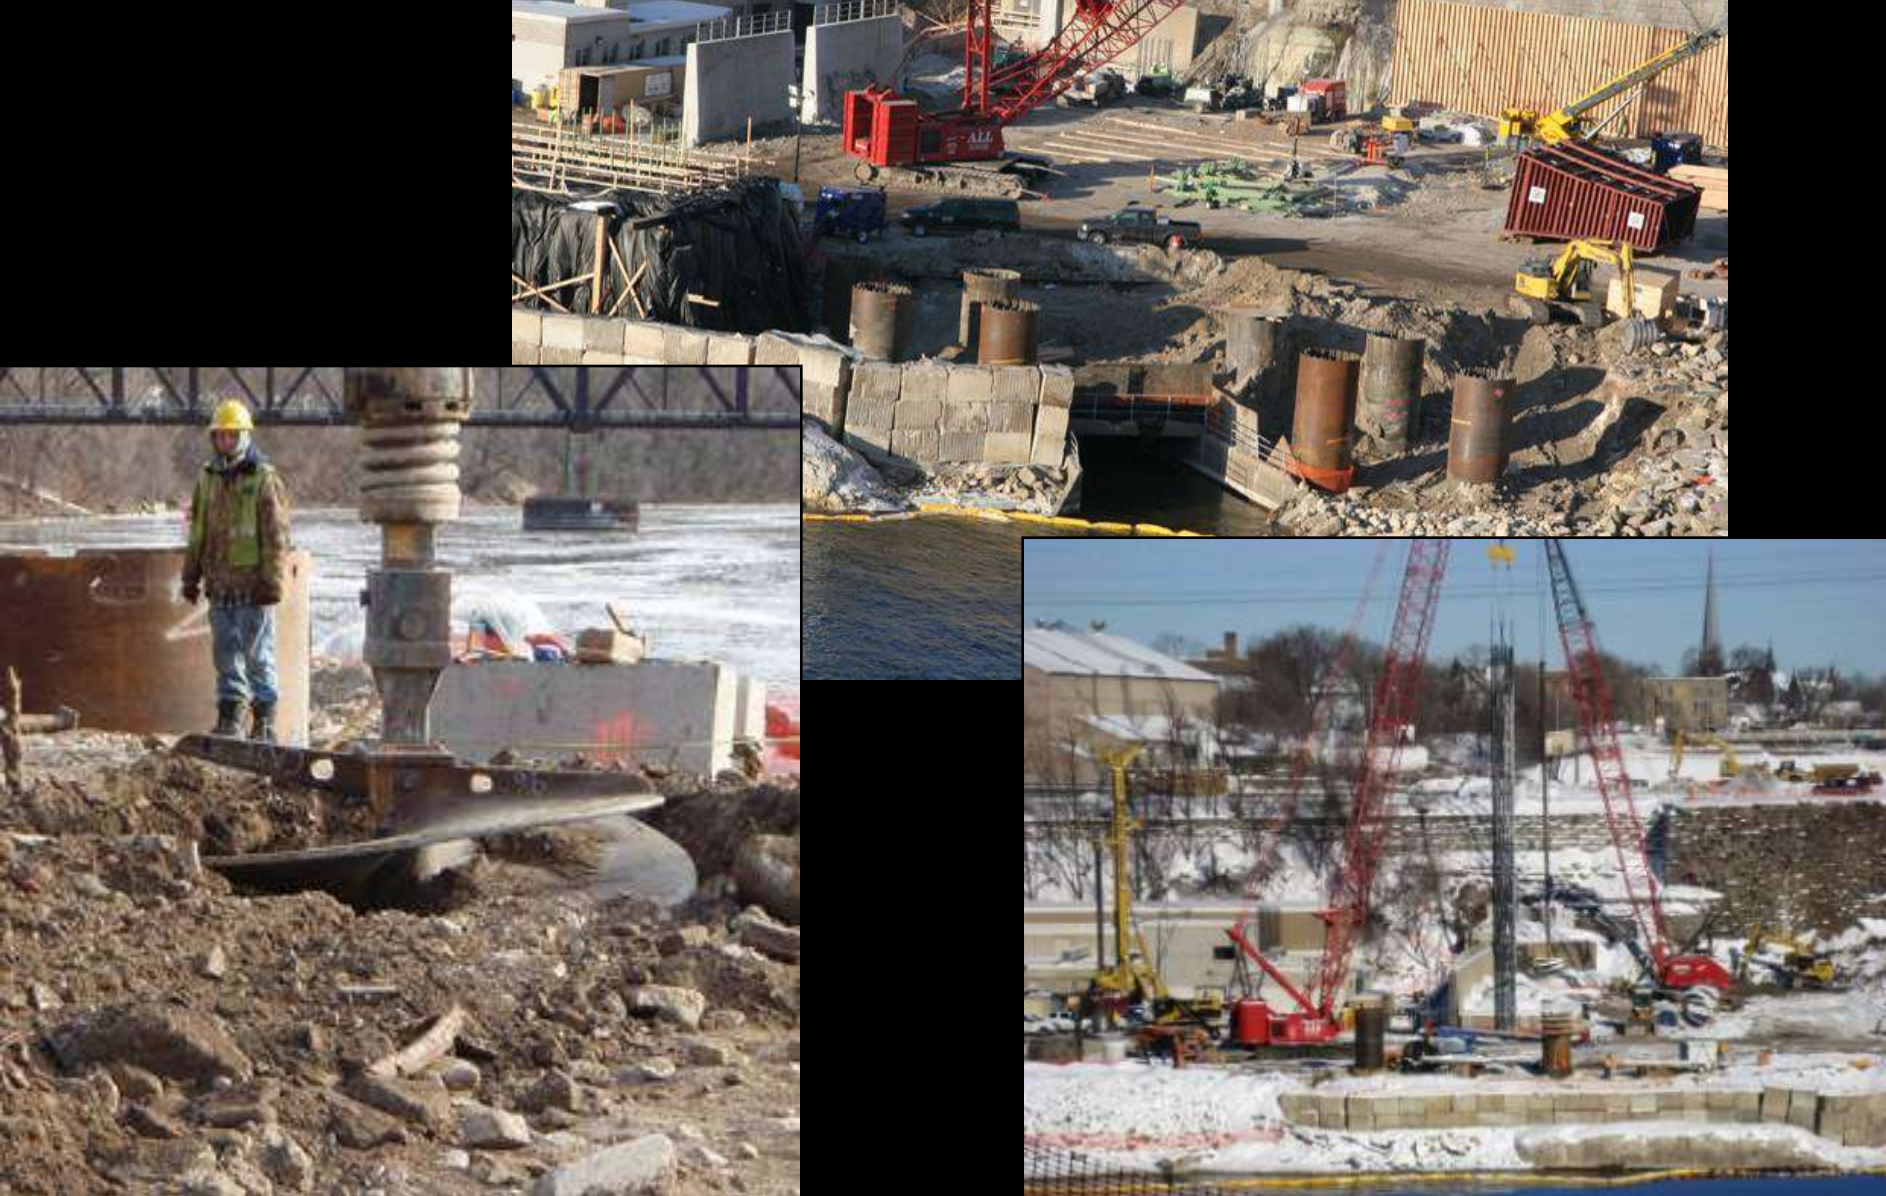
## MAIN PIER FOUNDATIONS

7' and 8' diameter drilled shafts  
100' long with socket into bedrock  
Slurry method with SC concrete

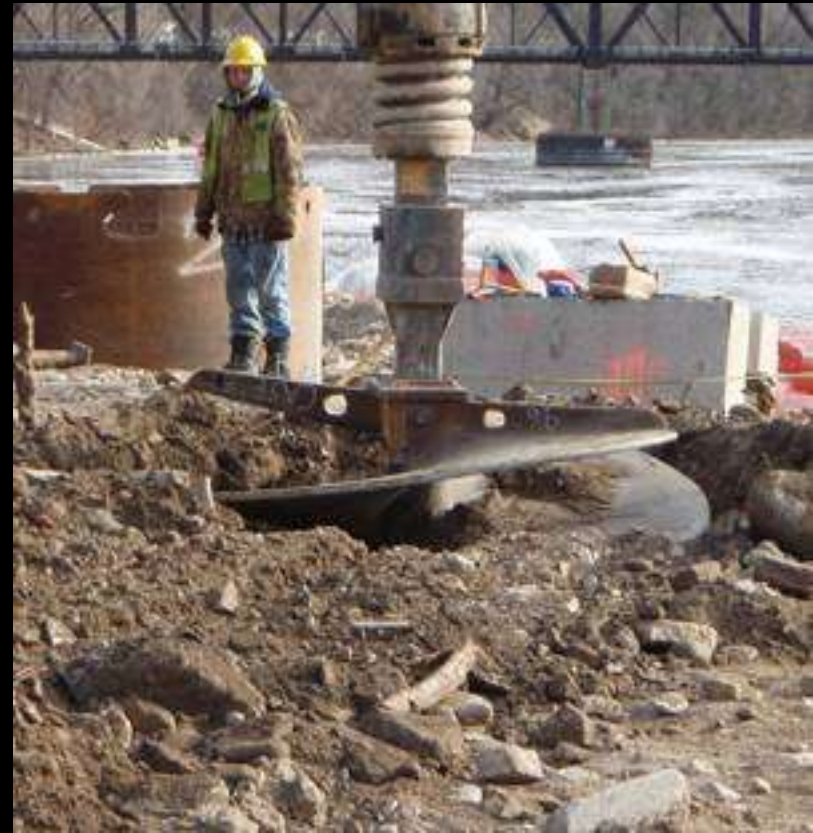
# DRILLED SHAFT ISSUES

- DRILLED SECOND TEST SHAFT ABOVE ARTESIAN
- USED 4 O-CELLS FOR SKIN FRICTION AND ONLY ONE TO ESTIMATE END BEARING
- USED SELF-CONSOLIDATION CONCRETE
- **TEST SHAFT EXCEEDED DESIGN BY 20%**
- **1<sup>ST</sup> PRODUCTION SHAFT AT CONTRACT DAY 50**

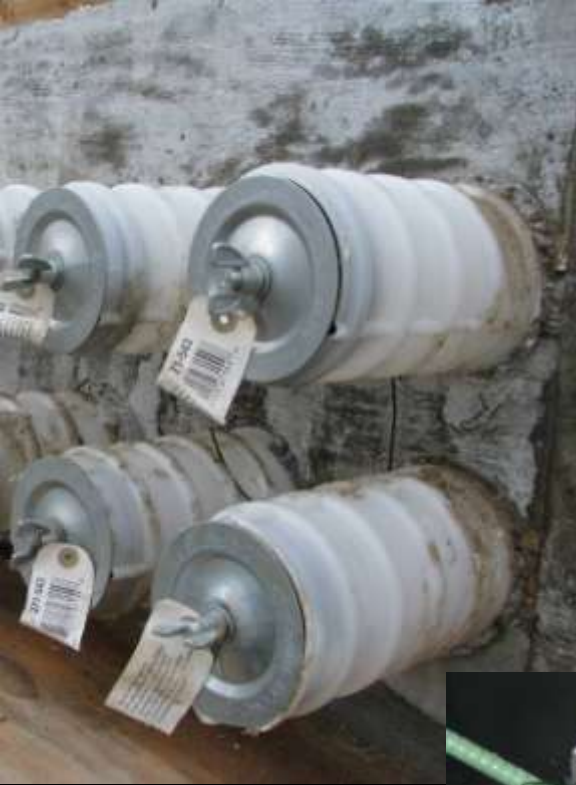
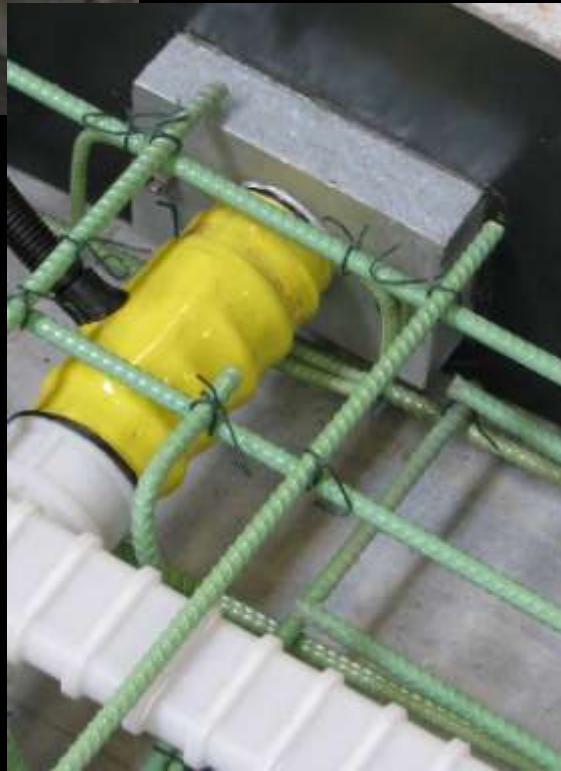
# CORROSION PROTECTION OF POST- TENSIONING STRAND SYSTEMS

High Performance Concrete provides a dense, barrier with low permeability

Post-tensioning ducts – corrugated plastic in the top slab, high-density polyethylene for external tendons, and galvanized steel corrugated duct for all other locations

Enhanced cementitious prepackaged grout with Thixotropic Properties

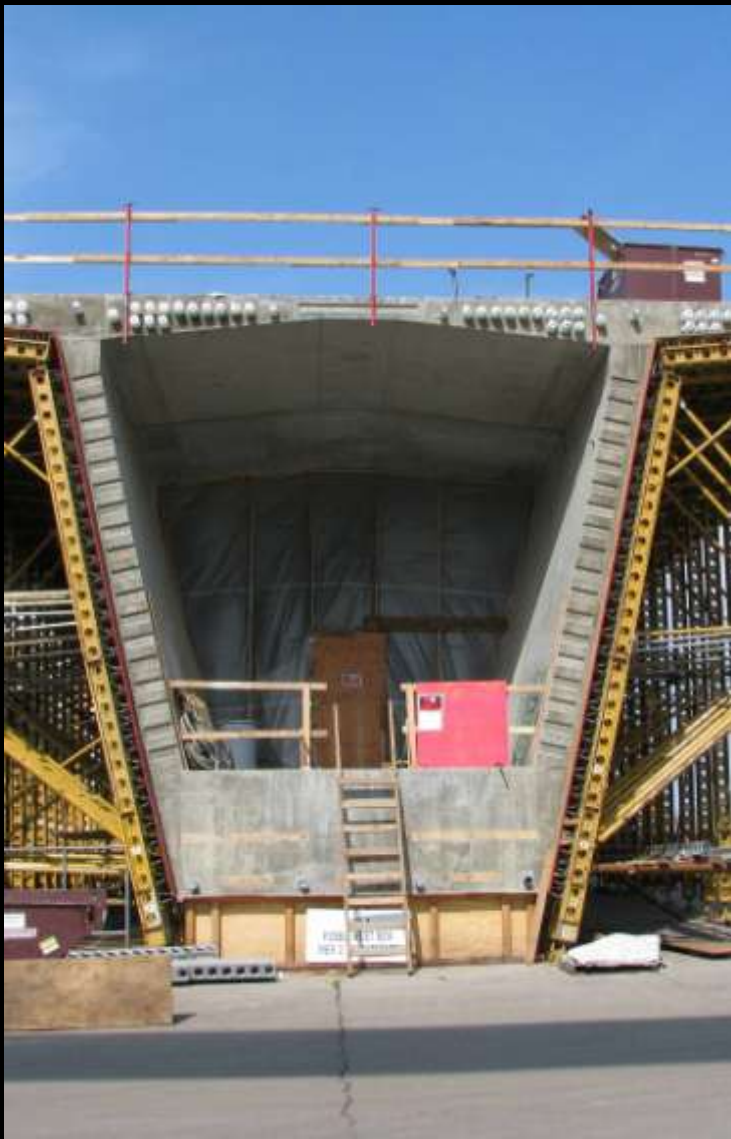
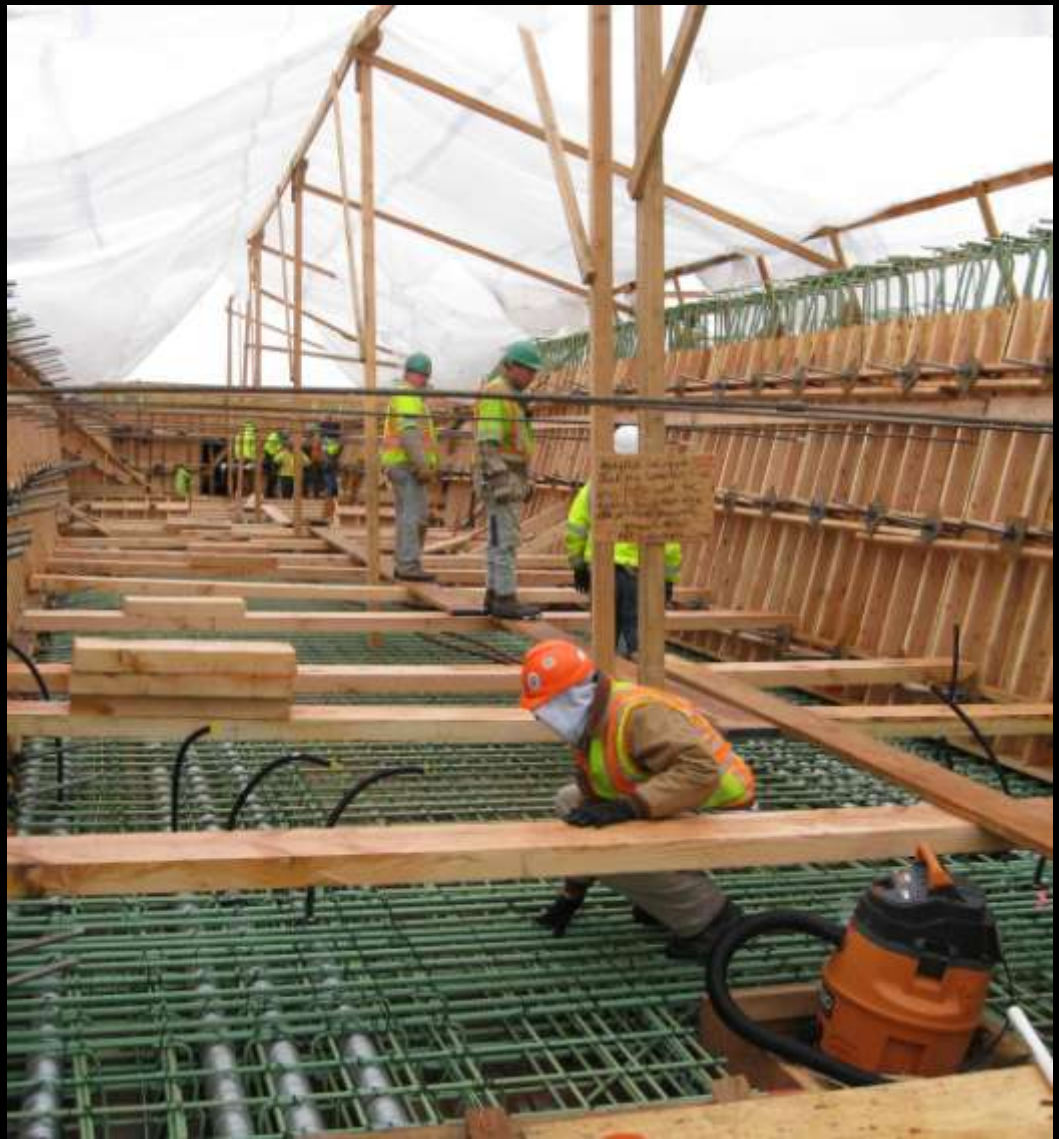
## **SUPERSTRUCTURE**

25' to 11' high CIP box girders (back spans)  
25' to 11' high precast segments (main span)  
Back spans and main span cast simultaneously

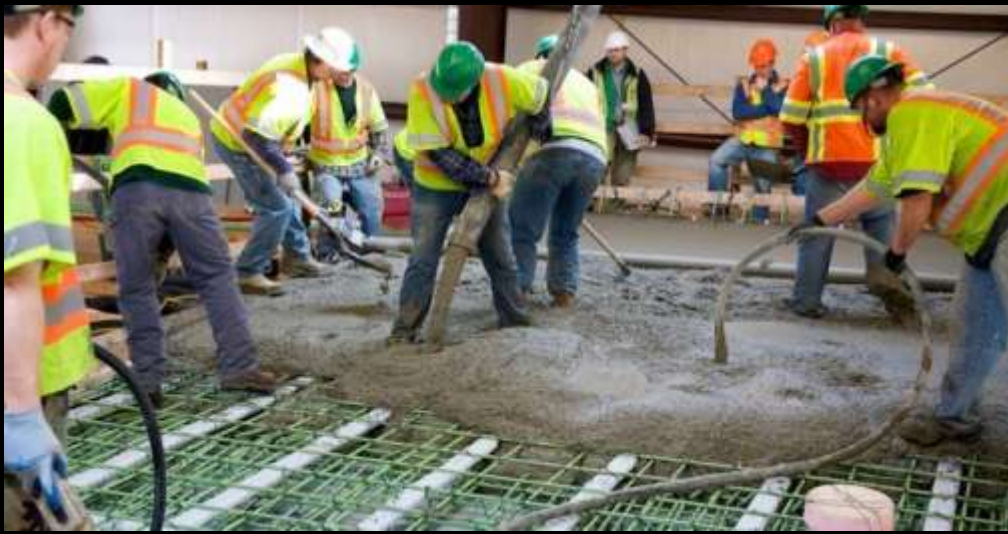
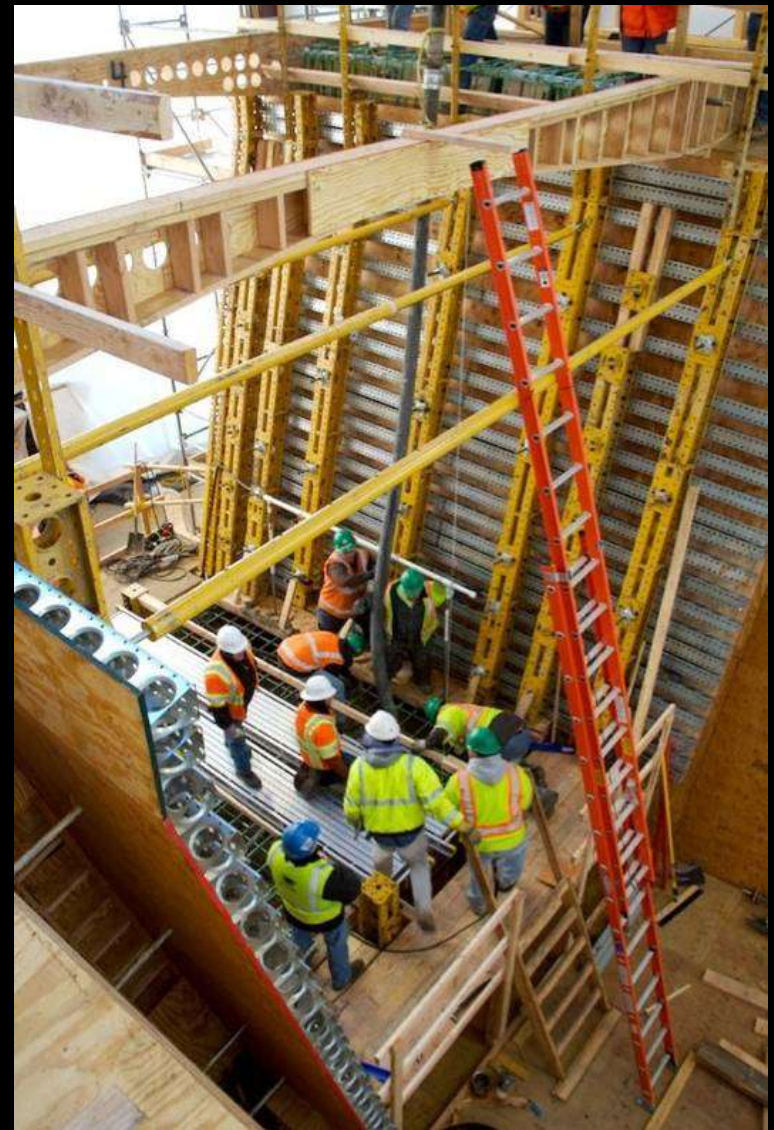
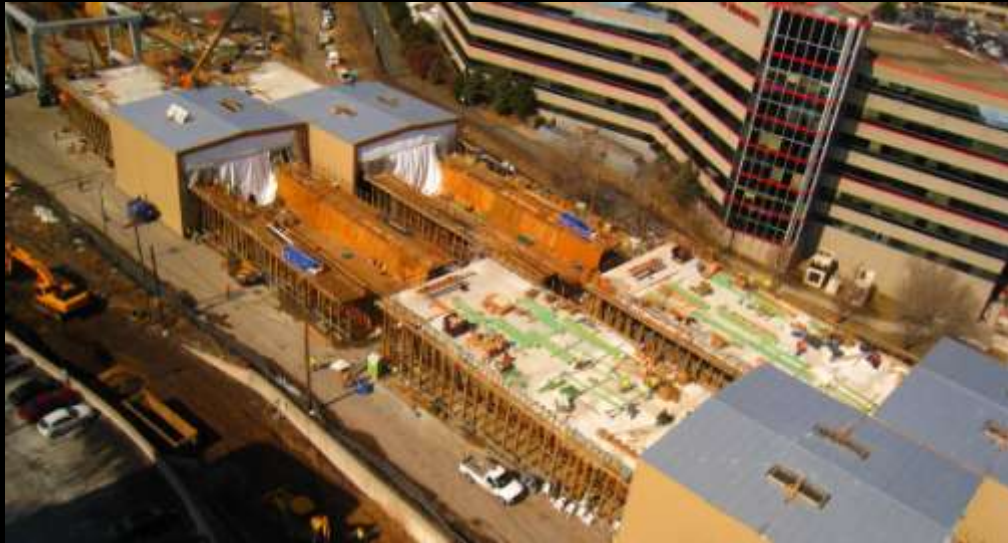
**SUPERSTRUCTURE  
(MAIN SPAN — PRECAST SEGMENTS)  
(CASTING YARD — LONGLINE CASTING)**

All 8 headings cast simultaneously  
Longline casting method  
Heated enclosures

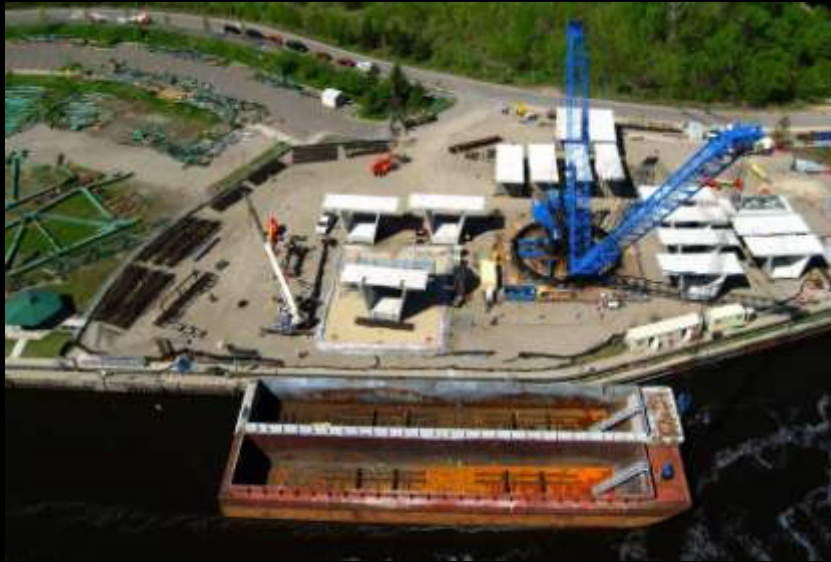
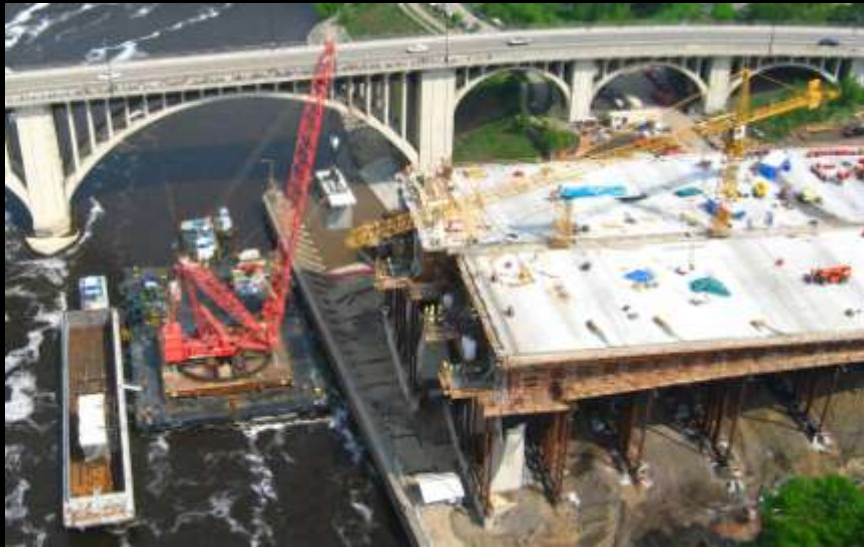
**SUPERSTRUCTURE**  
**(MAIN SPAN — PRECAST SEGMENTS)**  
**(UNIDIRECTIONAL CANTILEVER)**

**SEGMENT LENGTHS - 13.5' TO 16.5'**  
**WEIGHTS - 380 KIPS TO 216 KIPS**  
**15 SEGMENTS PER CANTILEVER**

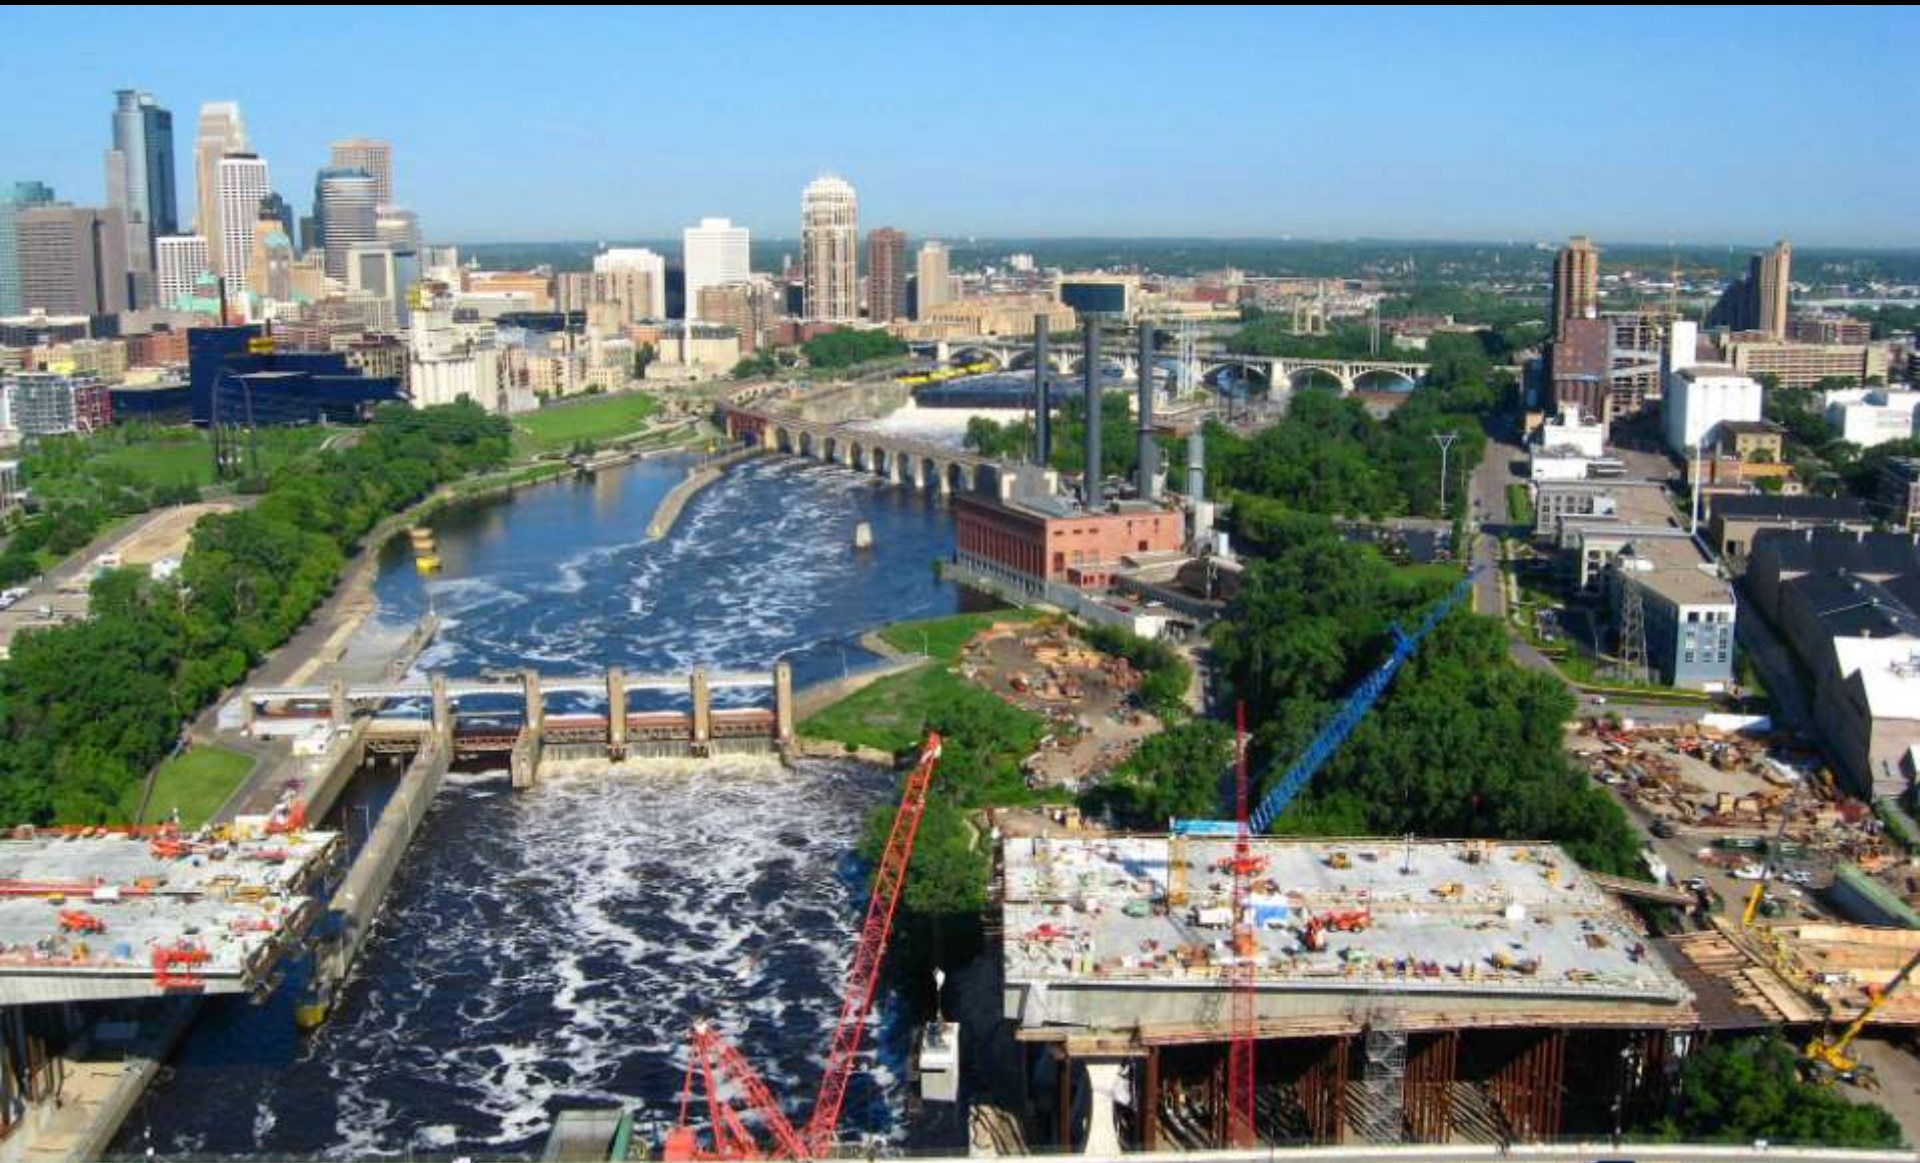
**SPANS 1 AND 3**

CIP casting complete  
Longitudinal span PT stressing complete  
Currently supported on falsework

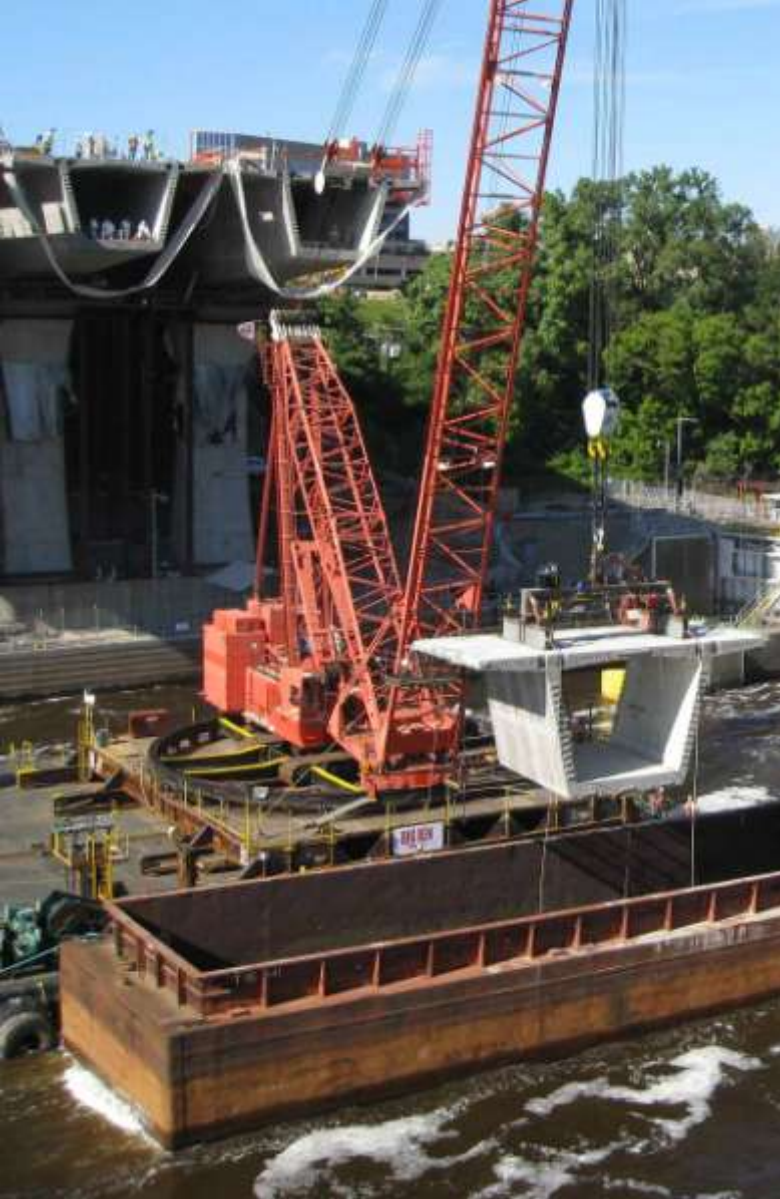
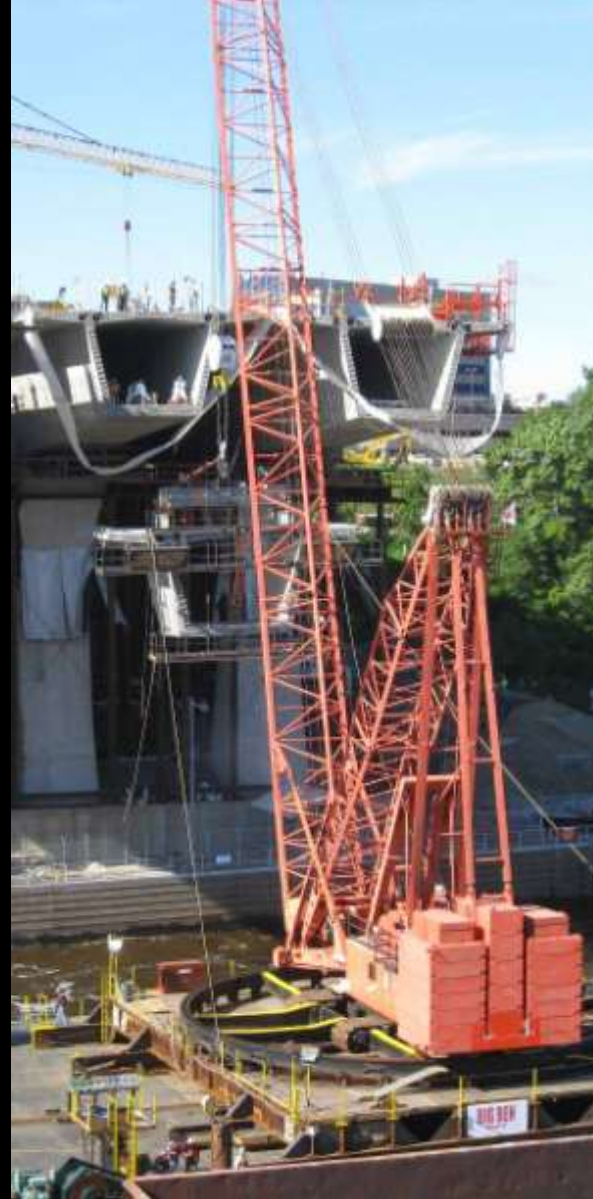
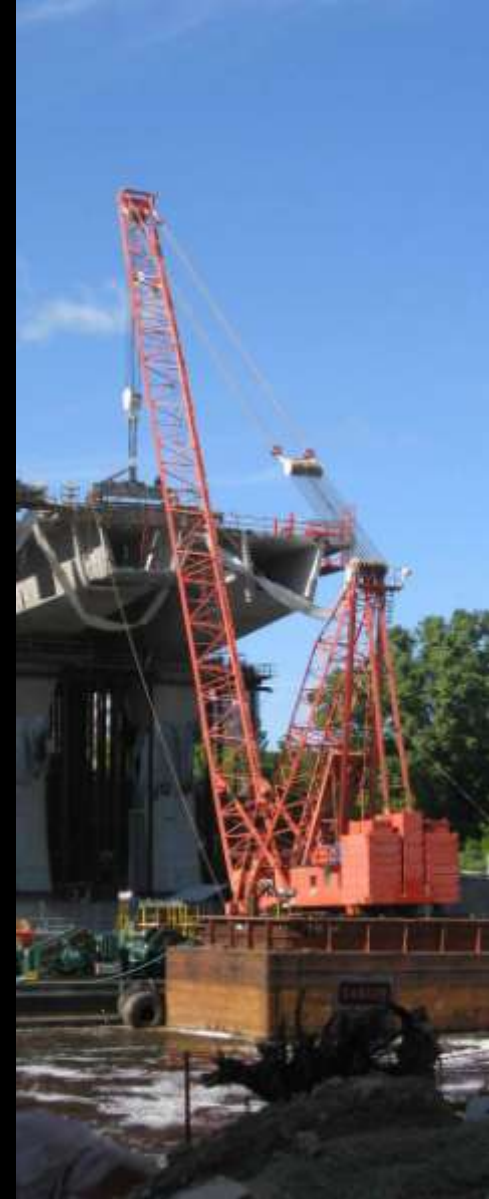
**SPAN 2  
(PRECAST MAIN SPAN)**

**PRECASTING IS COMPLETE  
120 PRECAST SEGMENTS WERE PLACED  
IN 47 DAYS  
PLACED UP TO 6 PER DAY**

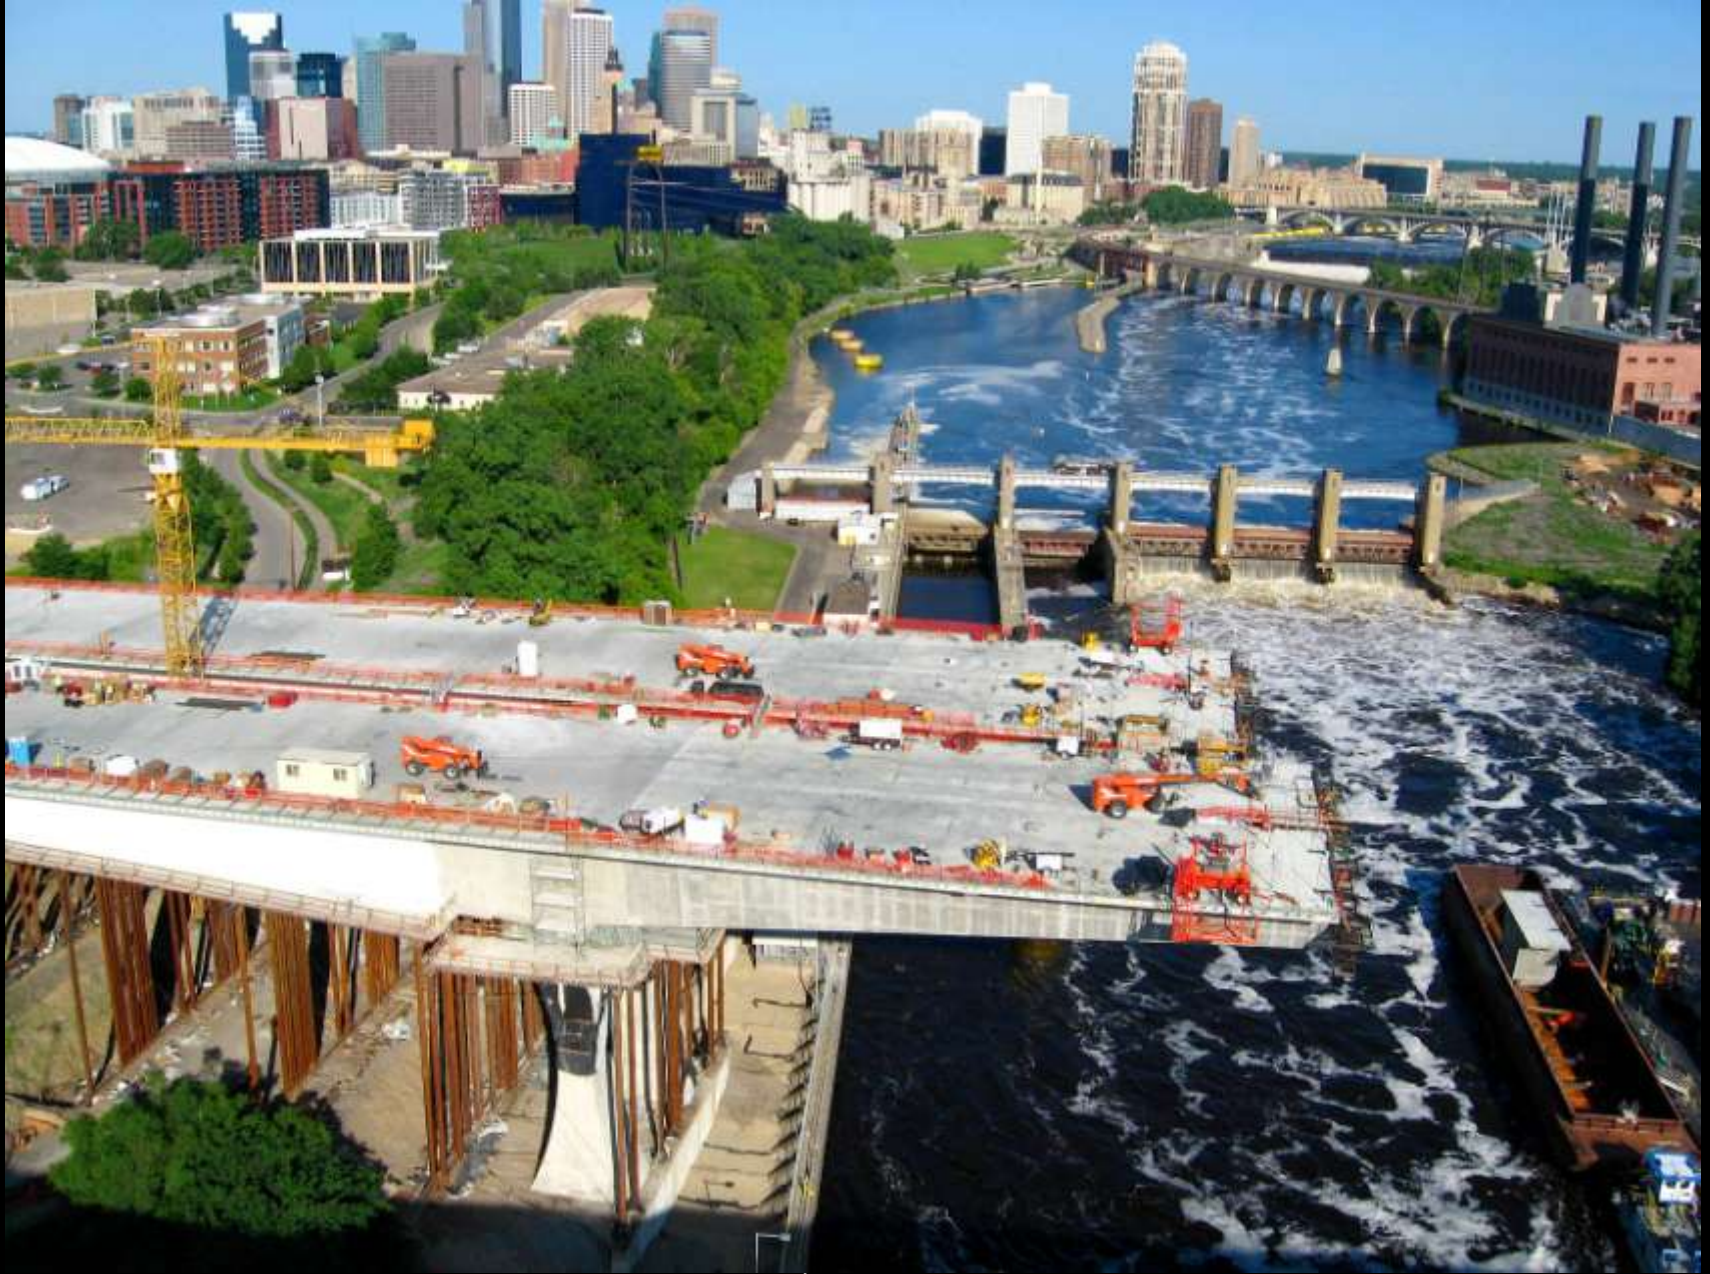
**SPAN 2**

Precast Segment Erection

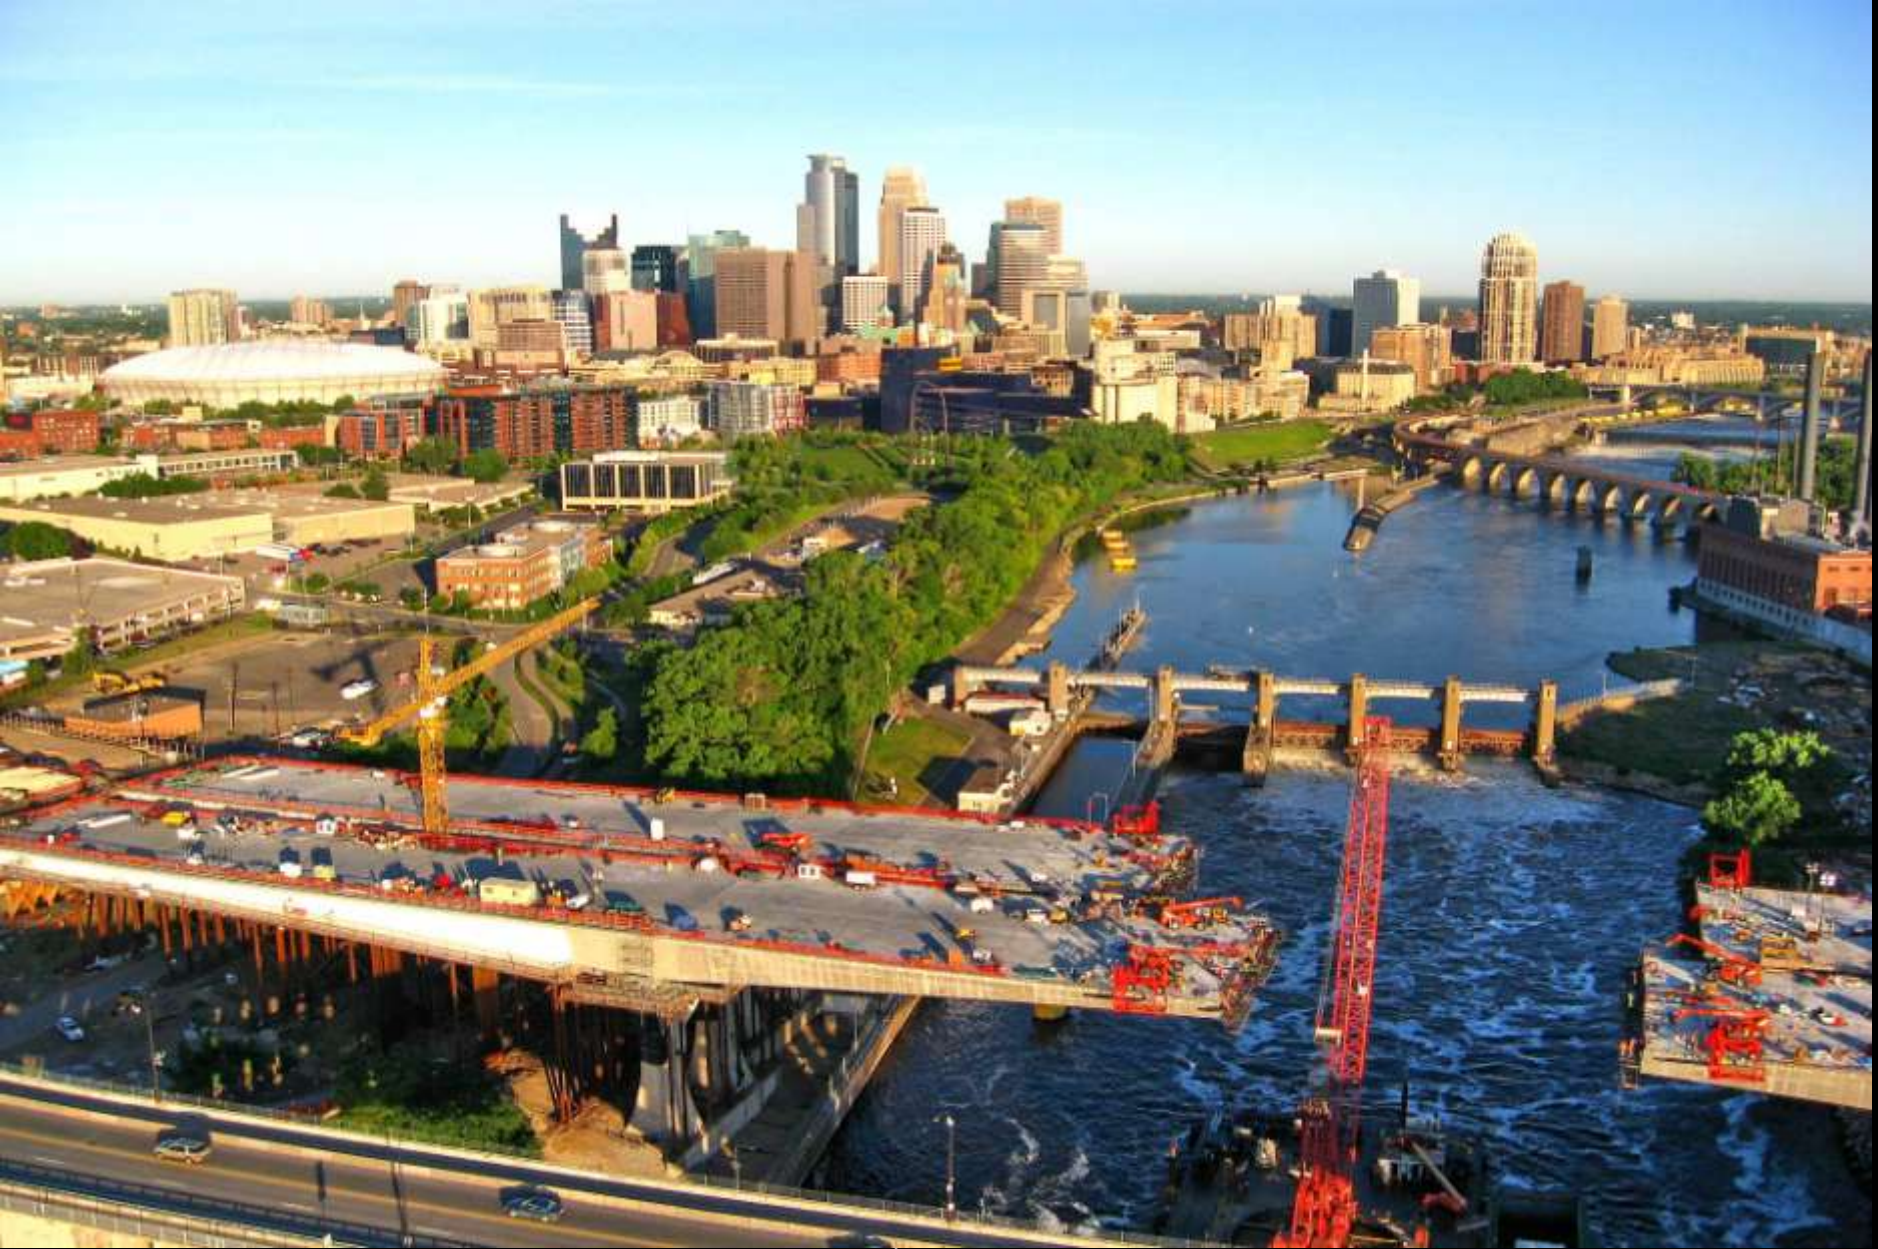
**SPAN 2**

Cantilever Erection
