PROJECT

MOUNT HOPE BRIDGE

by Abdul Hamada, WSP

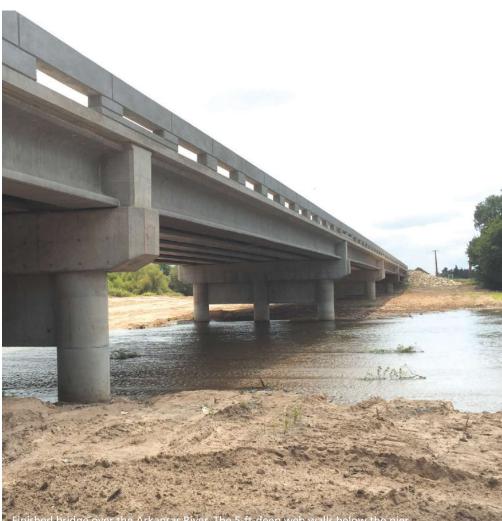
Finished bridge over the Arkansas River. The 5-ft-deep web walls below the pier beams between columns were designed to eliminate the accumulation of debris that could get tangled between columns. To keep road salts away from the piers, 6-in.-high curbs were added between railing posts above the piers. All Photos and Figures: Abdul Hamada.

For greater longevity, the threecolumn, cast-in-place concrete piers were constructed atop a concrete foundation supported by friction steel piles. Wooden piles had been used in the original 1954 bridge. The number of pier bents in the channel was decreased, and the piers were aligned with the flow of the channel to minimize impact of any potential scour. A 5-ft-deep web wall was added below the pier beam

and between columns to eliminate the accumulation of any debris or brush that could get tangled between piers, again to mitigate possible causes for scour.

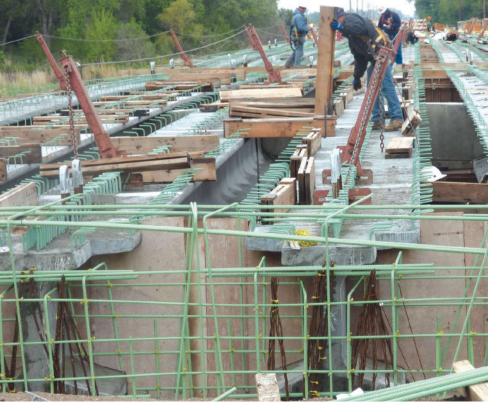
NU 1100+25 prestressed concrete girders are in place, and reinforcement is being placed for the abutment. Bent strands extending from girders are used for the connection to the abutment as well as in diaphragms between spans.

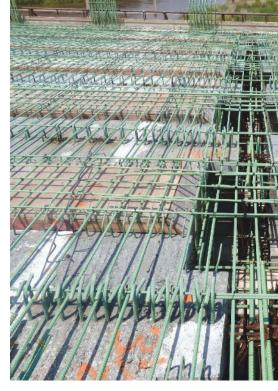
All reinforcement in the superstructure was epoxy-coated.

Kansas has harsh winters with snow and ice. To increase the life of the bridge, epoxy-coated reinforcement was used in the superstructure to minimize corrosion in the abutments, girders, deck, and railings that are exposed to road salts during the winter months. The piers can also be exposed to road salts if measures are not taken to protect them. In addition to strip-seal assemblies at the expansion joints, 6-in.-high curbs were added between the posts of the open corral railing above the pier bents, to keep salted water and water runoff from reaching the piers and help prevent corrosion in those vital areas.

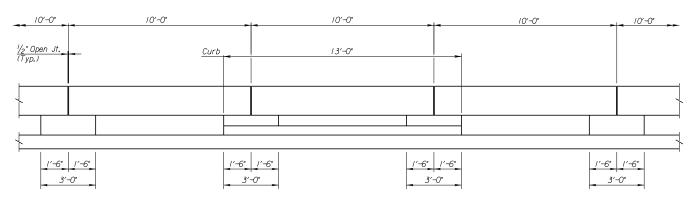
PARTIAL CORRAL RAIL ELEVATION (Along Traffic Face, West Corral Rail shown, East Corral Rail similar) Showing curb above Pier *2 and Pier *4 the channel below ordinary high water.

Open corral rail with 6-in.-high curb above piers to keep runoff from reaching piers and help prevent corrosion.
