REPORTING ON INDUSTRY NEWS, NOTEWORTHY APPLICATIONS &
NEW DEVELOPMENTS ON FUSION BONDED EPOXY COATINGS
FOR CORROSION PROTECTION OF REINFORCING STEEL

Runway 10-28 at Hartsfield-Jackson Atlanta International Airport (ATL) uses 2,033 tons of epoxy-coated steel bars

CRSI sponsors visual test for corrosion-resistance in reinforcing bars

I-580 Extension—Galena Creek Bridge, longest concrete arch bridge in U.S.

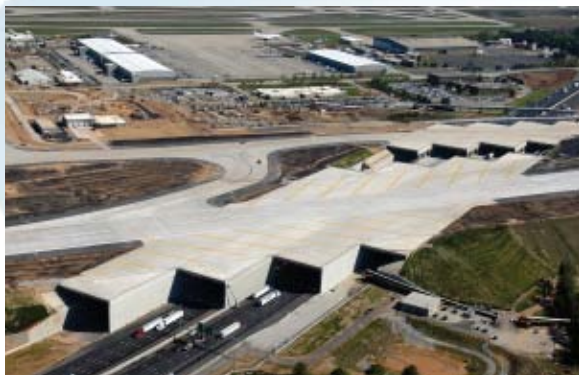
Aerial view of Interstate 285 and box culverts

Runway 10-28 crosses over ten lanes of traffic on Interstate 285, with two-thirds of the runway pavement on the west side and the remainder across the road on the east. Although the unique bridge culvert spans 10 lanes, expansion is possible up to 18 lanes. An impressive size, the main

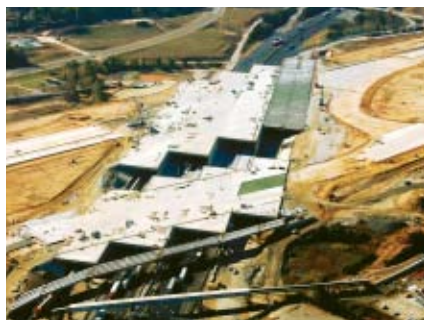
Aerial view of box culverts under construction

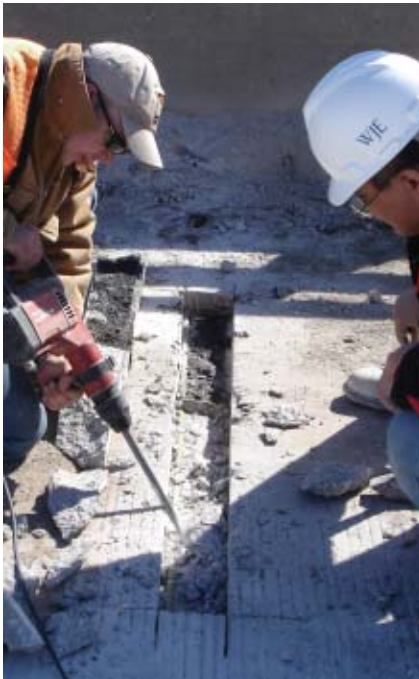
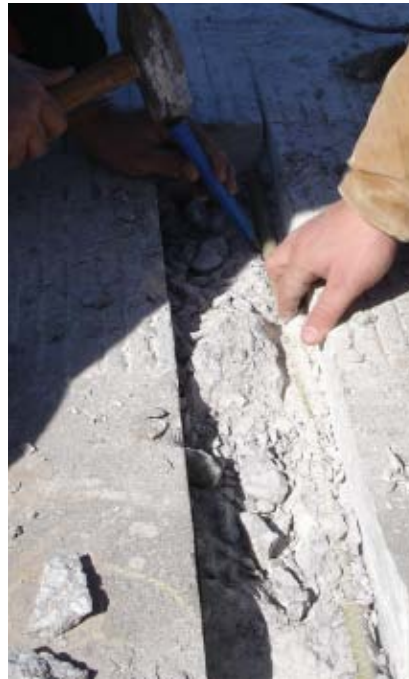
Extraction procedure of 15 year old epoxy-coated rebar used in this study

The epoxy-coated bars and galvanized bars were tested as-received and with 1/16-inch drill holes. Recently produced epoxy-coated reinforcing (ECR) and ECR retrieved from a bridge deck about 15 years old were used. Chloride analysis of the concrete indicated that the chloride level was twice the threshold level.

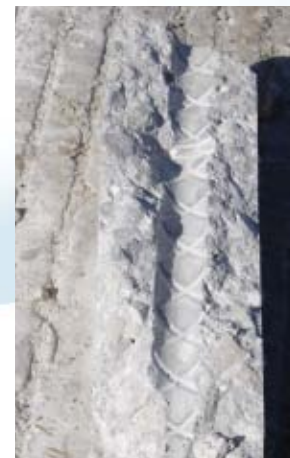
Concrete core sample with smooth, unstained rebar impression

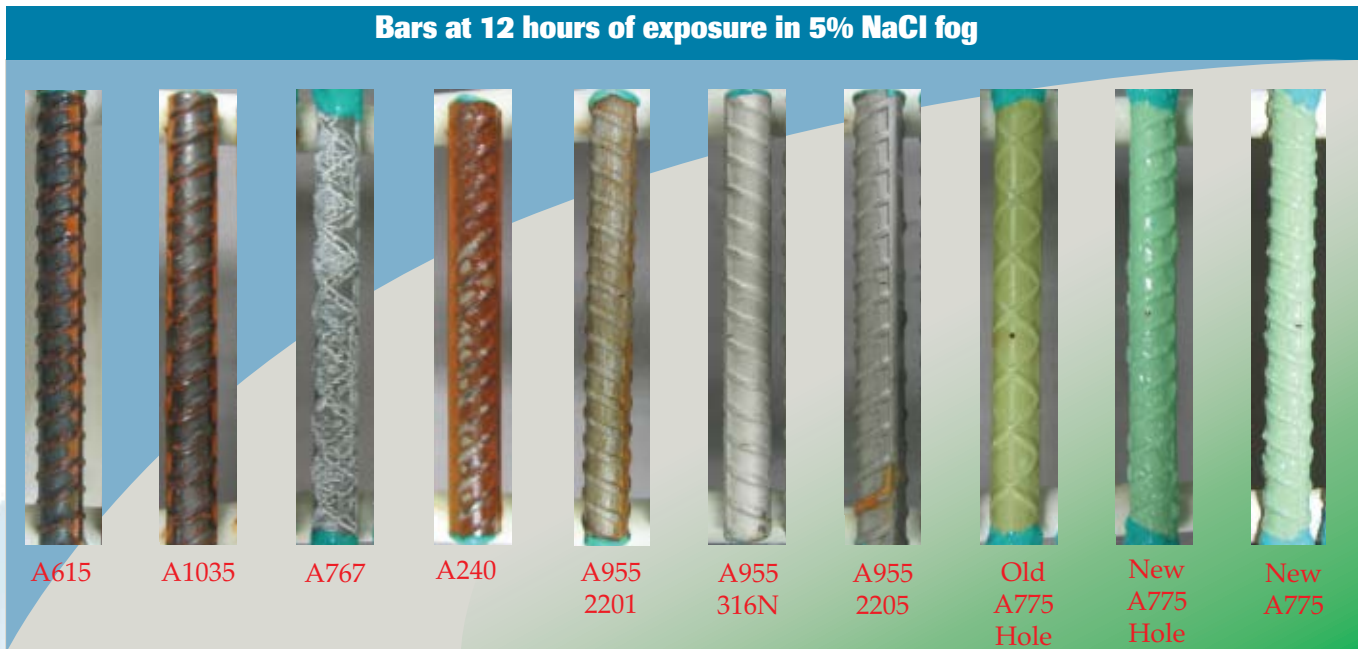
Bars at 12 hours of exposure in 5% NaCl fog

After just 12 hours of exposure, A615, A1035, A767 and A240 bars showed progressive corrosion

Both as-received and sandblasted bars corroded extensively and the corrosion aggressively progressed with time. Weight analysis shows that the bars experienced significant corrosion.

Both as-received and sandblasted bars corroded significantly and the corrosion aggressively progressed with time.

While galvanized bars with two different types of deformation were tested, all the bars experienced extensive corrosion of similar pattern. The zinc (Zn) coating corroded first, producing a white-color corrosion product. Then the underlying carbon steel started to corrode, producing a rusty color. Rust color was prominent after 2 weeks of exposure. The exposed carbon steel at drilled holes was protected until the adjacent zinc coating was consumed. Weight loss analysis showed that these galvanized bars experienced extensive corrosion with very high corrosion rates. Average corrosion weight loss of the undamaged galvanized bars was about 30 percent higher than that of the as-received A615 bars.

The sandblasted bars corroded extensively. After cleaning, it was observed that the bars experienced general corrosion attack at most areas and also some deep pitting corrosion near the ribs. While corrosion of 3Cr12 appeared to be extensive, its average corrosion was about half of the A1035 and about 1/3 the rate of the as-received A615 steel bars.

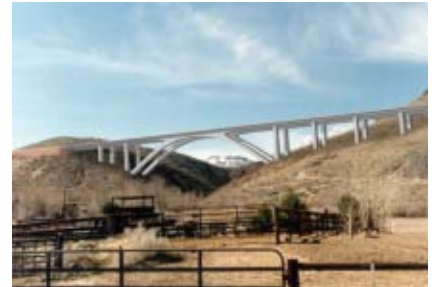
Galena Creek Bridge

Originally, the arch was to be constructed using segmental construction. However, after considerable thought, a less customary option, a pilot truss arch bridge, was chosen since it would be easier and more economical to build. Pilot truss arch construction is characterized by erecting a steel truss (a web-like assembly of smaller beams that makes it stronger and lighter than a single beam or girder) in the shape of an arch first, then using this to support the formwork, reinforcing steel and concrete.

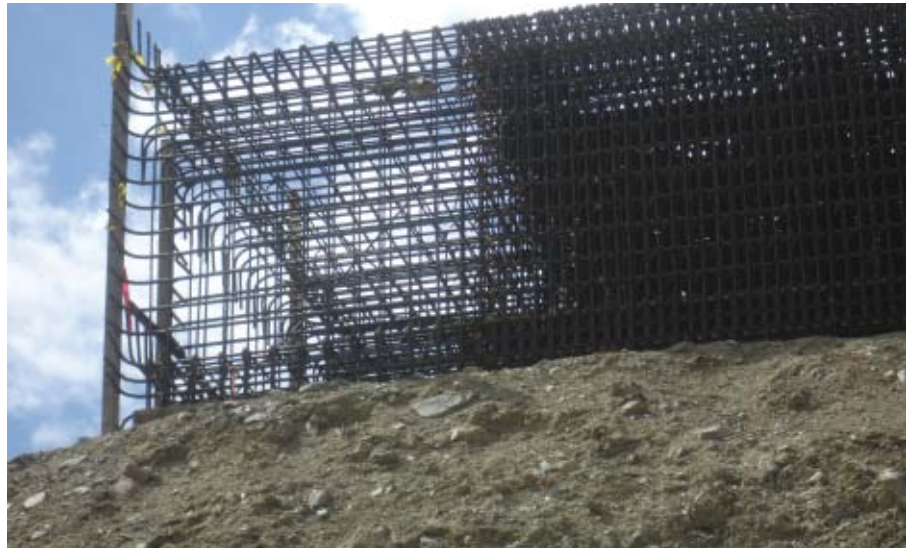
Reinforcing cage for Galena Creek Bridge Arch

- ~ Maximum height of bridge is 302 feet
- ~ Arch span of 663 feet
- ~ Arch section nearly 20 feet by 12 feet
- ~ Constructed with pilot truss rather than the typical segmental method
