CORROSION RESISTANCE **Of Epoxy-Coated Reinforcing Bars**

Bridge Substructure in a Marine Environment

In 2006, detailed field and laboratory evaluations were conducted by Wiss, Janney, Elstner Associates, Inc. for four concrete bridges in Georgia and North Carolina that contained epoxy-coated steel reinforcing bars. No concrete distress induced by corrosion of epoxy-coated bars was observed. It was further found that coating adhesion was a poor indicator of bar performance. Despite poor adhesion, a number of epoxy-coated bar segments were found to resist high chloride concentrations (up to five times the threshold normally assumed for uncoated bars). Modeling calculations suggested that the most critical areas of these bridges would have developed significant concrete damage if uncoated bars had been used. The use of epoxy-coated reinforcing steel provides extended service life even though most bars examined from these bridges had greater coating damage and lower coating thickness than admissible by current standards.

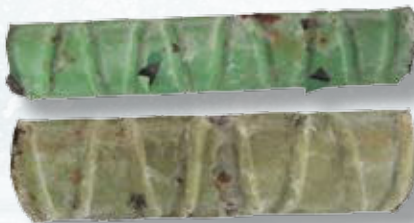
Active corrosion was observed on three epoxy-coated bar segments (one from the MacKay River Bridge and two from the Ocean Isle Bridge) that had significant coating damage (2 to 5%). This coating damage appears to have been present since construction. These bars were all located in the tidal zone and exposed to chloride concentrations (0.183 to 0.251 wt%)

Two bars from the Ocean Isle Bridge show light corrosion: a) a horizontal No. 6 bar with a cover of 4.75 in. and bar-level chloride concentration of 0.199 wt%; b) a vertical No. 8 bar with a cover of 5.1 in. and bar-level chloride concentration of 0.183 wt%.

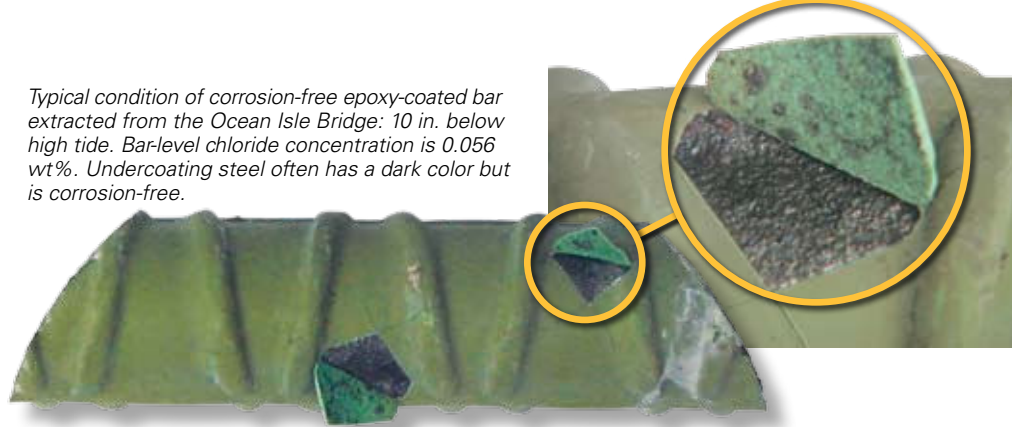
Typical condition of corrosion-free epoxy-coated bar extracted from the Ocean Isle Bridge: 10 in. below high tide. Bar-level chloride concentration is 0.056 wt%. Undercoating steel often has a dark color but is corrosion-free.

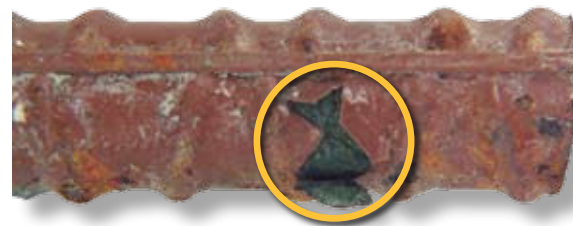
Poor adhesion of coating to steel for bar obtained from the MacKay River Bridge (tidal zone, bar-level chloride concentration is 0.251 wt%).

coating used in the MacKay River Bridge was an old generation of epoxy coating and this product demonstrated particularly poor performance in terms of adhesion and thickness. Modern epoxy-coated bars, which are required to have thicker coatings, should exhibit greater corrosion resistance than was observed in these four bridges.

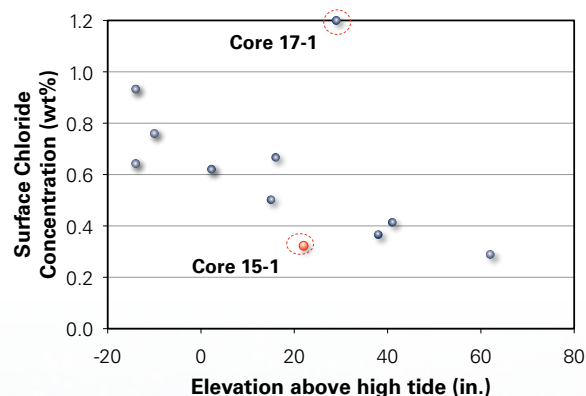
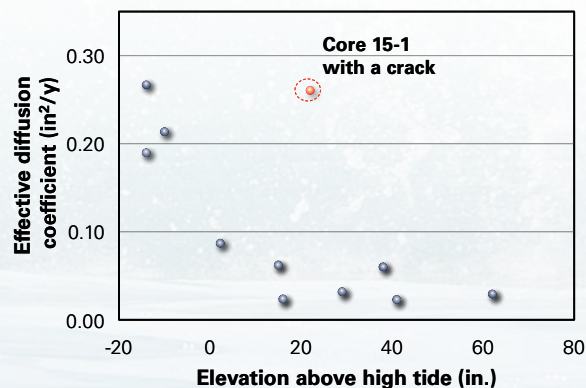
Calculated surface chloride C_s and effective diffusion coefficient D for the MacKay River Bridge.

Approximately twelve cores were extracted from each bridge. The effective diffusion coefficient, D , and surface chloride content, C_s , were calculated based on the chloride concentrations measured at various depths from these cores. Based on the chloride profiles, the chloride concentration at the depth of the steel was estimated. Both the effective diffusion coefficient and the surface chloride content typically decreased with increasing elevation and can be grouped into two zones: tidal zone (between low and high tide) and splash zone (0 to 5 ft. above high tide).
