# CORROSION-RESISTANCE OF REINFORCING BARS: An Accelerated Test

**Epoxy-coated bars have shown good corrosion protection in concrete structures since 1973. Recently, interest in other corrosion-resistant bar systems has resulted in new products being supplied to the marketplace. Tests were conducted by Wiss, Janney, Elstner Associates using a wide range of products including 15-year old epoxy-coated reinforcing bars that had been removed from salt-contaminated concrete. Results from the tests show that even old coated bars perform significantly better than other products. This work supports conclusions of other longer-term research, that epoxy-coated bars provide cost-effective corrosion protection.**

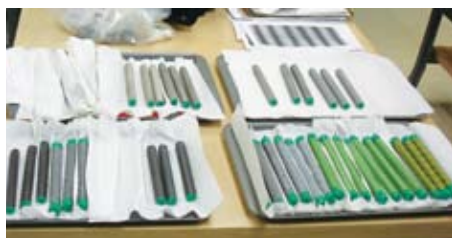
**The bars met the following ASTM Standards:**

Carbon steel (black)	A615
Low-Carbon, Chromium, Steel (LCC, MMFX)	A1035
Galvanized	A767
Stainless steel 3CR12	A995
Stainless steel 2201	A995
Stainless steel 2205	A995
Stainless steel 316LN	A995
Epoxy-coated reinforcing	A775

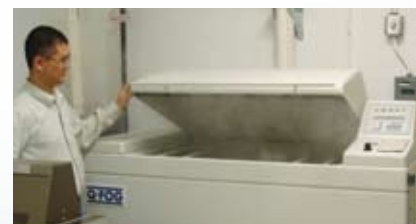
Reinforcing bar samples were tested in a fog cabinet for a period of 28 days. During this period they were exposed to a 5% sodium chloride fog at 35°C following the ASTM B117 protocol.

Prior to placing into the fog chamber, all bars were degreased with solvent, rinsed with deionized water and air-dried. After 7, 18 and 28 days of testing, one bar per test condition was removed from the chamber and cleaned following ASTM G1 test method for weight analysis.

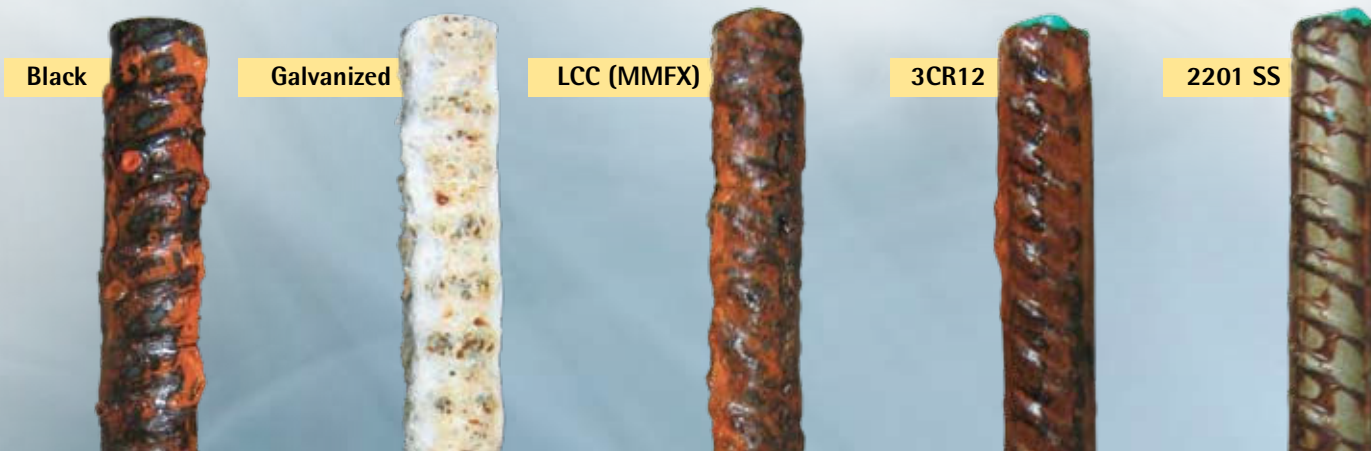
**BARS AFTER 28 DAYS**

All bars corroded extensively during the test period, and the corrosion aggressively progressed with time. Weight analysis shows that the bars experienced significant corrosion.

Both as-received and sandblasted bars corroded significantly and the corrosion aggressively progressed with time.

All galvanized bars experienced extensive corrosion. The zinc coating corroded first, producing a white-color corrosion product, and then the underlying carbon steel started to corrode, producing a rusty color. The rust color was prominent after 2 weeks of exposure. For the samples with drill holes, the exposed carbon steel at drilled holes was protected until the adjacent zinc coating was consumed. Weight loss analysis showed that these galvanized bars experienced extensive corrosion with very high corrosion rates. Average corrosion weight loss of the undamaged galvanized bars was about 30 percent higher than that of the as-received carbon steel bars.

The sandblasted bars corroded extensively. These experienced general corrosion attack at most areas and some deep pitting corrosion near the ribs. While corrosion of 3CR12 appeared to be extensive, its average corrosion was about half of the LCC (MMFX) and about one third the rate of the as-received carbon steel bars.

surfaces and corrosion appeared to progress with time. However, the cleaned bar showed that corrosion was rather superficial and no obvious pits were observed. Weight loss analysis yielded a very low average corrosion of about 3% of as-received carbon steel bars.

These stainless steel bars experienced some localized corrosion and this corrosion apparently progressed with time. The total amount of corrosion was superficial and such corrosion was speculated to have been induced by local contamination or crevices generated by the coating used to seal cut ends.

The new ECR bars with no defects had no corrosion throughout the testing program. The specimens with a drilled hole only corroded at the holes.

The bars extracted from a 15-year-old bridge deck performed very well with little corrosion. For the first seven days of exposure, corrosion only occurred at the drilled holes where carbon steel was exposed. Visual observation indicated that corrosion of the bars was minor. For all the ECR specimens, weight loss was so minor that it was not possible to effectively estimate actual corrosion rates. The epoxy coating adhesion did not affect the corrosion performance. Even bars with poor coating adhesion performed well in the test, which does not support conclusions of some researchers who have indicated that old coatings will provide little or no benefit.
