EPOXY-COATED REINFORCING STEEL BARS IN NORTH AMERICA

A presentation to World Corcon
2009, Mumbai, India

David McDonald, Ph.D., P.E., FACI
September 2009

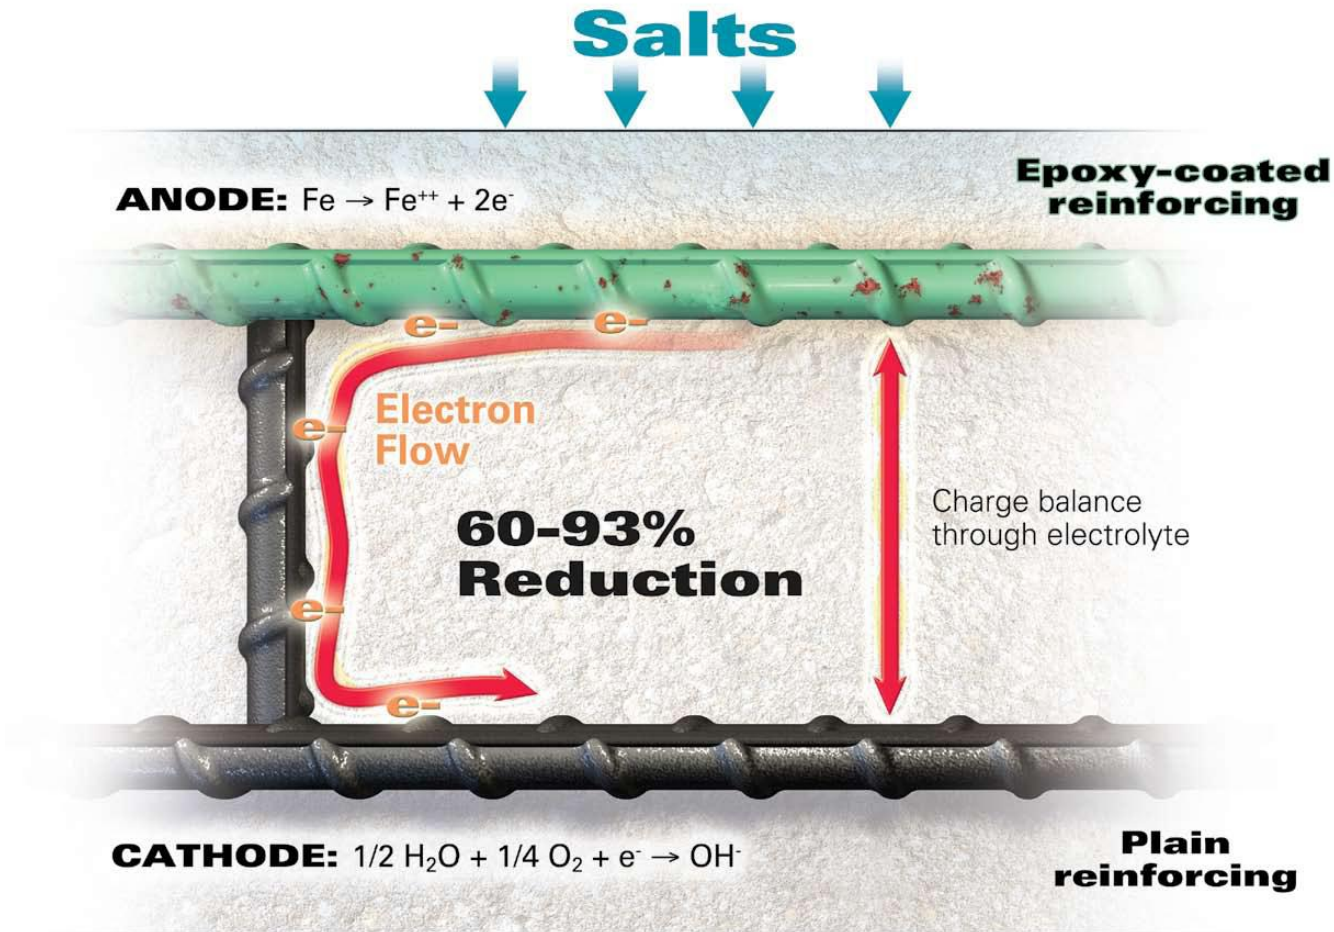
Epoxy-Coated Bars

Top mat only

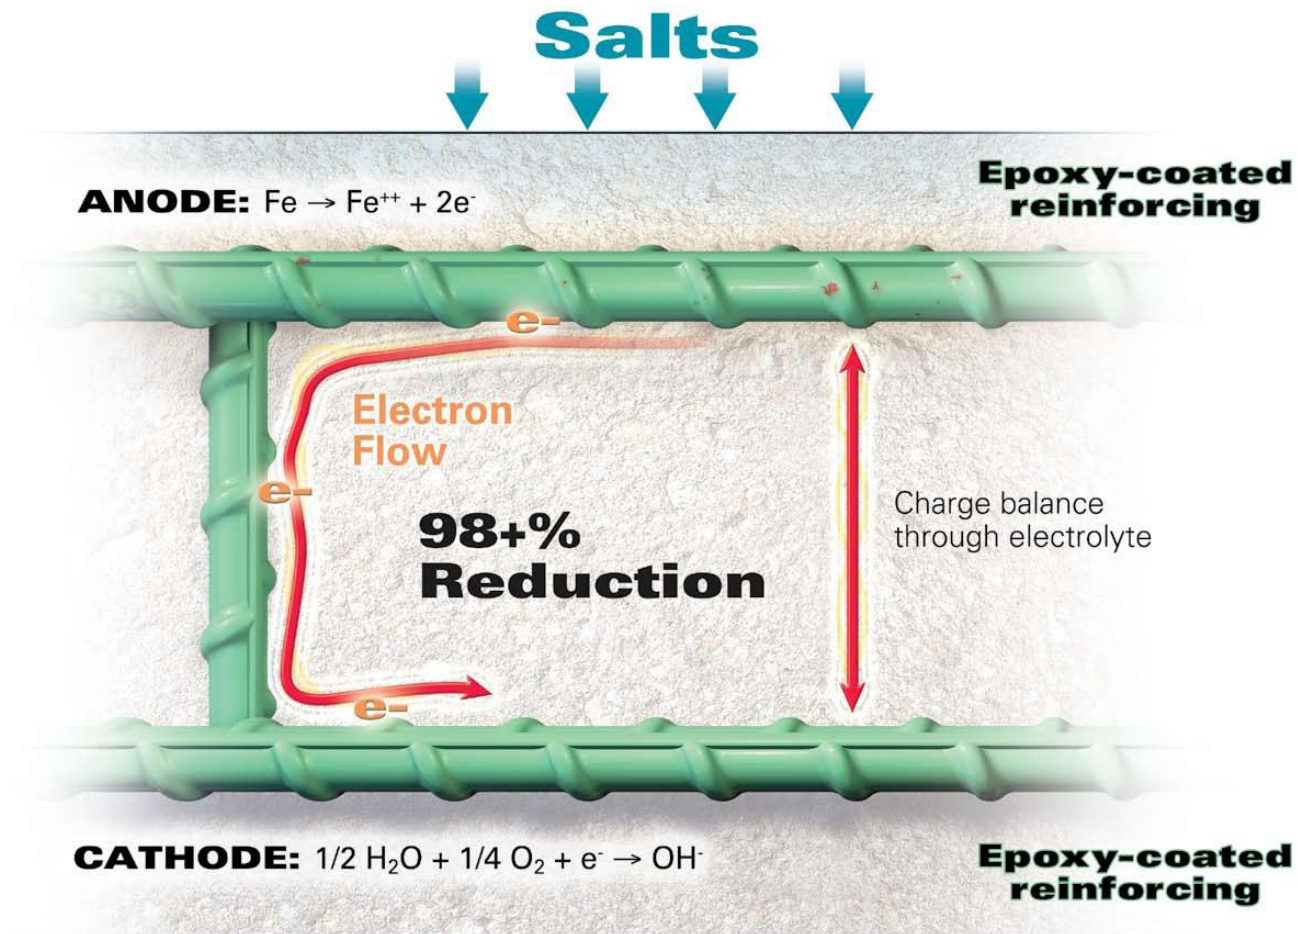
Epoxy-Coated Bars

Both mats

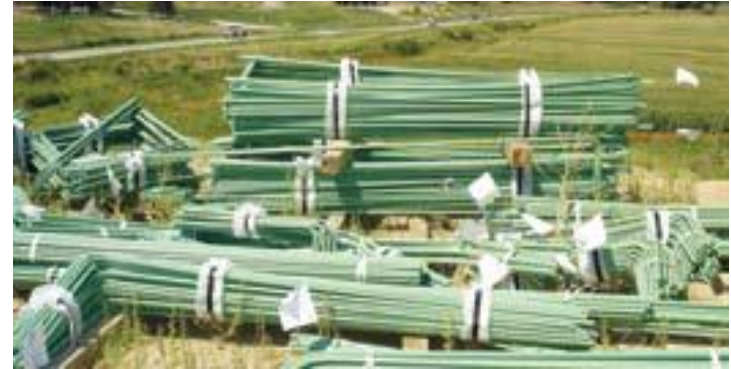
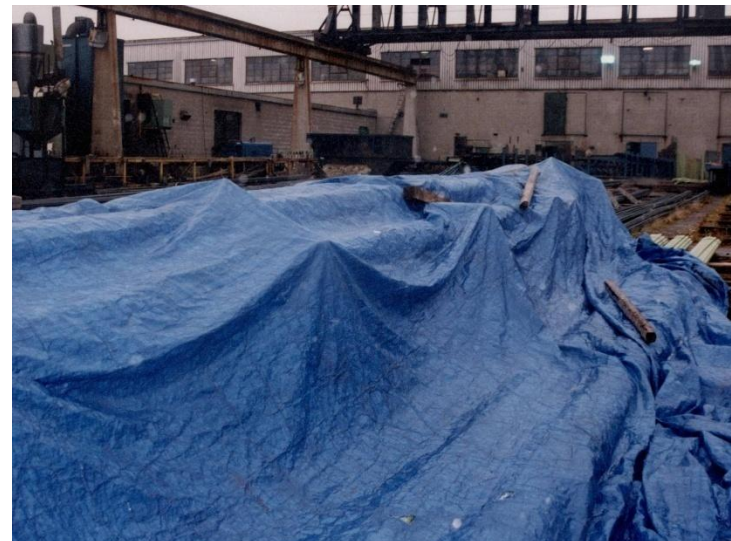
Storage

- Timber cribbing
- Opaque covering
- Store coated and uncoated bars separately

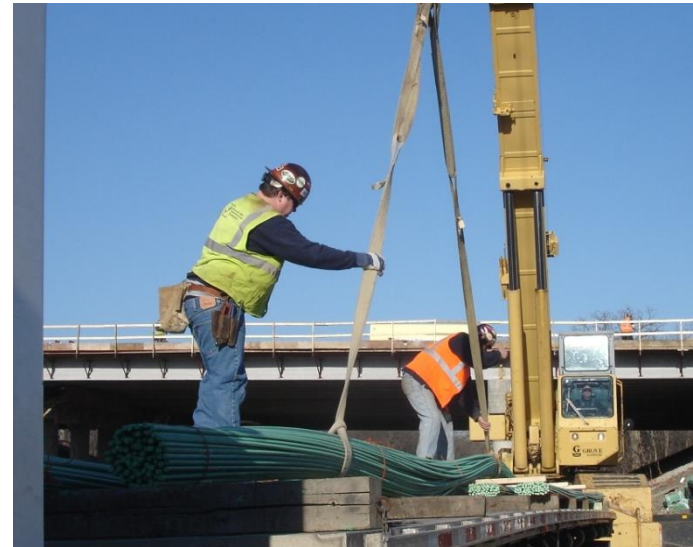
Loading, Securing and Lifting

- Protect against damage
 - Padded material
 - Nylon strapping
 - Spreader bar
 - Multiple pick-up points
 - Unload as close as possible to the point of concrete placement
 - No bare chains or cables

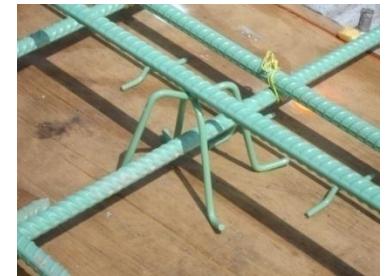
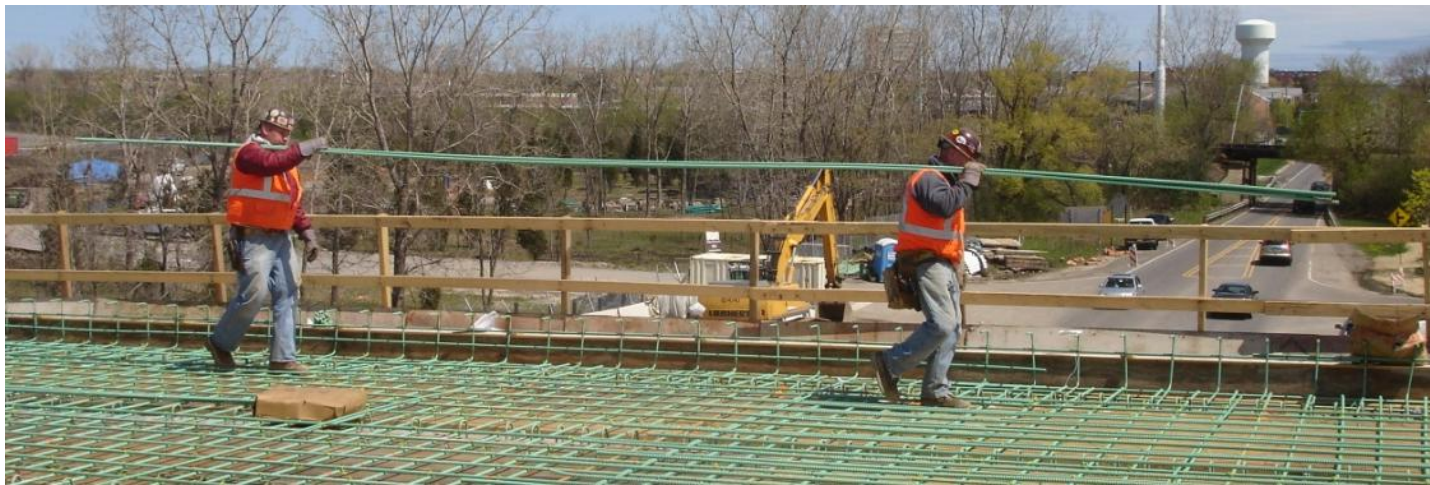
Setting, Bar Supports & Tie Wire

- Lift and set bars into place
- Use non-conductive material or plastic bar supports
- Coated tie wire
- Do not drag

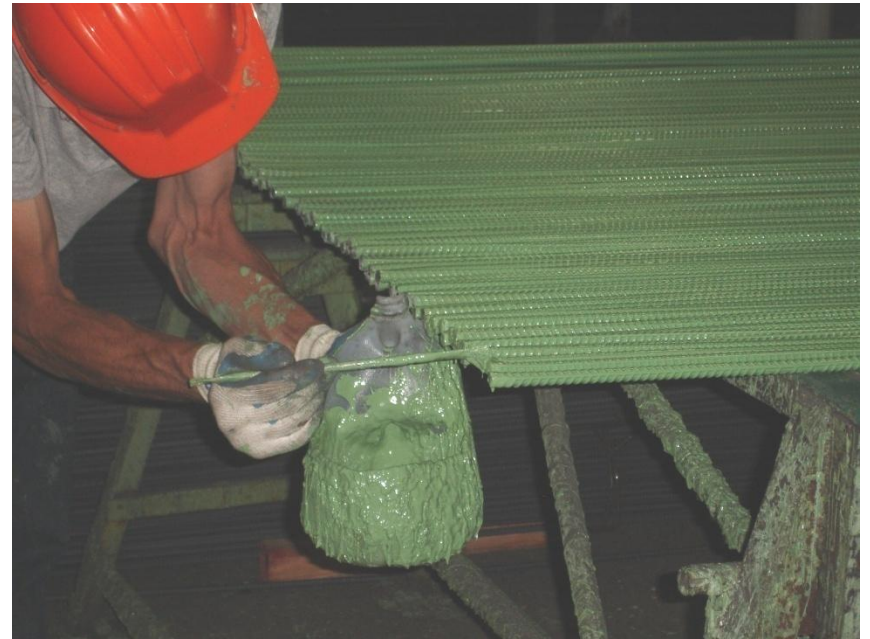
Patching

- Inspect bars
- Patch all damage
- Two-part epoxy repair material
- Follow manufacturer's directions

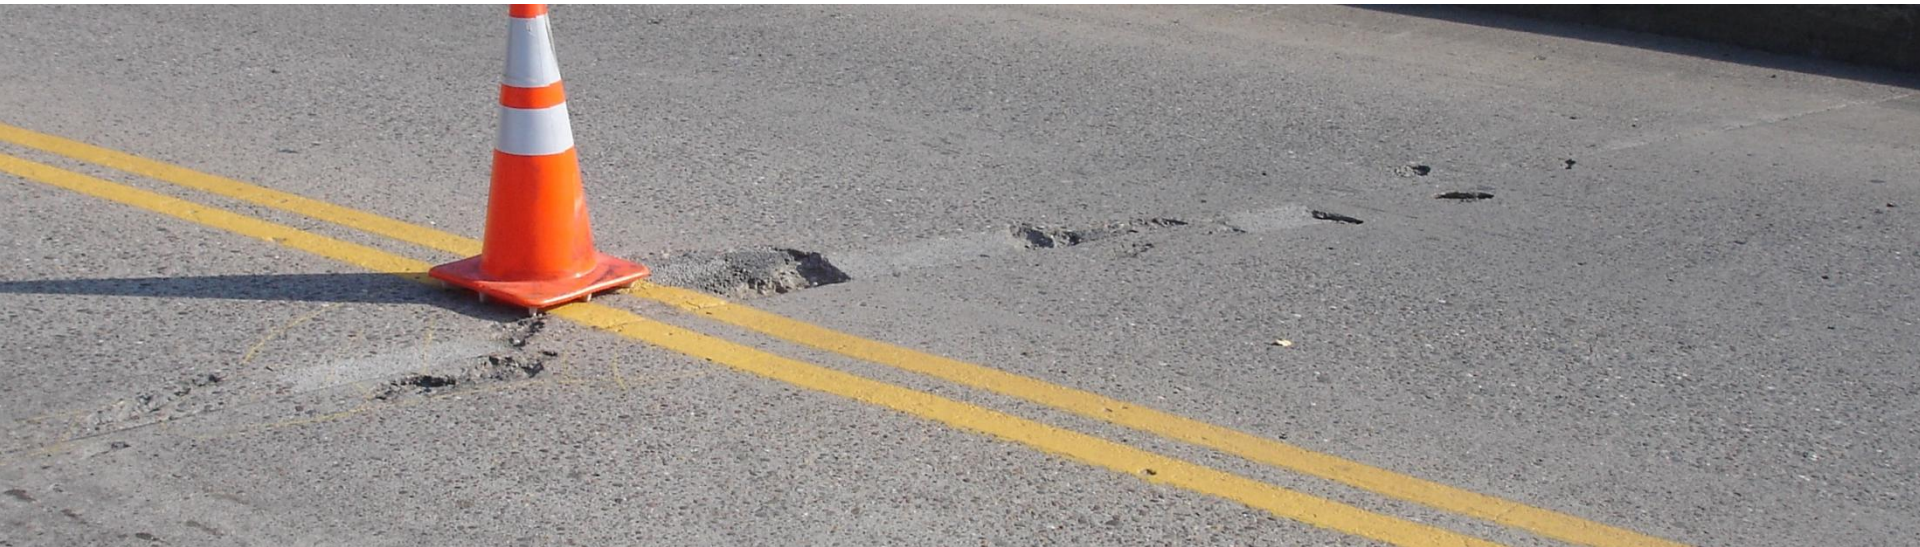
West Virginia Bridge 2930

- Constructed in 1974
- Black bar - significant delamination in 1993
- Epoxy-coated bar – no delaminations or repair in 2009
