IMPACT OF DECK CRACKING ON DURABILITY

Sponsored by the Project Development Division
of the Iowa Department of Transportation
and the Iowa Highway Research Board
Iowa DOT Project TR-405
CTRE Management Project 97-5

MARCH 2000

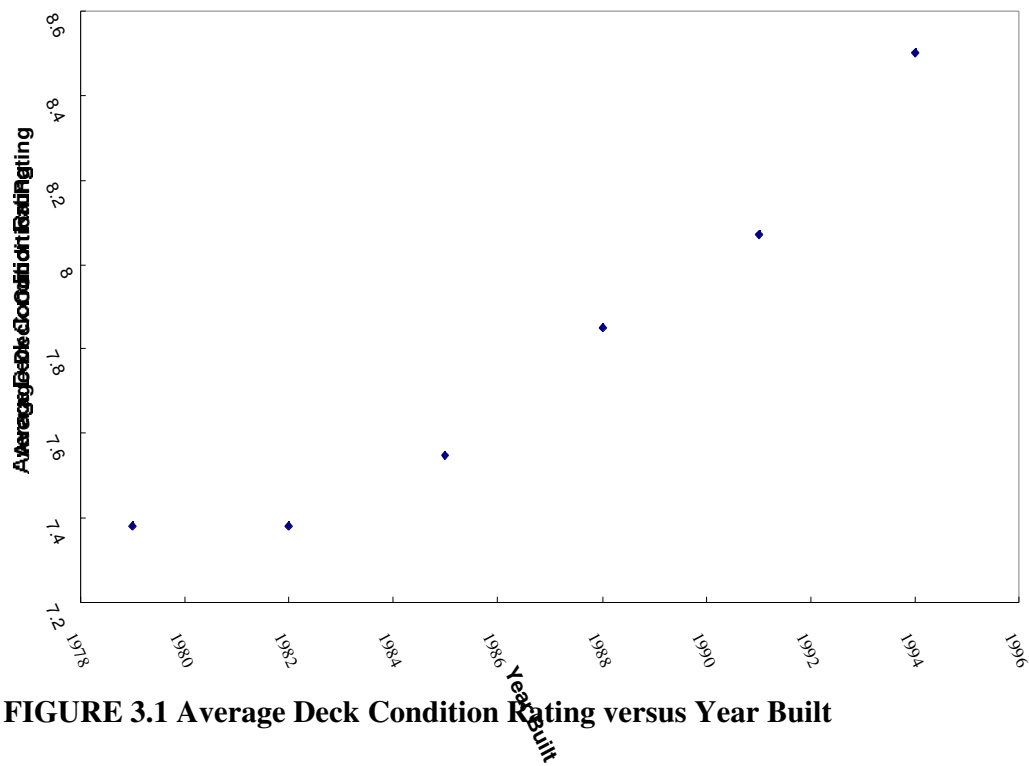
FIGURE 3.1 Average Deck Condition Rating versus Year Built

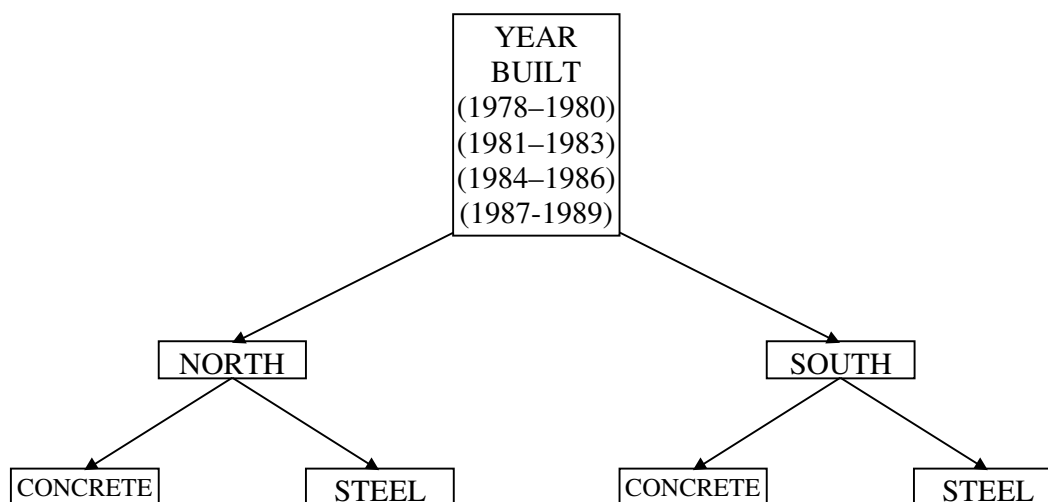
FIGURE 3.2 Bridge Grouping Used in Phase I

examined. The bridges with the most deck cracking were chosen from each group. This allowed the selection of bridges based on cracking severity without having to compare inspection records for all 711 bridges.

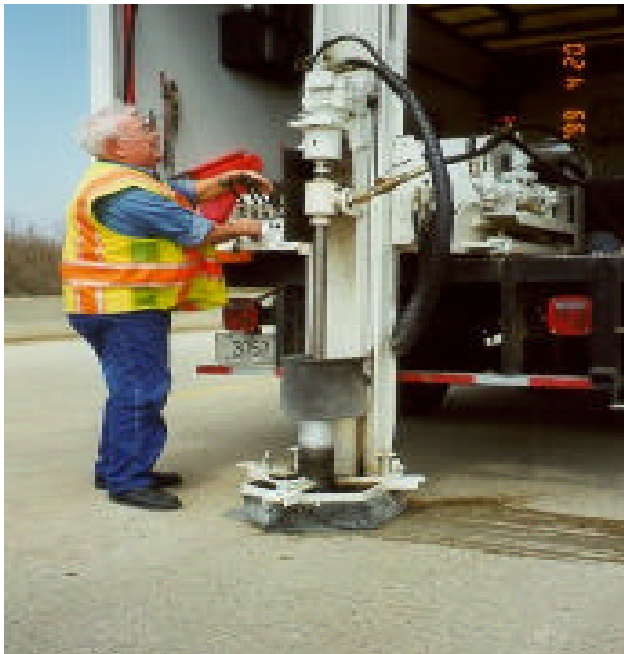
FIGURE 4.2 The Setup of the Coring Process

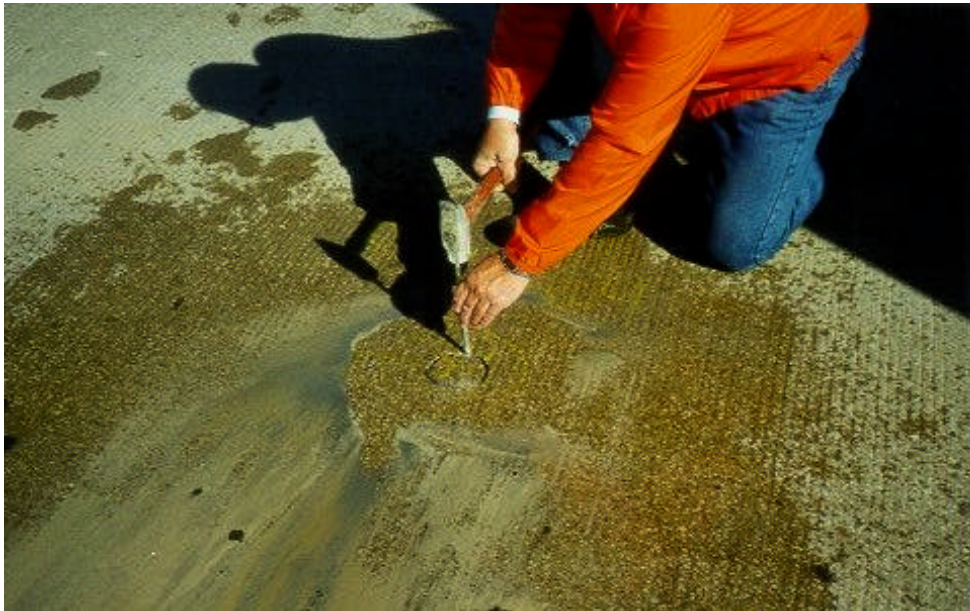
FIGURE 4.3 Breaking the Core

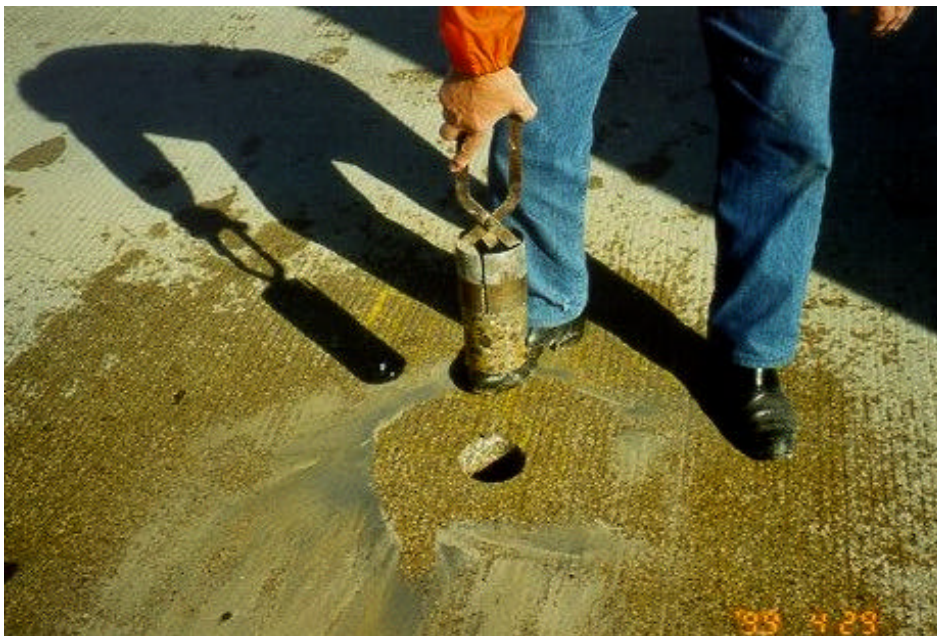
FIGURE 4.4 Extracting the Core

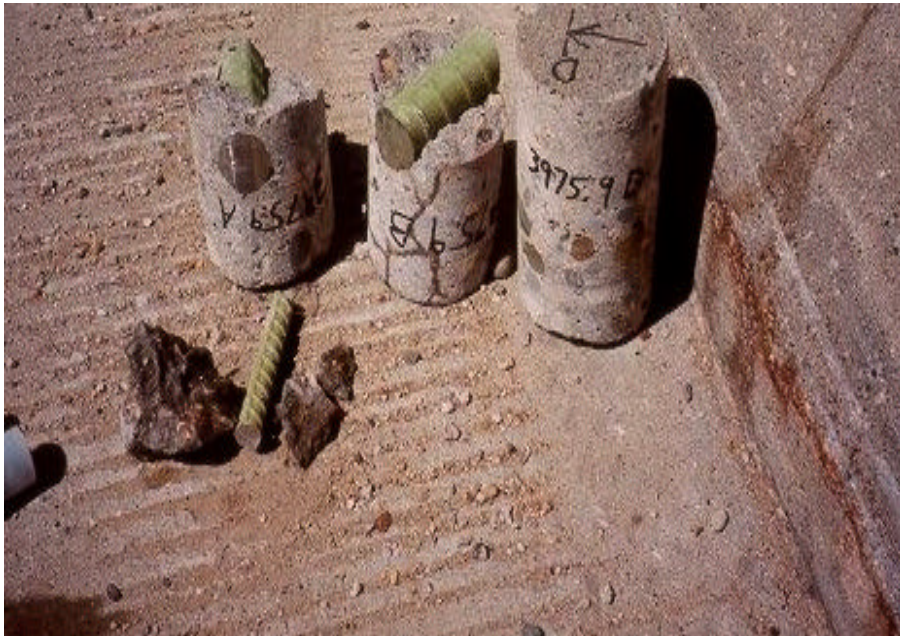
FIGURE 4.5 Extracted Cores

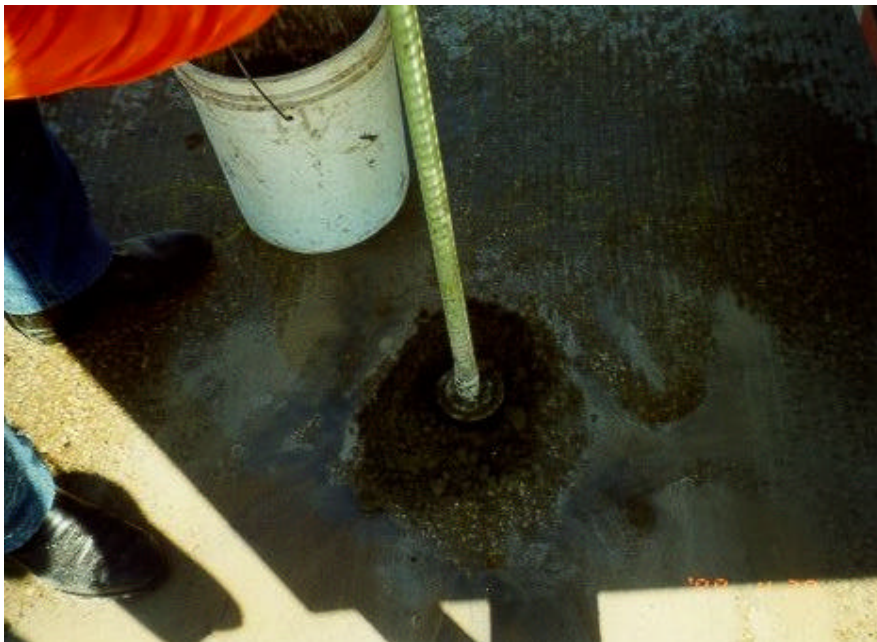
FIGURE 4.6 Patching the Cored Hole after a Core Being Extracted

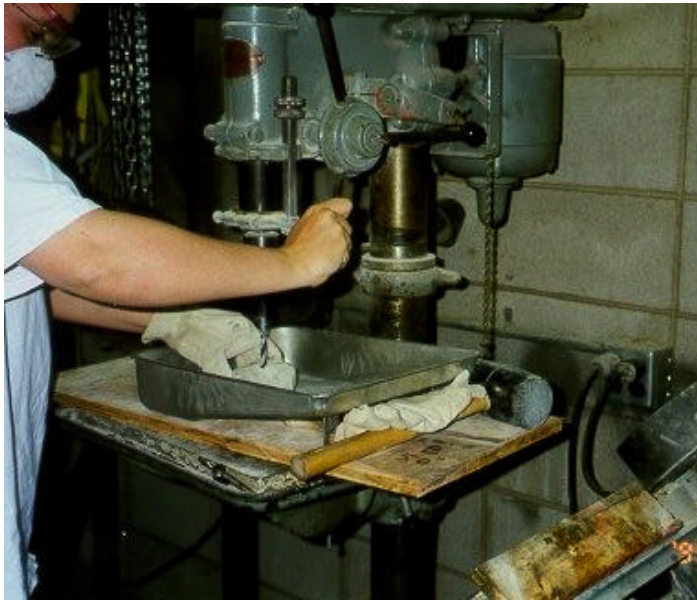
Figure 4.8 Collection of Powder Samples

Collection of powder samples is shown in Figure 4.8. At least 20 grams of powder were collected for chloride content analysis. Four powder samples were collected from each core using three-eighths-inch drill bit. The location of these samples were at 0.5 inches below the surface, midway between the first sample and rebar level, rebar level, and one inch below the rebar level.

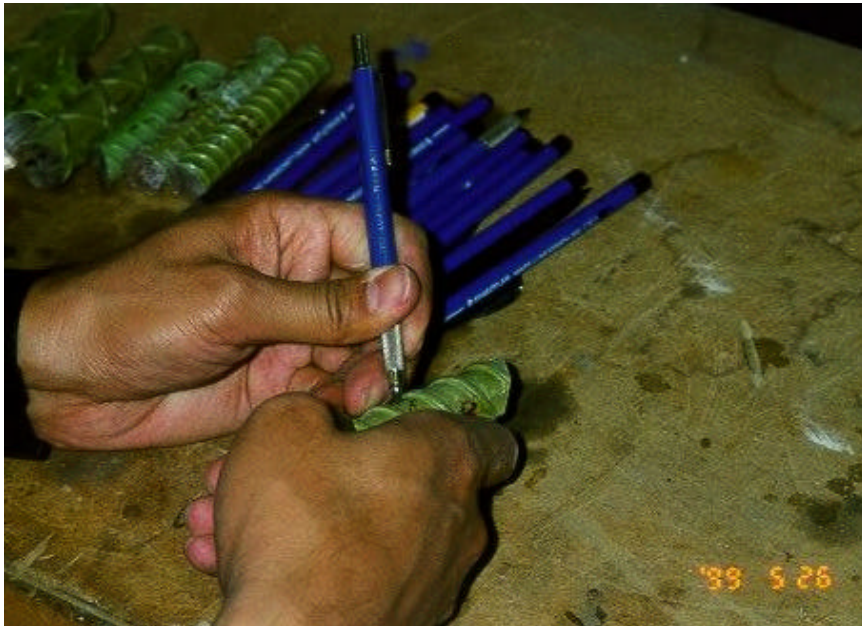
FIGURE 4.9 Coating Hardness Test

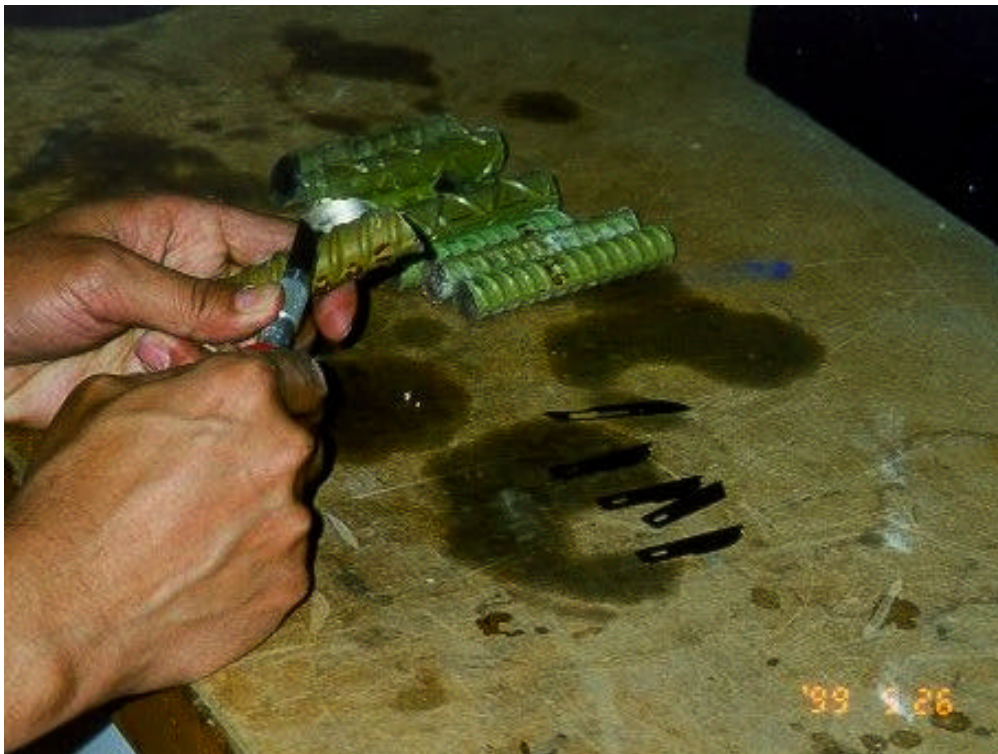
FIGURE 4.10 Epoxy Coating Bond Test

To determine the coating bond in between steel and coating film, the dry knife adhesion test was performed for each rebar as shown in Figure 4.10. The recommended standard procedure is described in NACE TM-0185, section 5.3.2.1, as follows:

The recommended method for determining adhesion is to cut the coating to the base metal using a Number 22 hobby knife blade. The point of the blade shall be drawn across the film (using multiple cuts if necessary to cut a single V-shaped groove. Using the sharp side of the blade as a wedge, the coating film should be pried up within the groove. The exposed base should be observed under a 10 to 15X microscope to determine adhesion performance. An average of three attempts shall be used to rate the sample.

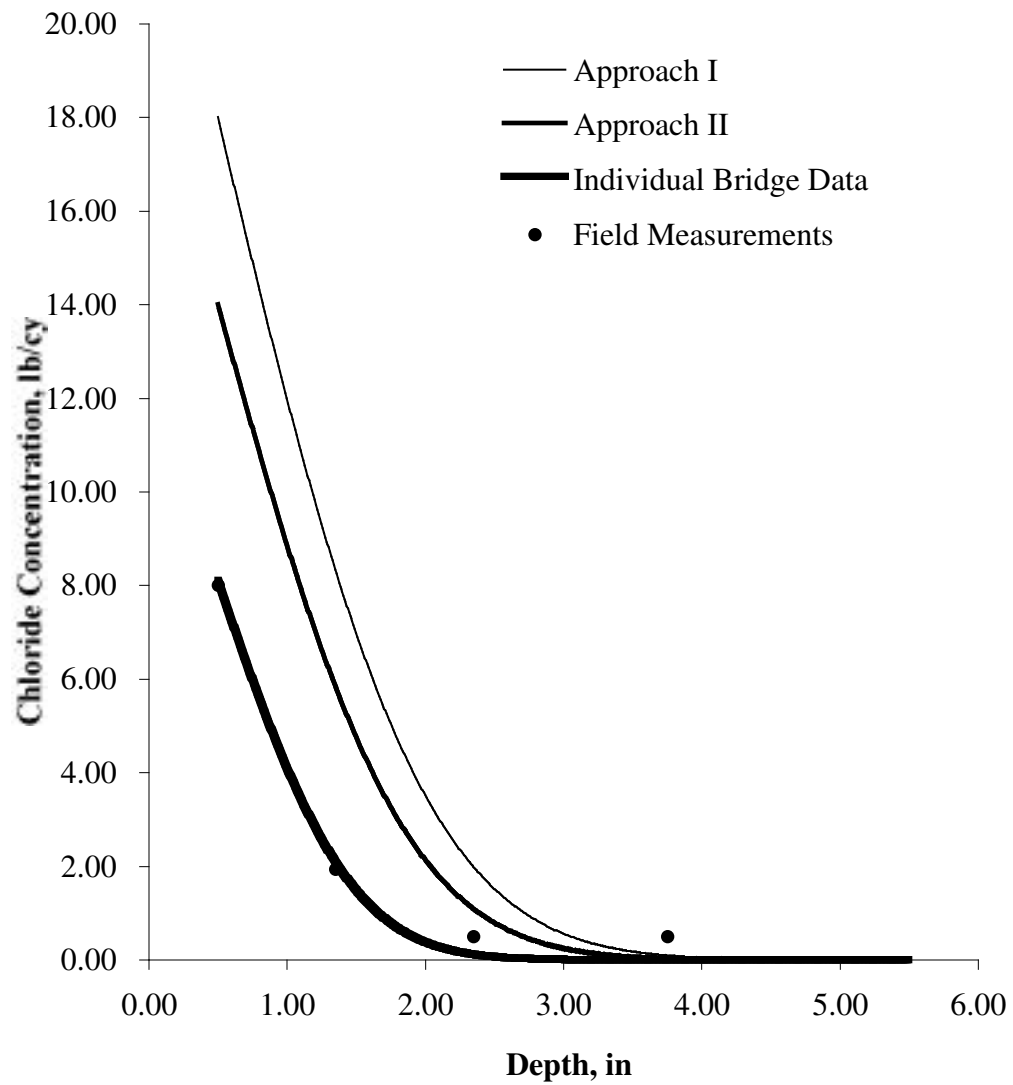
Figure 5.9 Chloride Concentration vs. Depth , 8609.2S030 B

For illustrative purpose, based on equation 2.2, the results of chloride diffusion in three bridge decks are shown in Figures 5.8, 5.9, and 5.10 for bridges with ID numbers 0668.7S021A, 8609.2S030B, and 0781.5L218A, respectively. Shown in each figure are three relationships that were obtained using C_o and D_c from approaches I, using C_o and D_c from approach II, and using C_o and D_c for each individual bridge. Also included in these figures is the chloride concentration measured in each bridge.

As can be seen, the chloride concentration decreases to almost zero sharply at about depth of 4 inches regardless of what approach is used in developing the chloride concentration and depth relationship. In addition, although the three relations showed significant difference at surface chloride content between the measured and predicted chloride contents, these differences were insignificant at the rebar level. The figures reveal that approach II yields closer results to the measured values than those of approach I.

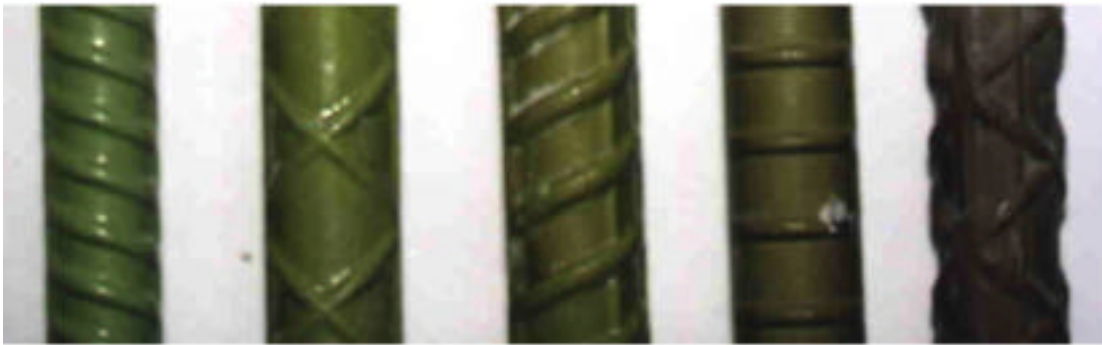
FIGURE 6.1 Rebar Samples Showing Some Discoloration

Most if not all of the collected rebar samples exhibited some level of epoxy discoloration. In most of the samples, the epoxy coating was discolored more on the top region of the rebars than on the bottom and side regions. There were a few exceptions to this trend though. Most discolored rebar samples came from the older bridges in this study, although some of the rebar samples from the newer bridges showed significant levels of discoloration as well. Figure 6.1 shows five rebar with some discoloration.

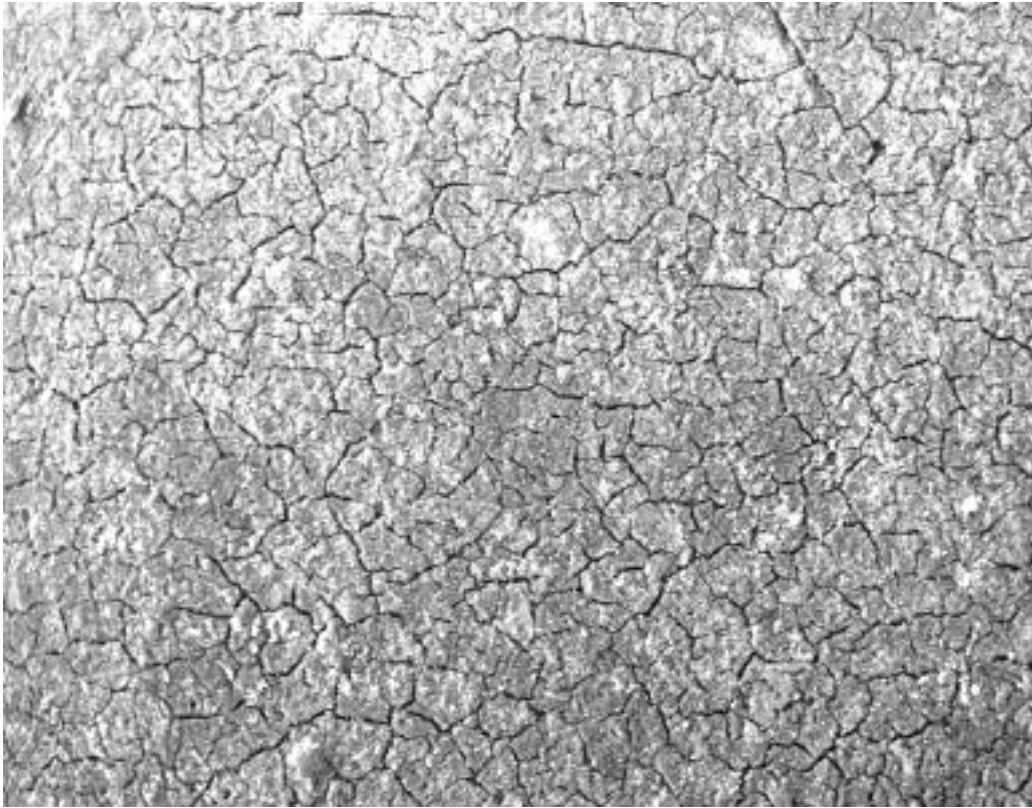
FIGURE 6.2 Microcracking in Discolored Epoxy Surface

From analyzing some of the rebar samples on the scanning electron microscope, it was observed that the severely discolored epoxy coating areas have small micro-cracks on the surface of the epoxy as shown in Figure 6.2. The exact cause of these microcracks is not known. Exposure to weather prior to construction or from aging and exposure to chloride could have caused these microcracks and discoloration. The impact that these microcracks have on the epoxy coating's ability to protect against reinforcement corrosion is not known. Because these cracks appear to be only on the surface of the epoxy coating, their significance may be minimal.

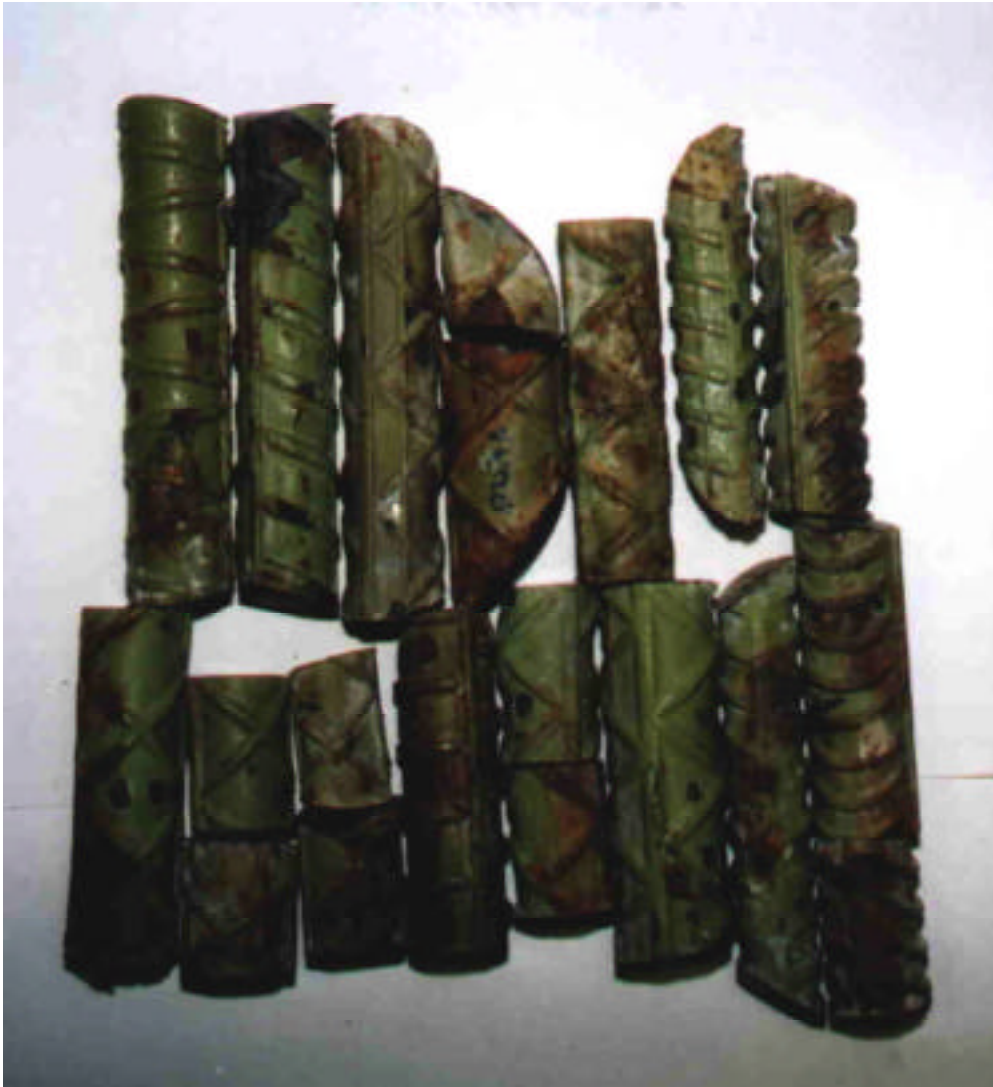
FIGURE 6.3 Rebars Samples with Significant Corrosion

Evaluation of the rebar samples collected from the bridge decks that were included in this study indicated a range of deterioration. The most corroded rebar samples were those collected from cracked locations. Although most of this corrosion was only on the surface of the steel, a couple samples were observed to have spots where corrosion product had built up slightly underneath the epoxy coating. The largest area of these spots observed was about two centimeters squared and bulged out to a depth of about one to two millimeters. One of the most significant findings from this study was that all of the rebar samples that were evaluated as having a rebar rating of one, two, or three came from cores that were taken from cracked locations. On all of the rebar samples rated one, two, or three, it appeared that surface corrosion was undercutting the epoxy coating. Figure 6.3 shows some of the rebar samples evaluated in this study that were given a rebar rating of one, two, or three.

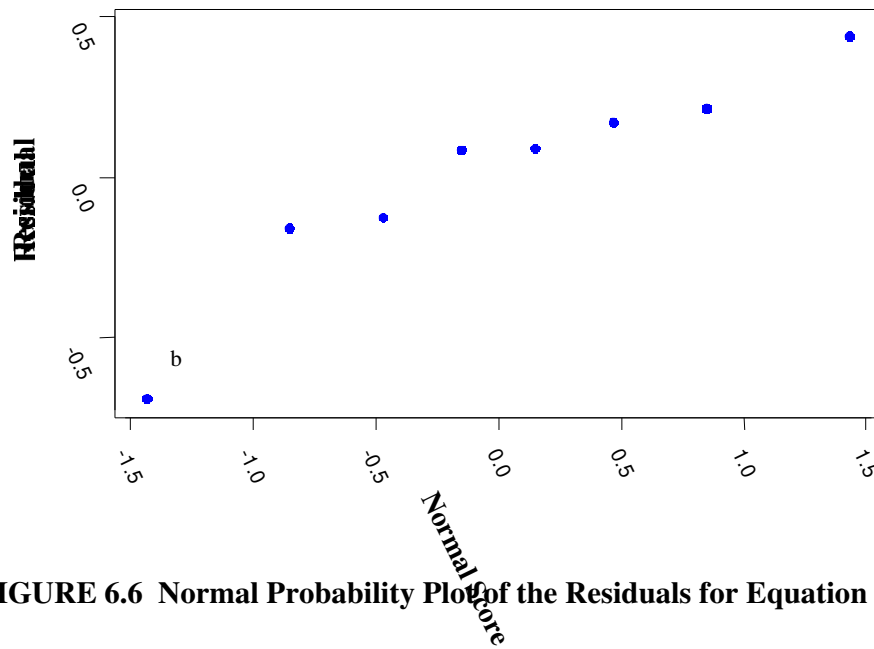
FIGURE 6.6 Normal Probability Plot of the Residuals for Equation 6.5

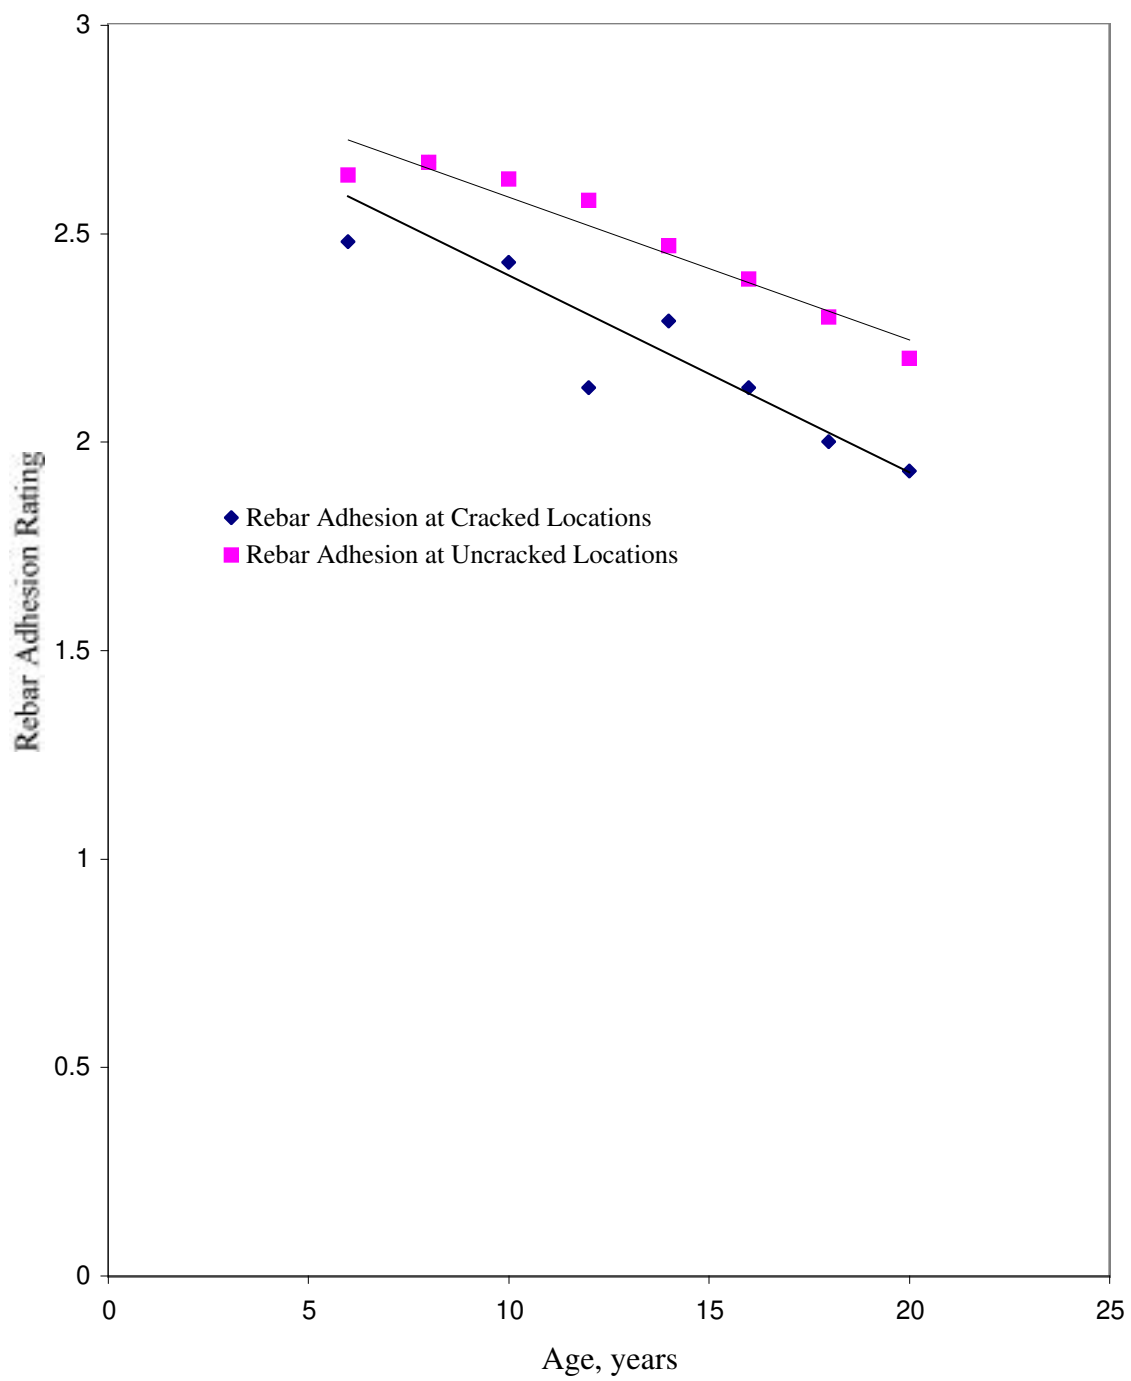
Figure 6.7 Rebar Adhesion Rating vs. Age

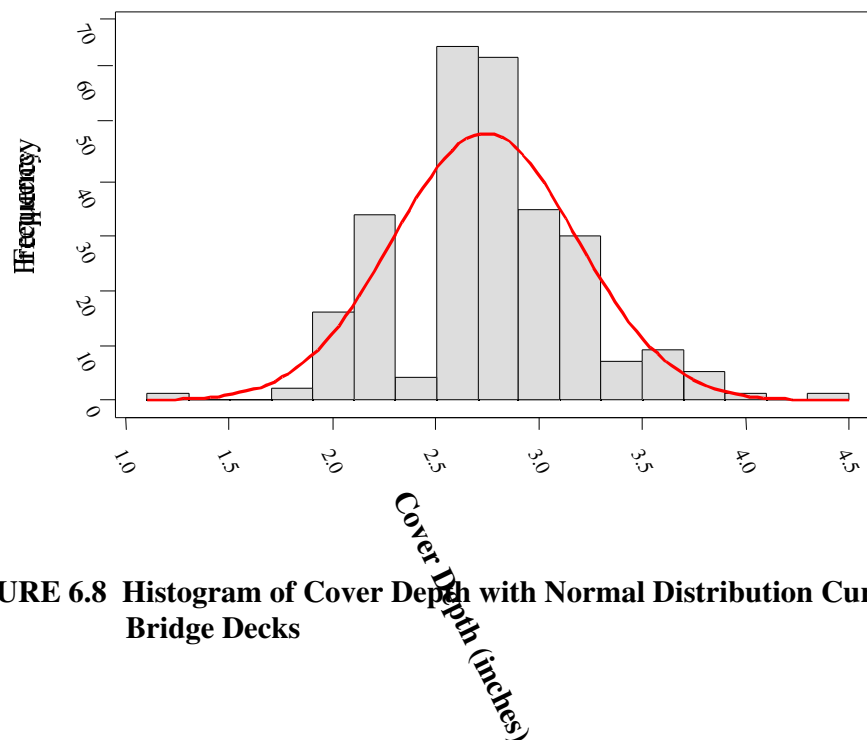
FIGURE 6.8 Histogram of Cover Depth with Normal Distribution Curve for Iowa Bridge Decks

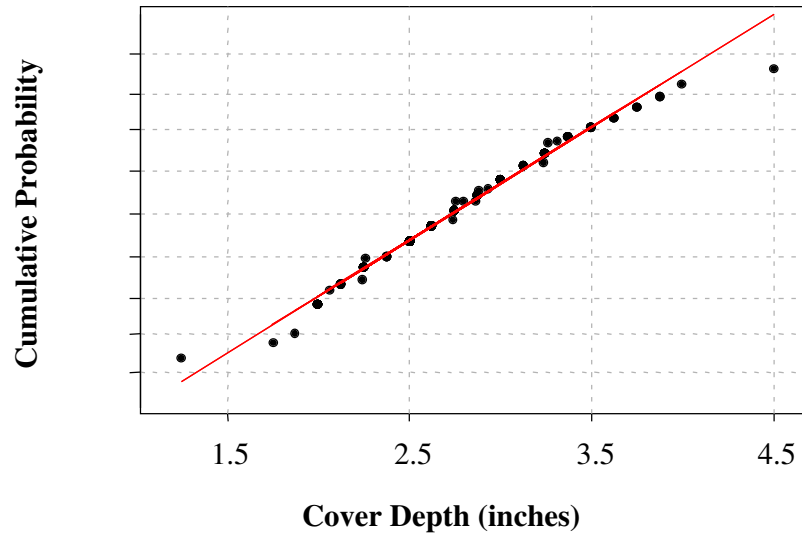
FIGURE 6.9 Normal Probability Plot

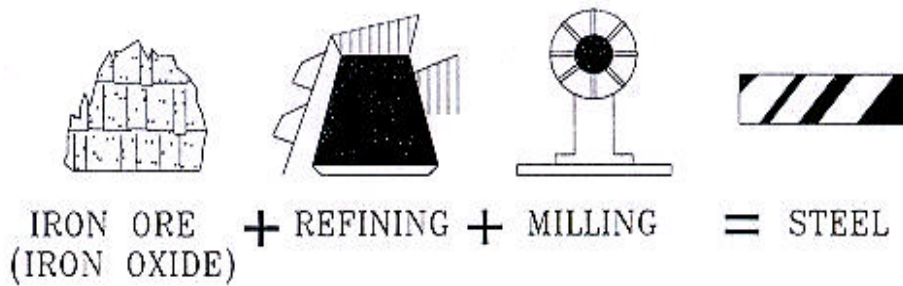
FIGURE A.1 Conversion of Iron Ore to Steel (5)
