# TECHNICAL SUMMARY

# Corrosion Performance of Epoxy-Coated Reinforcement Bars

*This Technical Summary pertains to Report 2008-47, “Corrosion Protection Performance of Epoxy-coated Reinforcing Bars,” published September 2008. The full report can be accessed at <http://www.lrrb.org/PDF/200847.pdf>.*

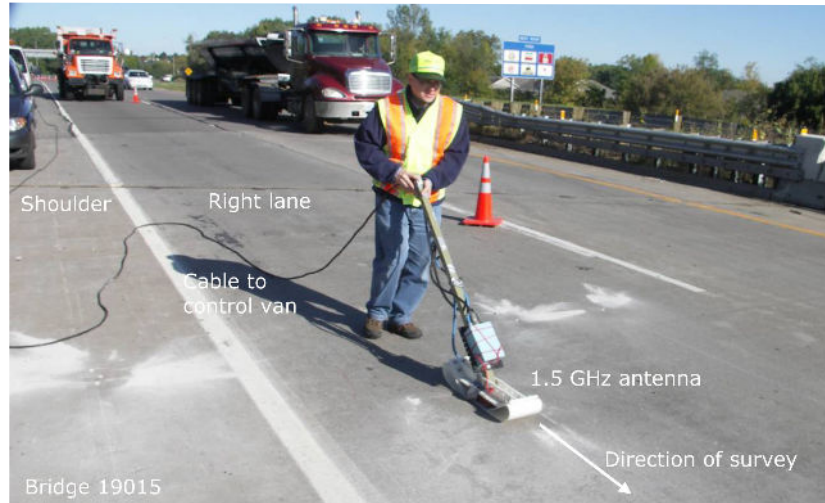
Researchers used ground penetrating radar (pictured), impedance spectroscopy and half-cell potential measurements in the field to evaluate the level of corrosion of the bars.
