What We Have Learned About the Use and Performance of Epoxy-**Coating Reinforcing Bars** TRB 2010, Washington DC David McDonald, Ph.D., P.E., FACI January 10, 2010

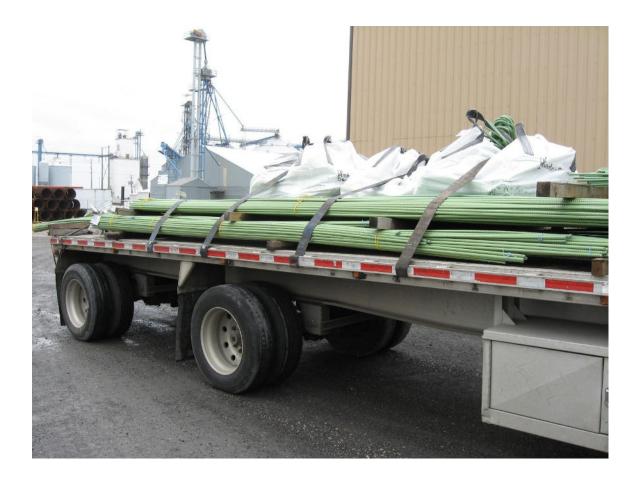
Proper loading

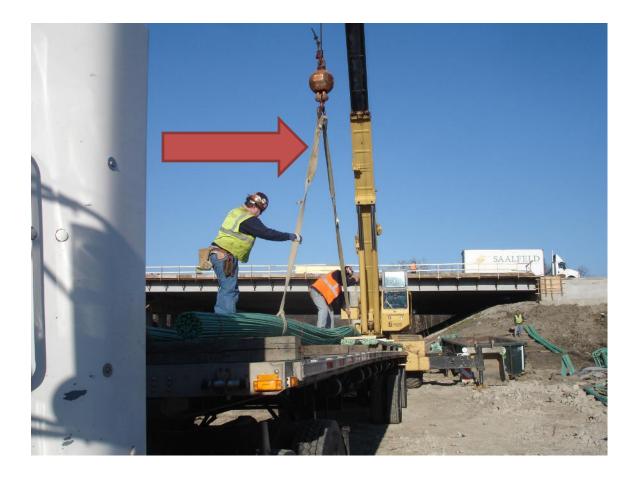
Good lifting practices

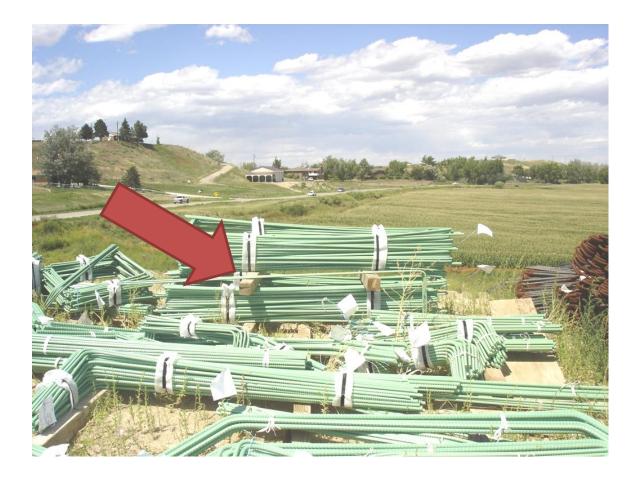
Appropriate Storage

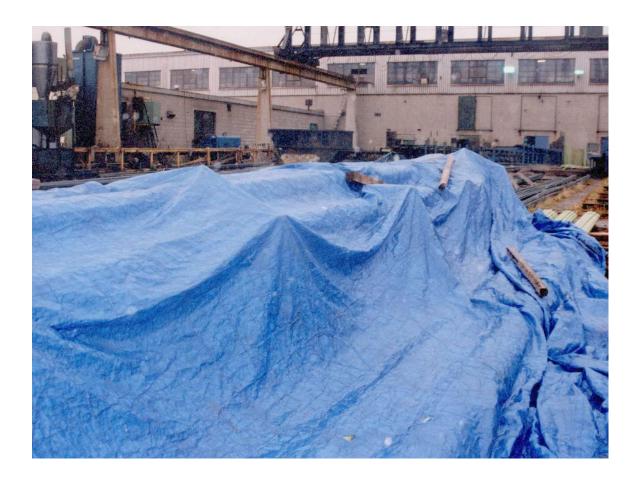
Covering to protect from UV

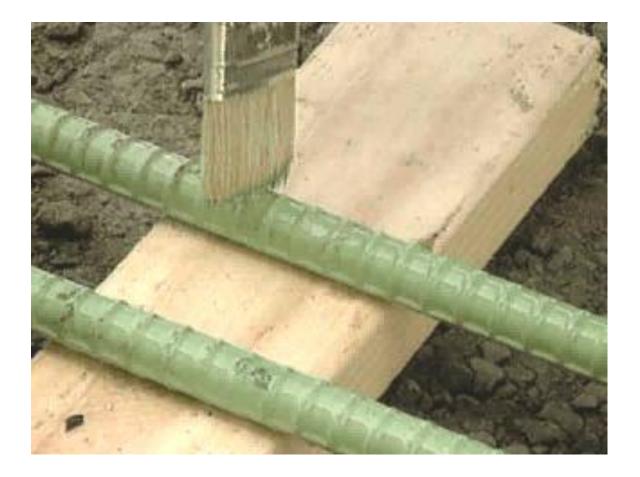
Repair ALL damage

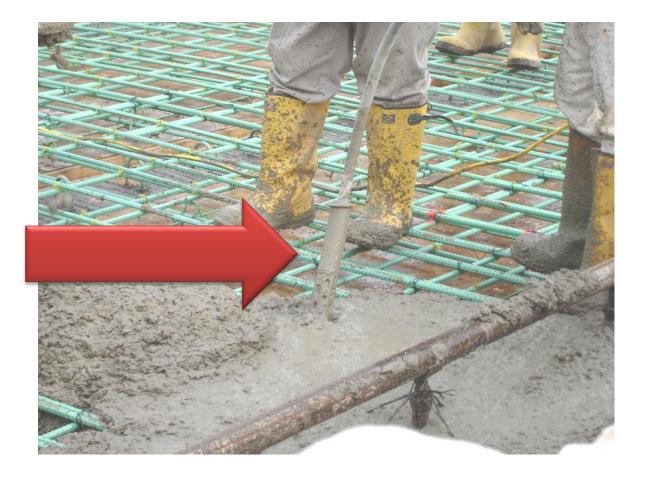
Use non-metallic vibrator heads
