# RAPID MACROCELL TESTS OF ASTM A775, A615, and A1035 REINFORCING BARS

A Report on Research Sponsored by the  
EPOXY INTEREST GROUP  
OF THE CONCRETE REINFORCING STEEL INSTITUTE

Structural Engineering and Engineering Materials  
SL Report 10-4  
November 2010

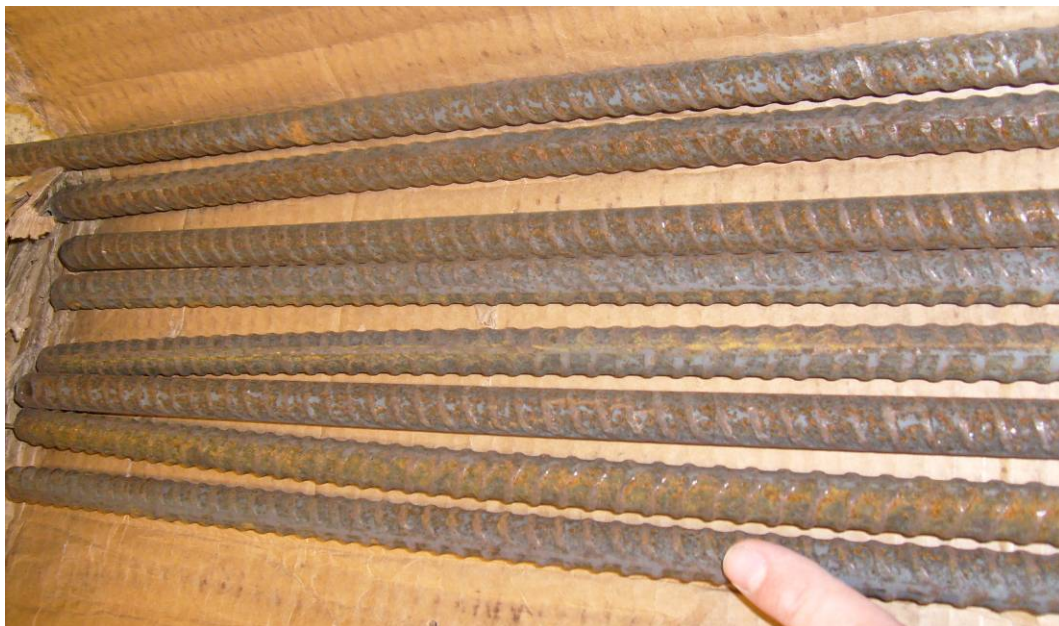
**Figure 1:** A1035 steel in the as-received condition exhibit corrosion on the surface of the bars.

The bars were inspected upon receipt, and the conventional steel and ECR were found to be in good condition. The A1035 exhibited significant corrosion, as shown in Figure 1. As a result, macrocell tests were performed on the A1035 bars after pickling, as well as in the as-received condition.

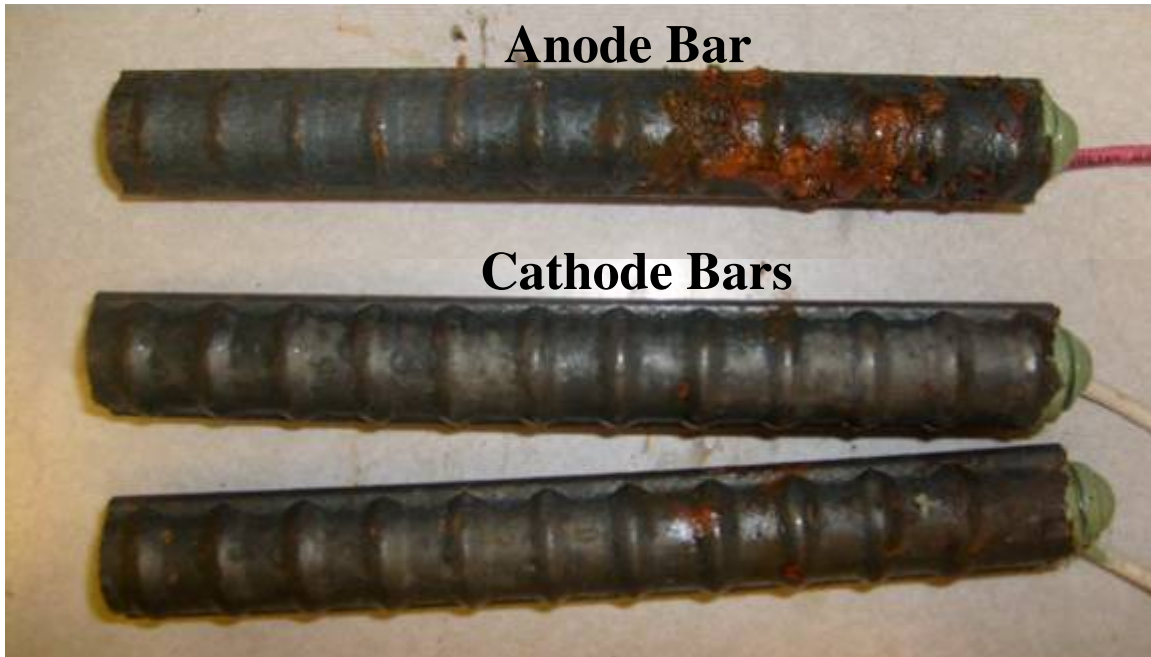
**Figure 20:** Conventional steel. Specimen 3, side A one week after removal from solution, after rinsing. Specimen exhibits significant corrosion above the liquid level.

All conventional, as-received A1035, and pickled A1035 steel specimens exhibit corrosion during the test, with the corrosion products forming at or above the liquid level. The conventional and as-received A1035 specimens exhibit significant corrosion products, such as shown for conventional steel in Figures 20 and 21, respectively. The pickled A1035 bars exhibited somewhat more limited corrosion products, as shown in Figures 22 and 23. The “grooves” along the length of the pickled specimens seem to provide a crevice at which corrosion initiates, with the corrosion products distributed along the length of the bar above the liquid level (Figures 22 and 23). This was not observed with the as-received bars, most likely due to the initial, corroded state of those specimens.

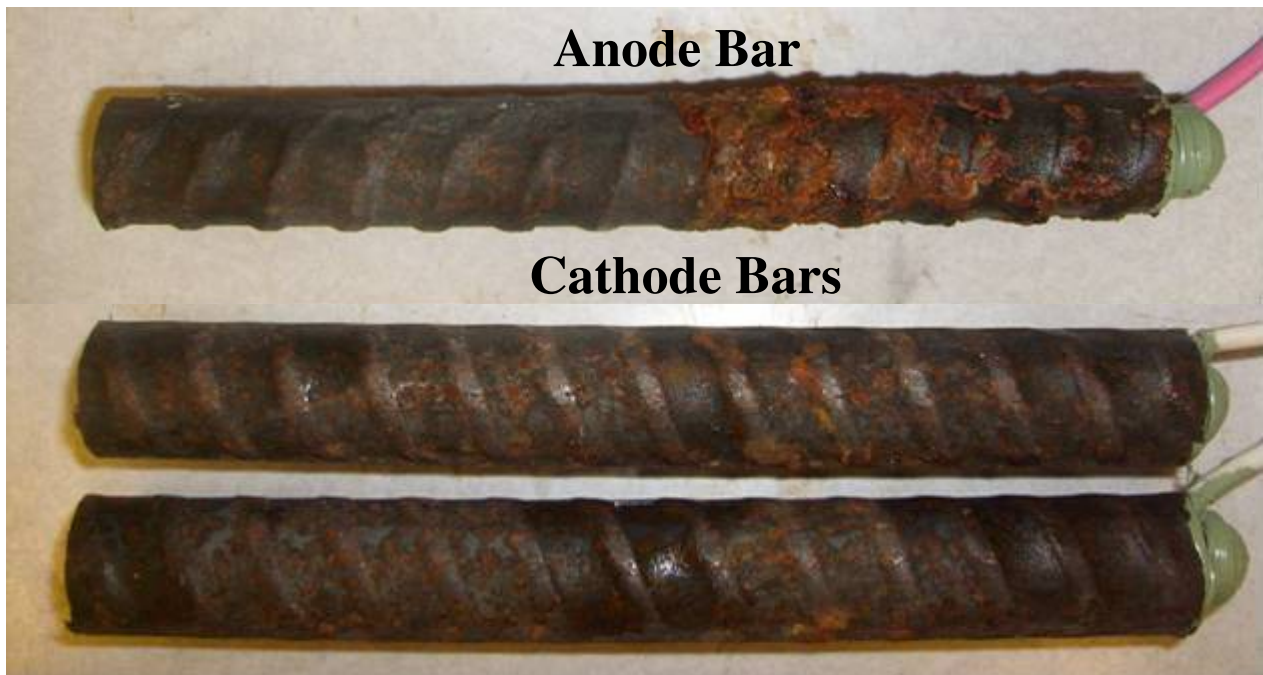
**Figure 21:** A1035 steel. Specimen 3, side B one week after removal from solution, after rinsing. Specimen exhibits significant corrosion above the liquid level.

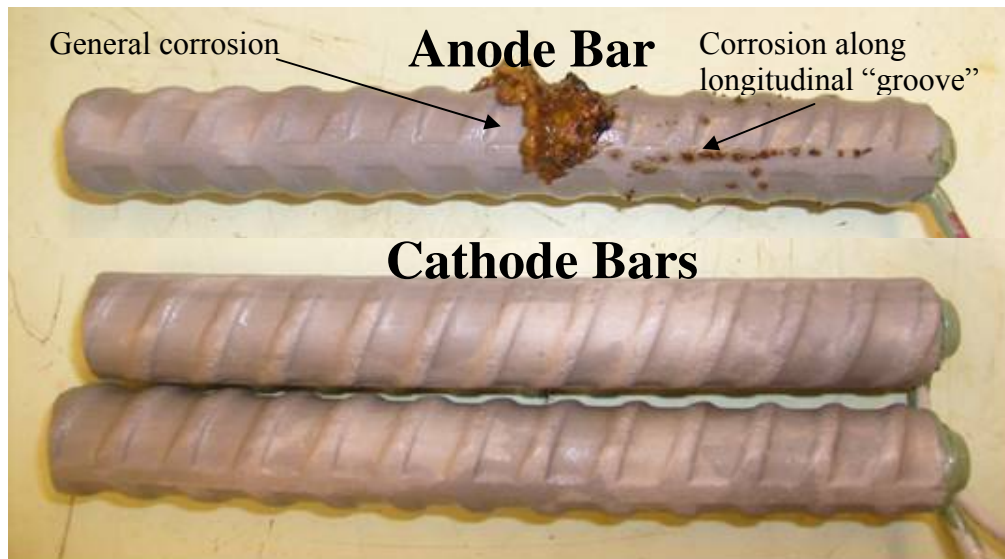
**Figure 23:** Pickled A1035 steel. Specimen 3, side A after removal from solution and rinsing.
