*Reducing Concrete Damage through
Corrosion Resistant Reinforcing: an
Overview of 40 years of Research
and Practice*

David McDonald, Ph.D., P.E., FACI

Epoxy Interest Group of CRSI

October 30, 2012

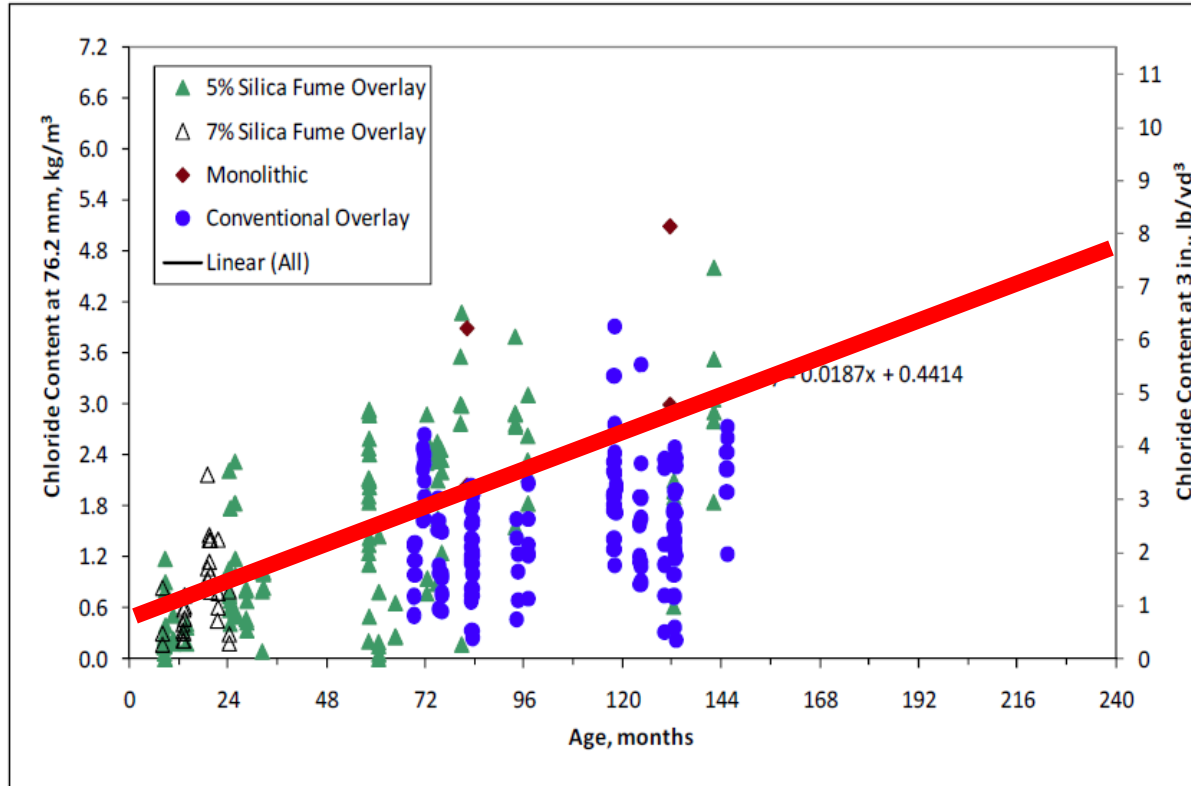
Chloride Data at cracks 3 in. depth, AADT > 7500

$$C(t) = 0.0316.t + 0.746$$

Where t = time (months)

$C(t)$ = chloride content (lb/yd³)

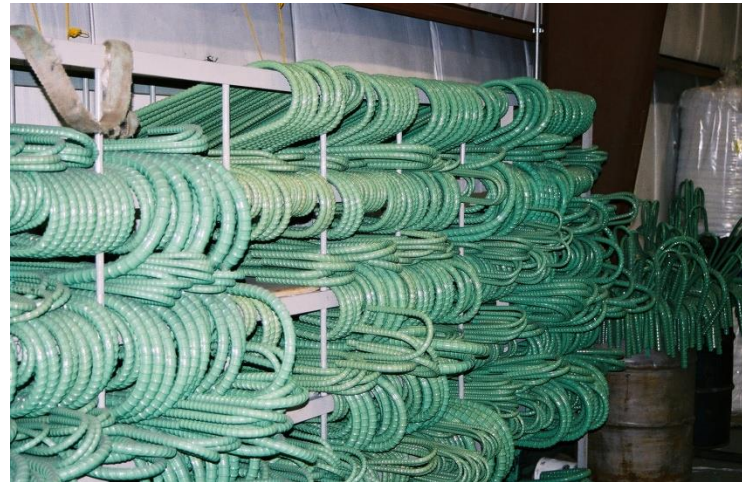
- 1992: ...zero to 32 cracks at the bends
 - Bending to 120°
- 2011: Cracks in coating not allowed
 - Bending to 180°

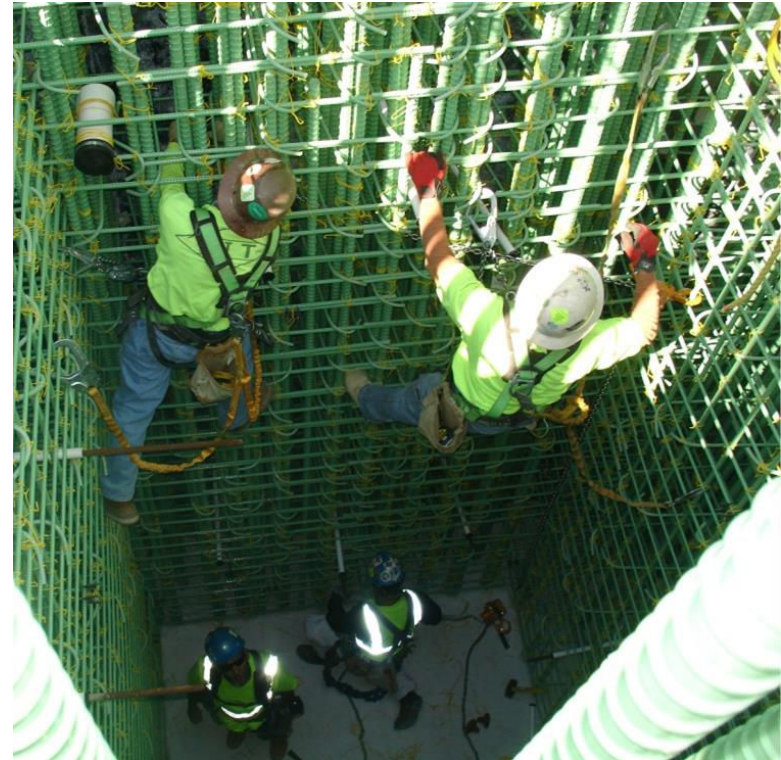
- Like all materials
- Appropriate handling
 - Damaged bars have lower performance than undamaged bars

Damaged bars still perform well

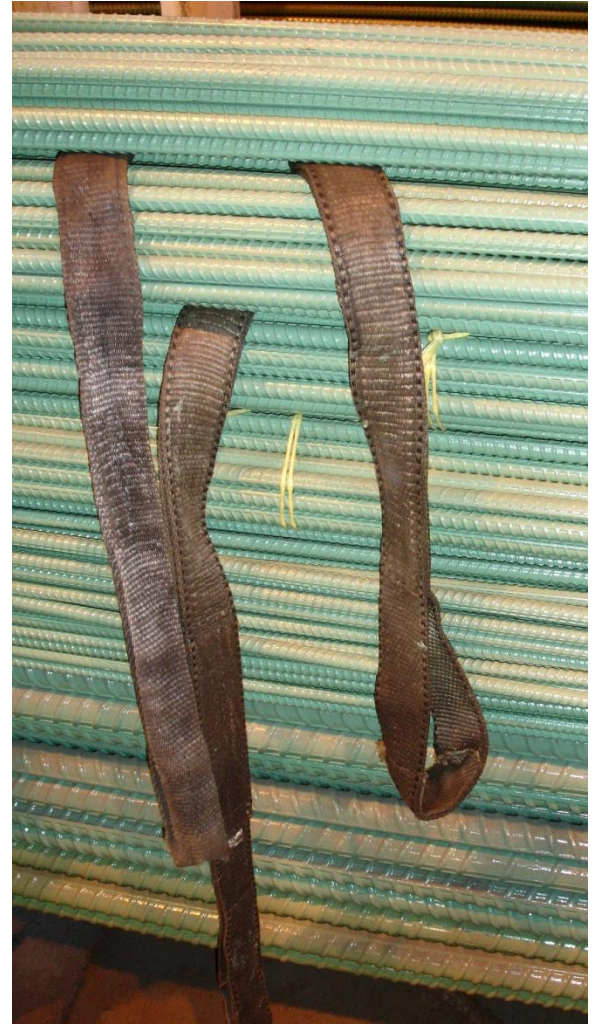
Slings

- Use nylon or padded slings
- **No bare chains or cables**

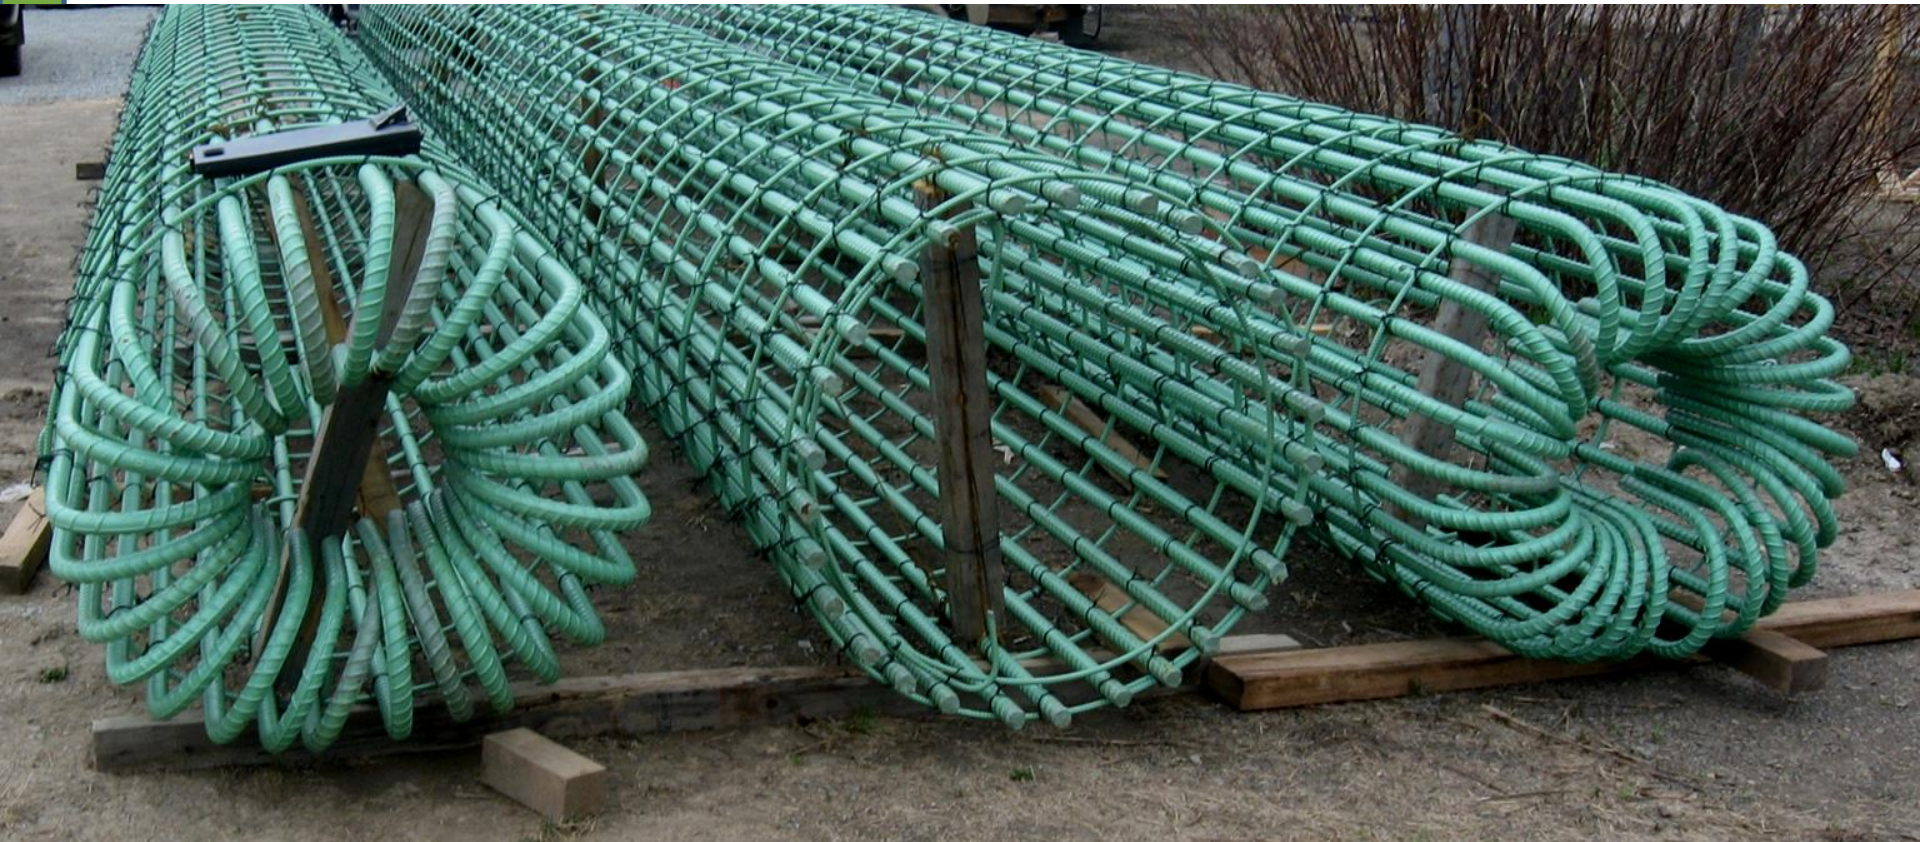
Storage

- Store bundles on timber cribbing
 - Do not store directly on the ground

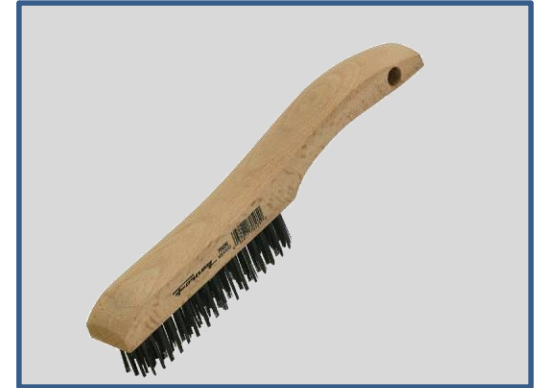
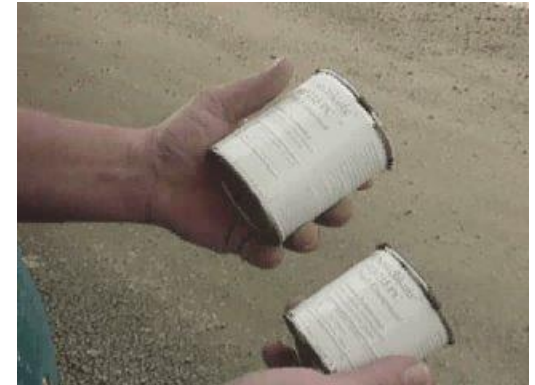
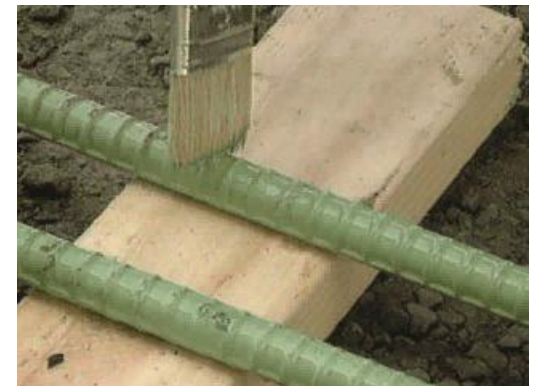
Coating repair

- Wire brush
 - Remove rust or other contaminants
- Two-part epoxy
 - **No spray cans**
 - Approved by the coating manufacturer
 - Mixed according to the manufacturer's direction
 - Used within the specified pot life
- Provided cure time prior to concrete

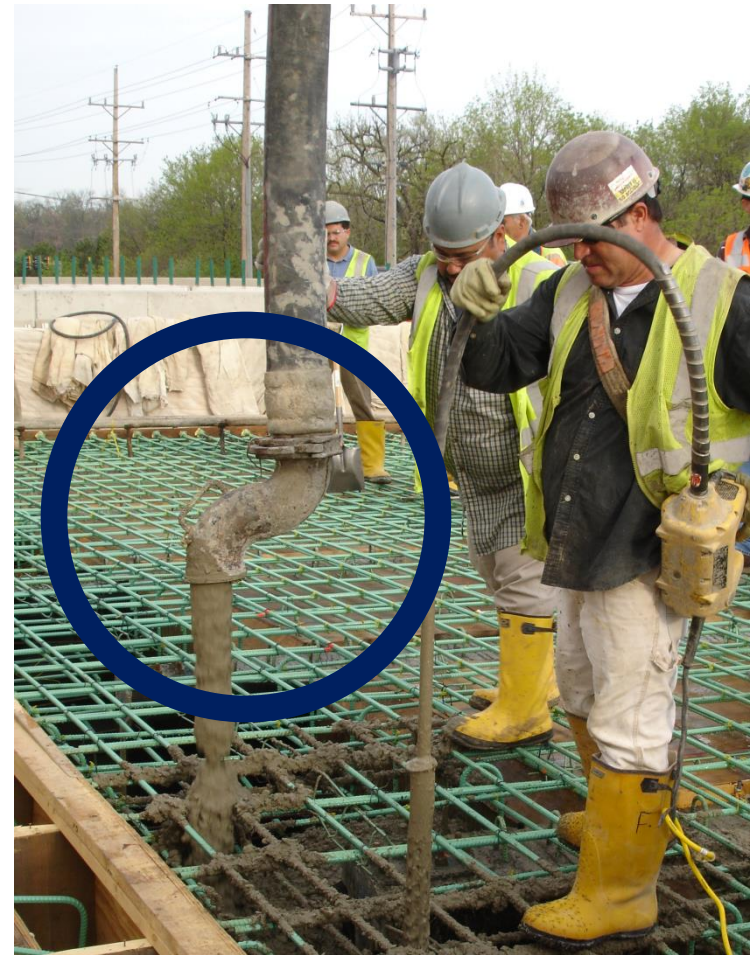
Concrete hose

- Fit concrete pumps with an “S” bend
- Protect bar against hose couplers
