VERIFICATION OF EFFECTIVENESS OF EPOXY-COATED REBARS

PENNSYLVANIA DEPARTMENT OF TRANSPORTATION

PROJECT NO. 94-05

FINAL DRAFT REPORT
November 24, 1998

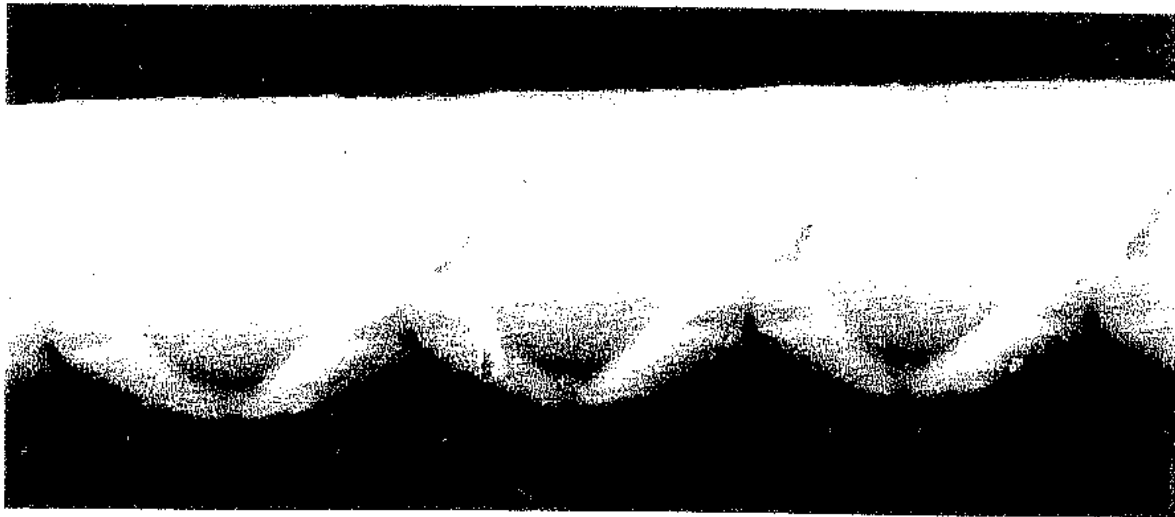
Figure 5-3. Photographs showing the typical condition observed for each adhesion rating.

Adhesion Rating 1

Adhesion Rating 3

Adhesion Rating 5
