# **Field Evaluations of Epoxy-Coated Bars in Inland and Marine Bridges**

David McDonald, Ph.D., P.E.

Epoxy Interest Group of CRSI

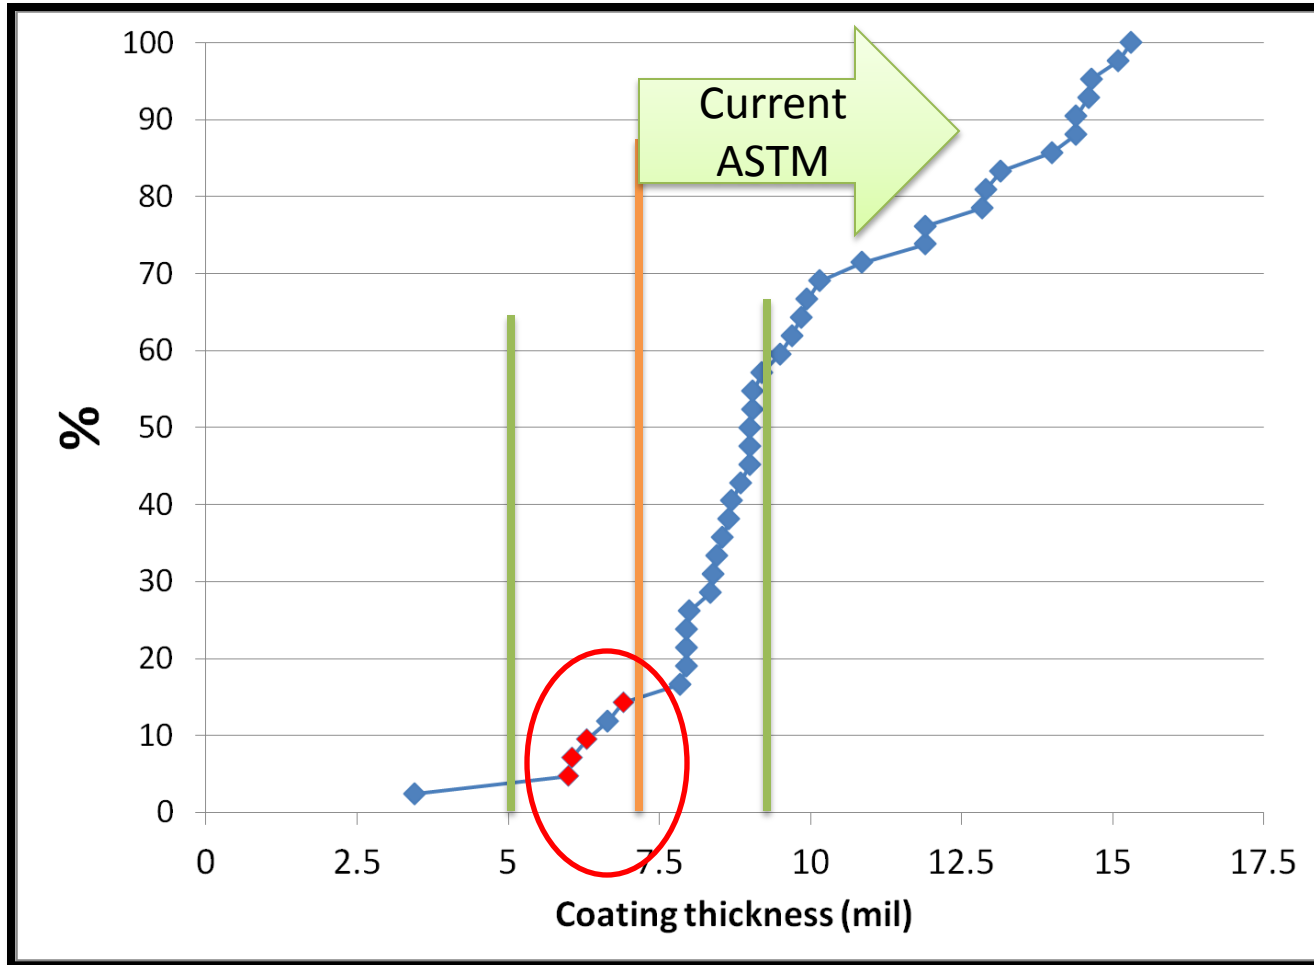
# Coating thickness

- Active corrosion in the epoxy-coated bars correlated to three factors:
  - high chloride concentration
  - low coating thickness
  - extended exposure to high chloride concentrations
- Many more years of service life are expected

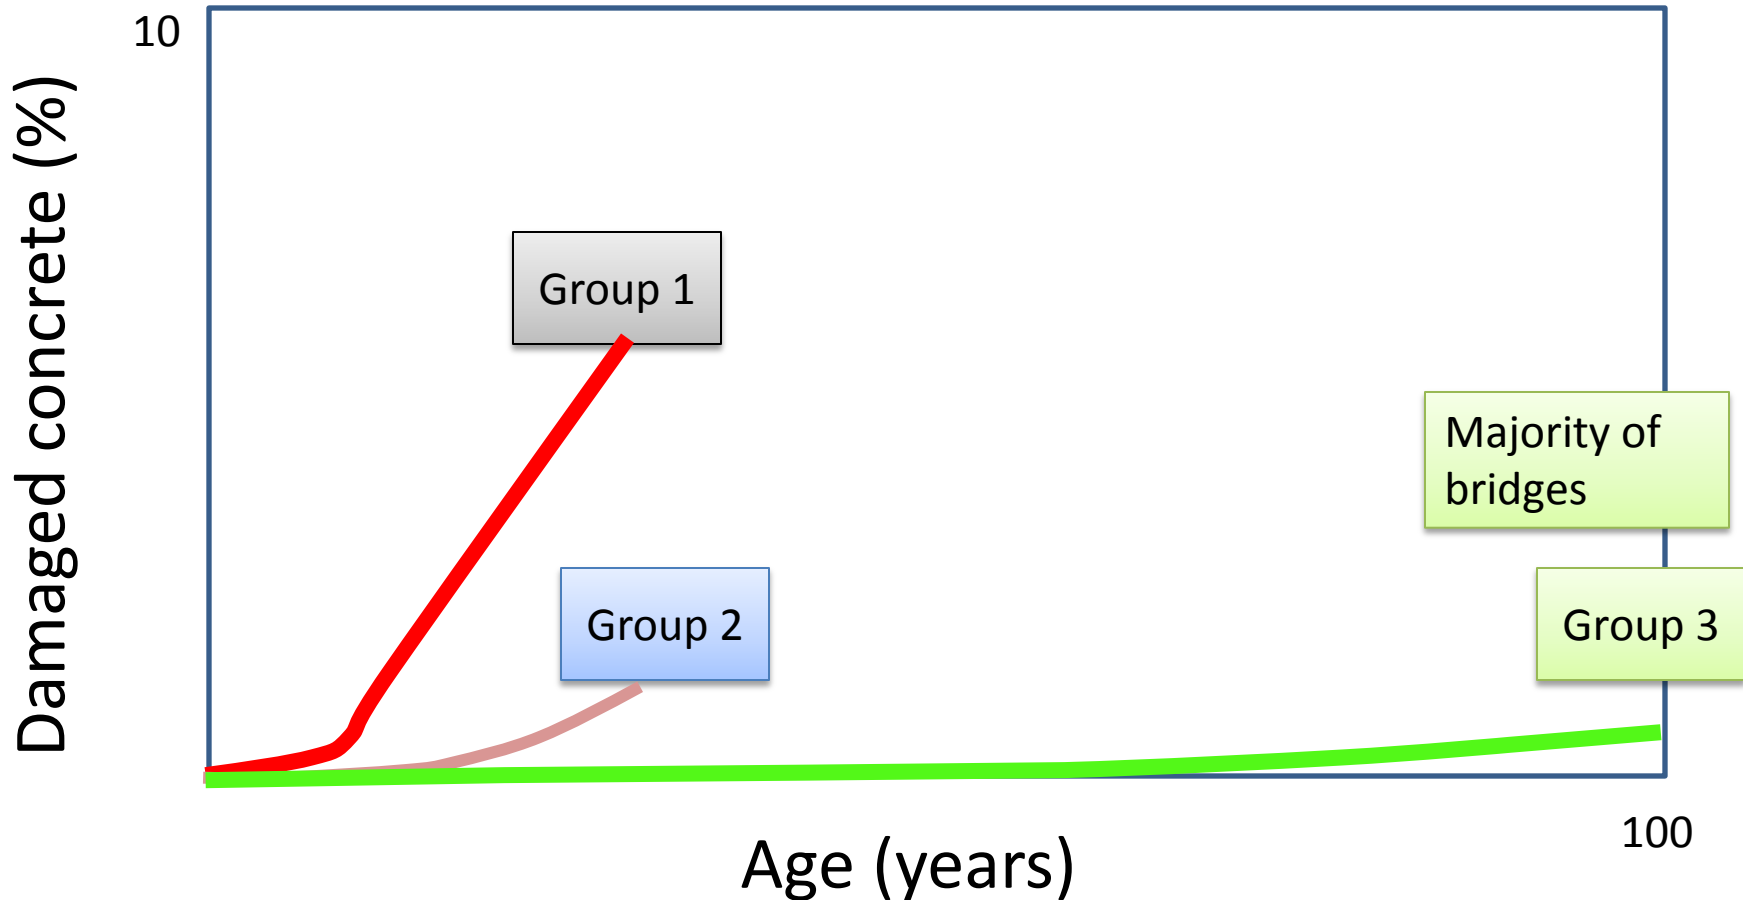
# Florida predictions

Most structures containing epoxy reinforcement are **predicted to have a 100 year life**

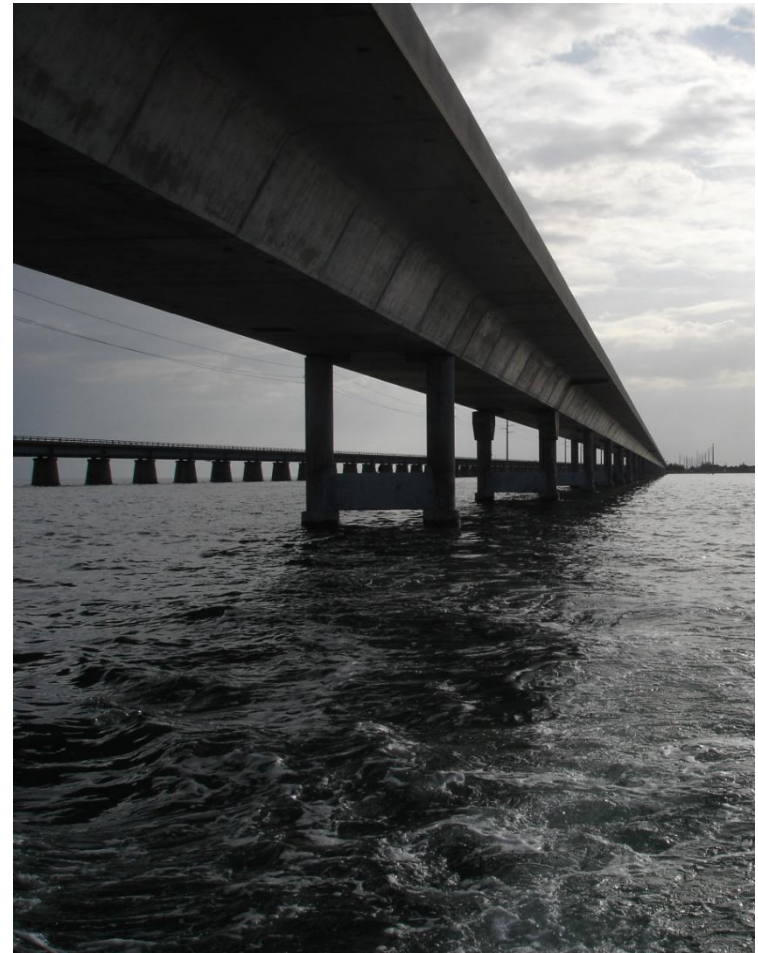
# Florida bridges

- Good concrete
- Good cover
- Aggressive environment
- Well manufactured and stored reinforcement

Good quality concrete and coatings lead to long life
