**CONDITION SURVEY AND SERVICE LIFE  
PREDICTION OF FOUR MARINE BRIDGE  
SUBSTRUCTURES CONTAINING EPOXY-COATED  
REINFORCING BARS**

**Final Report**

9 January 2007

**Wiss, Janney, Elstner Associates, Inc.**

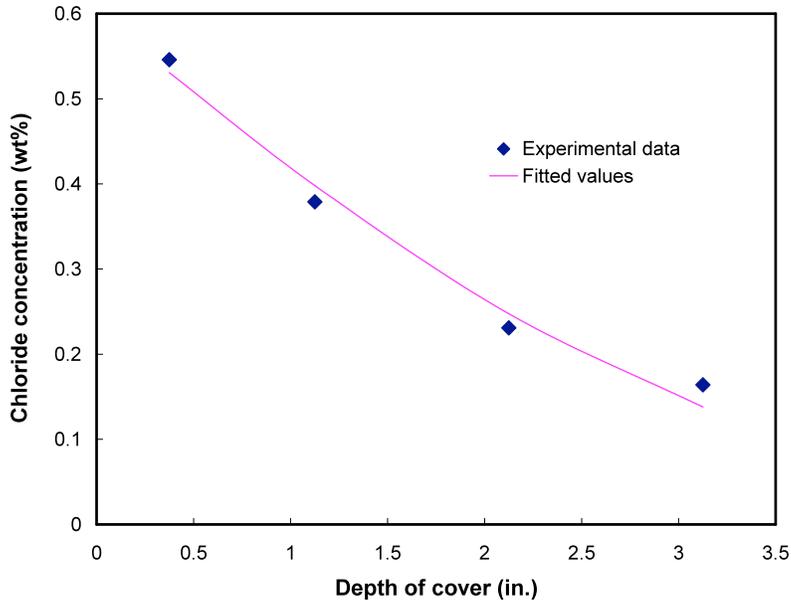
Based on this relationship, the values of  $C_s$  and  $D$  that provided the best fit to the measured chloride concentration depth profiles were determined using a least squares fitting method. The term  $t$  was assigned as the age of the bridge. For the McKay River Bridge in Georgia,  $t$  is 22 years; for the three bridges in North Carolina,  $t$  is 21 years. With these values, the chloride concentration at any depth can be predicted for any given time at that location. Figure 1 shows an example result of this analysis.

Figure 1. Typical chloride analysis result. Core chloride profiles were fitted using a least squares fit method to obtain estimation of effective chloride diffusion coefficient  $D$  and surface chloride concentration  $C_s$ .

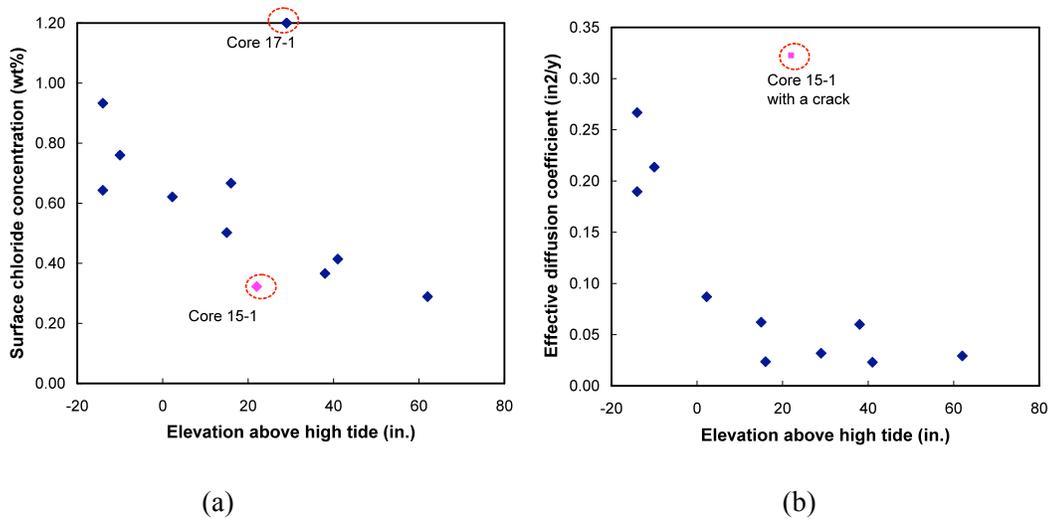
Figure 10. Calculated surface chloride  $C_s$  and effective diffusion coefficient  $D$  for the MacKay River Bridge.

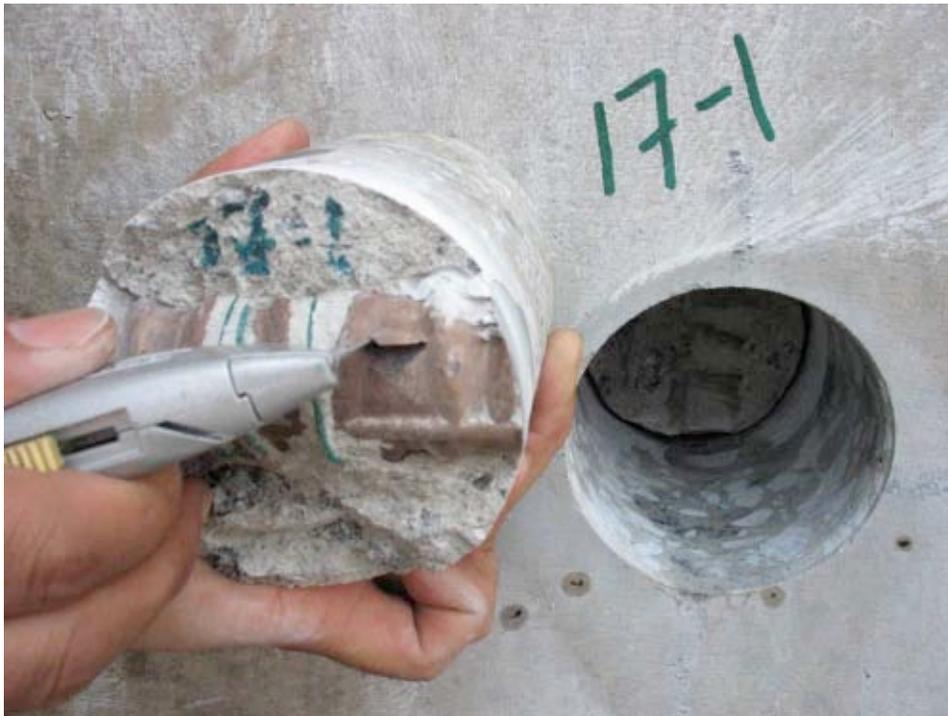
*Figure 11. On-site adhesion test on the MacKay River Bridge Core 17-1 (29 in. above high tide, bar-level chloride concentration is 0.009 wt%).*

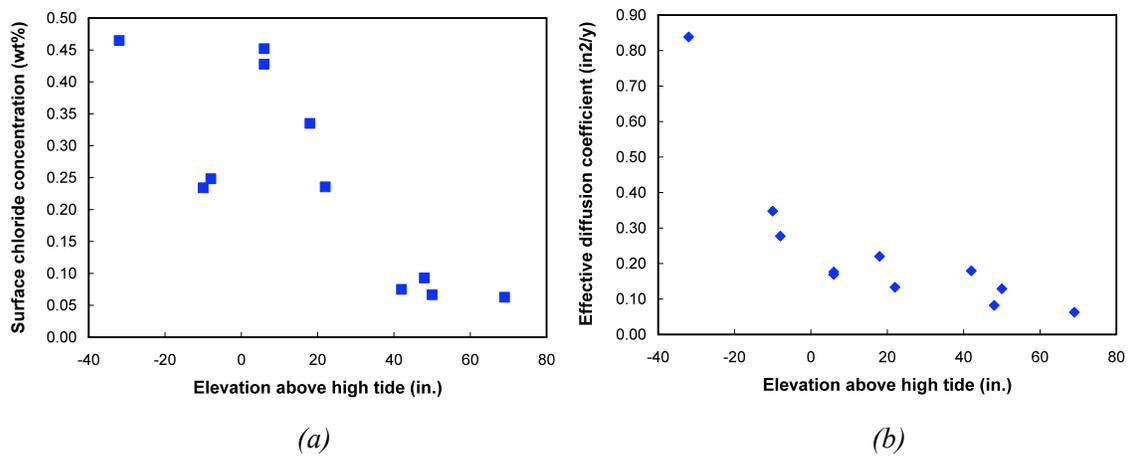
Figure 21. Calculated surface chloride  $C_s$  and effective diffusion coefficient  $D$  for the Ocean Isle Bridge.

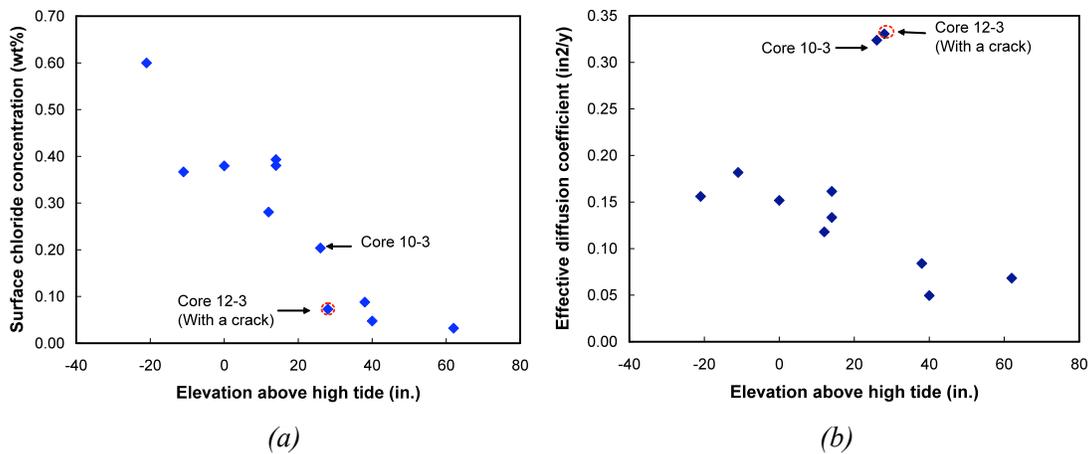
The calculated surface chloride concentrations ( $C_s$ ) and effective diffusion coefficients ( $D$ ) are summarized in Table 15. These values are plotted versus elevation in Figure 29. The concrete in the tidal zone has the highest  $C_s$ , and as expected,  $C_s$  decreases with increase of elevation. While  $D$  largely follows a similar trend to that observed on other bridges, for unknown reason, Core 10-3 (which has no crack) has exceptionally high diffusion coefficient (0.324 in.<sup>2</sup>/y). Cores 12-5 and 12-6, which both have full depth cracks, were found to have  $D$  and  $C_s$  values comparable to the sound cores taken at a similar elevation. Core 12-3, with a surface crack has a  $D$  several times higher than the  $D$  of other cores at comparable elevation. Chloride concentrations at bar level were also calculated for each core based on the Fick's Law least squares curve fitting analysis. As shown in Table 15, five cores have chloride concentrations at bar depths greater than the typical threshold for uncoated bars (0.030 wt%), yet no active corrosion was observed (Table 13).

Figure 29. Calculated surface chloride  $C_s$  and effective diffusion coefficient  $D$  for the Holden Beach Bridge.

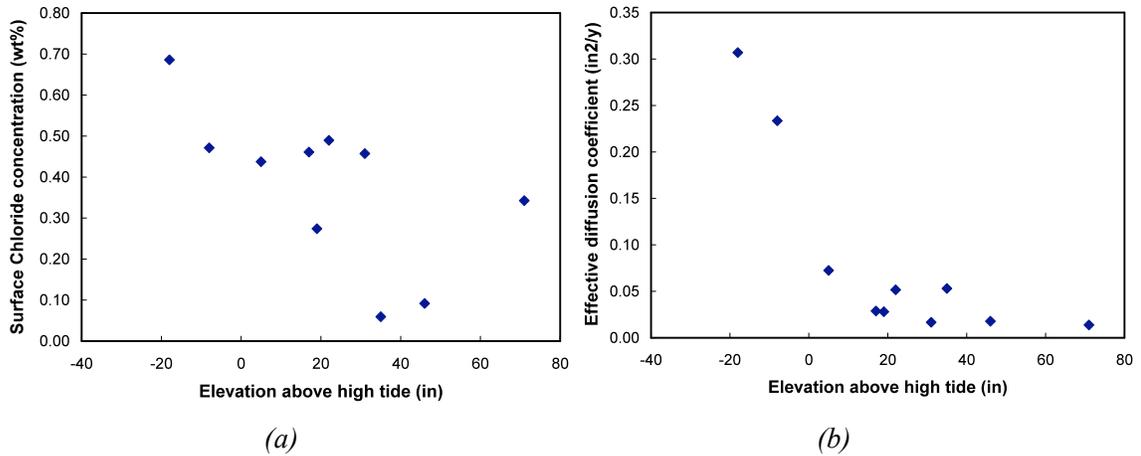
The calculated surface chloride concentrations ( $C_s$ ) and effective diffusion coefficients ( $D$ ) for the Atlantic Beach Bridge cores are summarized in Table 19. These values are plotted versus elevation in Figure 36. The concrete in the tidal zone has higher effective diffusion coefficients than the concrete in

Figure 36. Calculated surface chloride  $C_s$  and effective diffusion coefficient  $D$  for the Atlantic Beach Bridge.

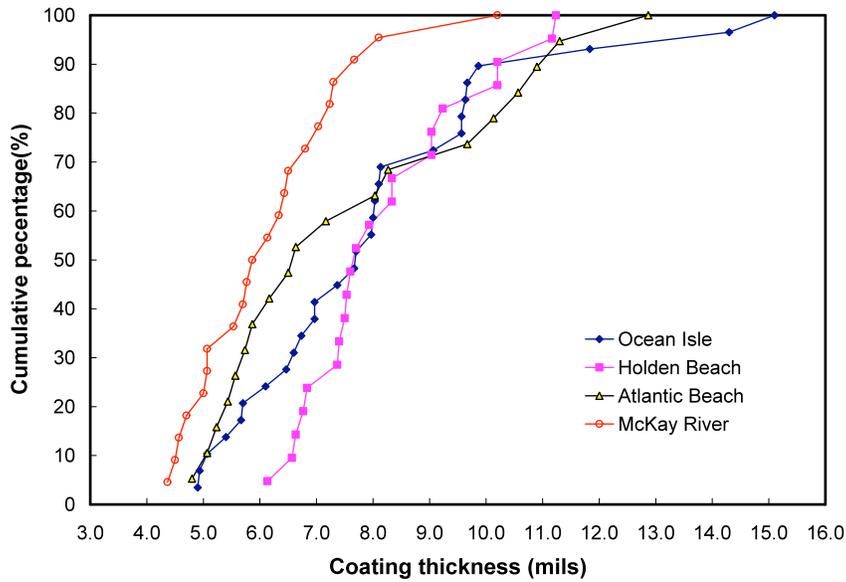
Figure 39 shows the cumulative distribution of coating thicknesses measured on samples of the four bridges and Table 20 compares the averages of the coating thicknesses. The epoxy-coated bars in the MacKay River Bridge had the lowest average coating thickness. No thickness specification was given in the NCDOT Project Special Provisions for the Ocean Isle and Holden Beach Bridges, dated March 1984. However, a specified thickness of  $7 \pm 2$  mils is listed NCDOT Project Special Provisions for the Atlantic Beach Bridge from July 1984. ASTM A775-81, which was in effect at the time of construction of these bridges, specifies a thickness of 5 to 12 mils and that "at least 90% of measurements shall be within the specified limits." Based on the sampled bars, the coating on the bars used in the MacKay River Bridge was thin and would not meet the thickness standard in 1984. Based on this limited sampling, the coatings of the other three bridges potentially met this older standard. However, only the bars from the Holden Beach Bridge appear to have the potential to meet the requirements of the current version of the epoxy-coated bar specification, ASTM A775-06. This specifies a coating thickness of 7-12 mils and that no single thickness measurement be less than 80% of the specified minimum thickness (5.6 mils).

Figure 39. Measured coating thickness measurements of all the extracted epoxy-coated bars.

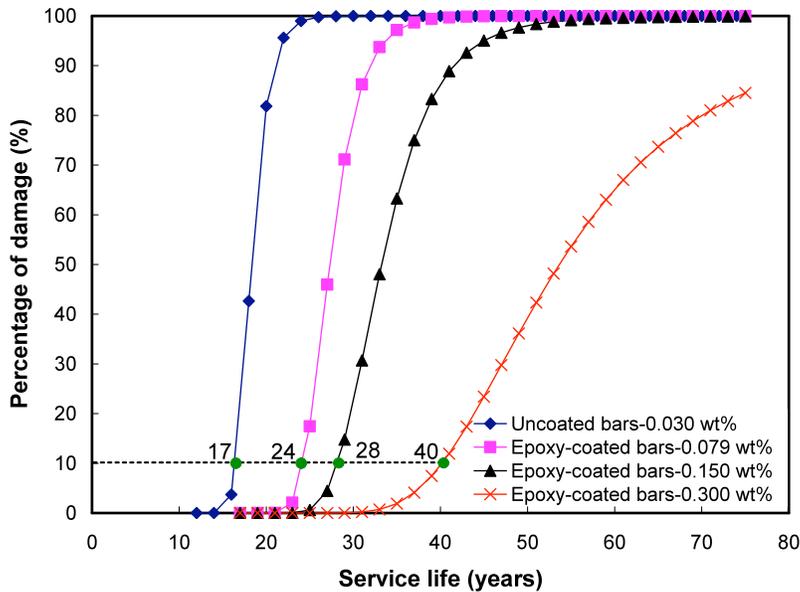
Figure 40. Model outputs for tidal zone: damage function for the MacKay River Bridge columns without cracks. Threshold based on field specimens: 0.079 wt%; thresholds included for comparison: 0.150 wt%, 0.300 wt%.

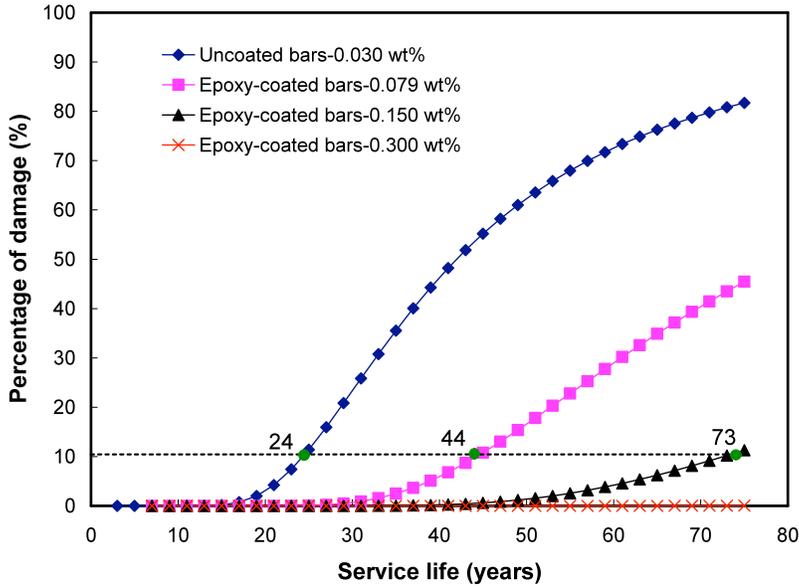
Figure 41. Model outputs for splash zone: damage function for the MacKay River Bridge columns without cracks. Threshold based on field specimens: 0.079 wt%; thresholds included for comparison: 0.150 wt% , 0.300 wt%.

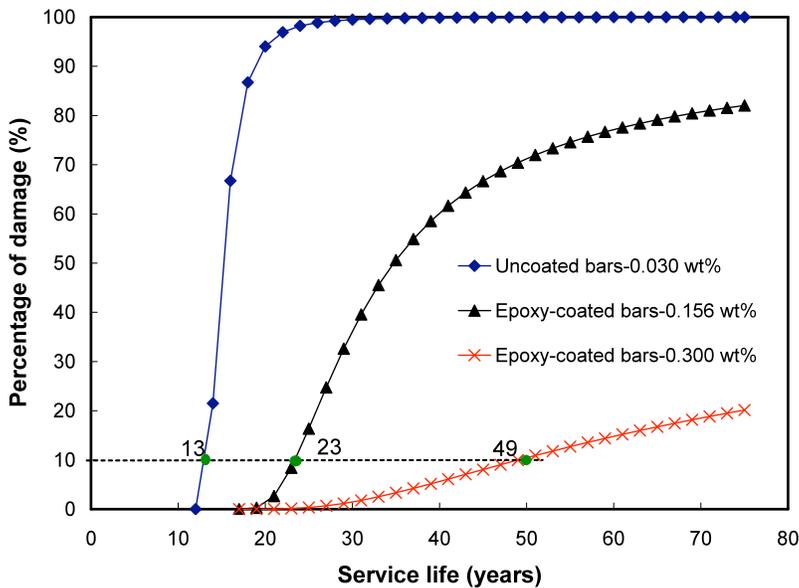
Figures 42 and 43 show the projected damage functions for columns reinforced with both uncoated bar and epoxy-coated bar. For the tidal zone, if 10% damage is considered to be the end of service life,

Figure 42. Model outputs for tidal zone: damage function for the Ocean Isle Bridge columns without cracks. Threshold based on field specimens: 0.156 wt%; threshold included for comparison: 0.300 wt%.

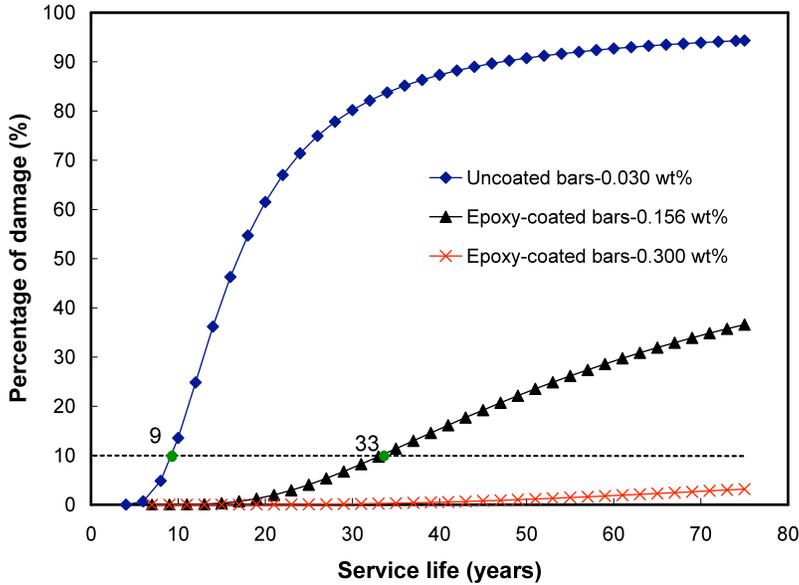
Figure 43. Model outputs for splash zone: damage function for the Ocean Isle Bridge columns without cracks. Threshold based on field specimens: 0.156 wt%; and threshold included for comparison: 0.300 wt%.

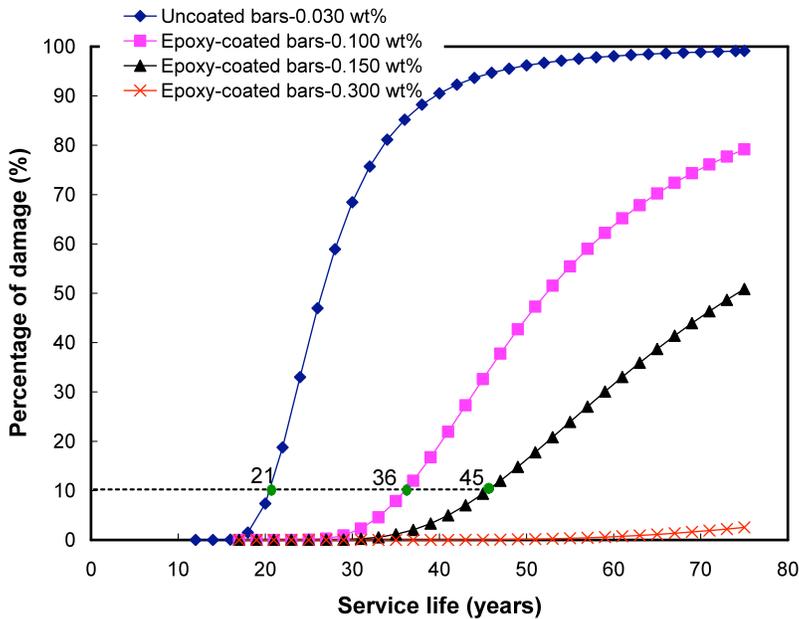
Figure 44. Model outputs for tidal zone: damage function for the Holden Beach Bridge pile caps without cracks. Threshold based on field specimens: 0.100 wt%; thresholds included for comparison: 0.150 wt% , 0.300 wt%.

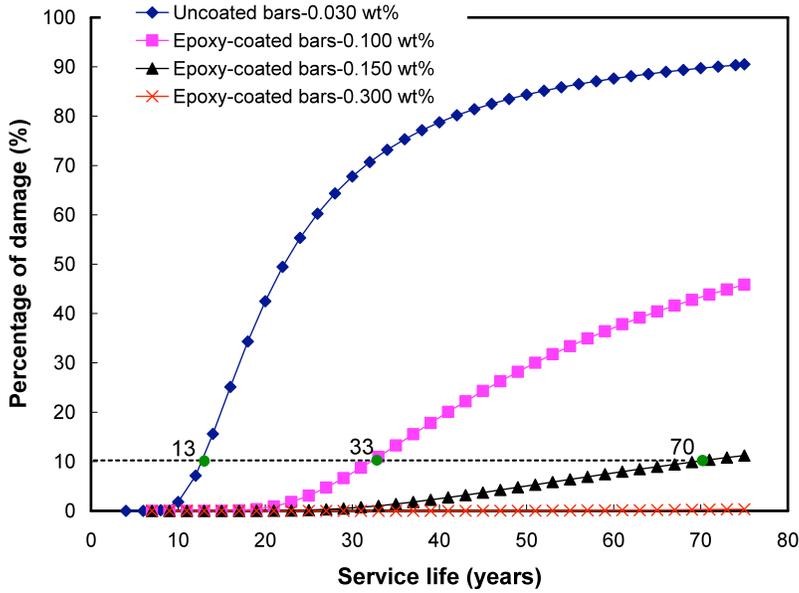
Figure 45. Model outputs for splash zone: damage function for the Holden Beach Bridge columns without cracks. Threshold based on field specimens: 0.100 wt%; thresholds included for comparison: 0.150 wt%, 0.300 wt%.

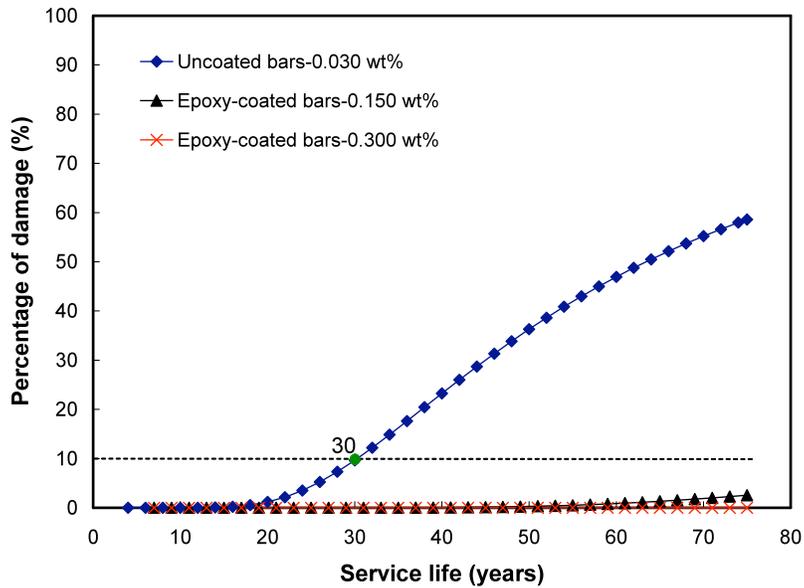
Figure 46. Model outputs for splash zone: damage function for the Atlantic Beach Bridge columns without cracks. Threshold based on field specimens of the Ocean Isle Bridge: 0.150 wt%; threshold included for comparison: 0.300 wt%.

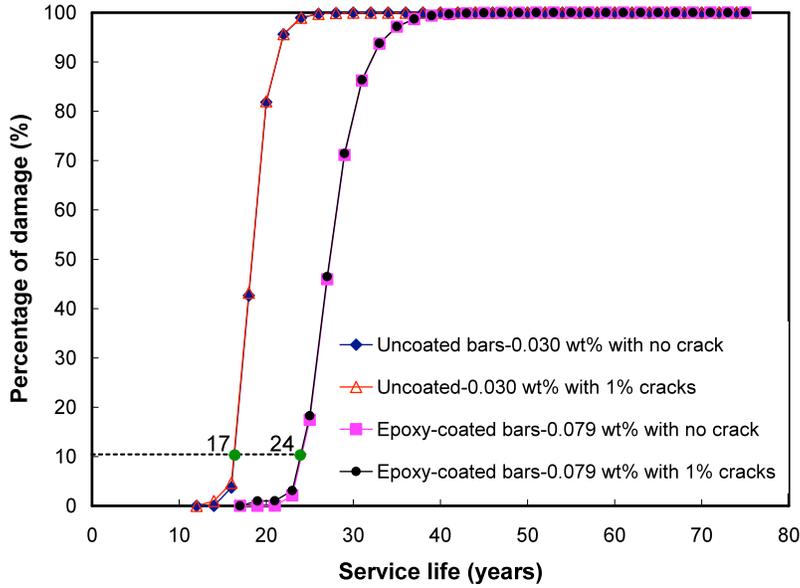
Figure 47. Model outputs for tidal zone: damage function for the MacKay River Bridge columns with 1% area affected by cracking. Threshold based on field specimens: 0.079 wt%.

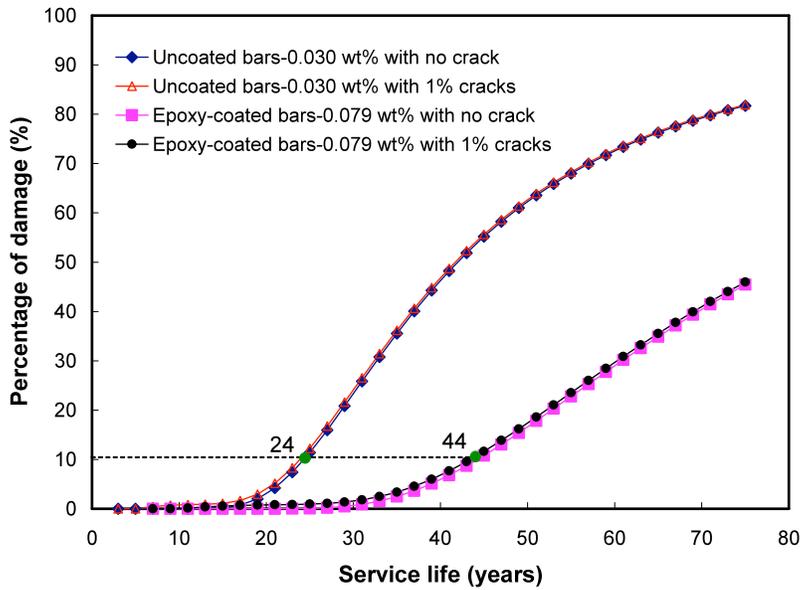
Figure 48. Model outputs for splash zone: damage function for the MacKay River Bridge columns with 1% area affected by cracking. Threshold based on field specimens: 0.079 wt%.

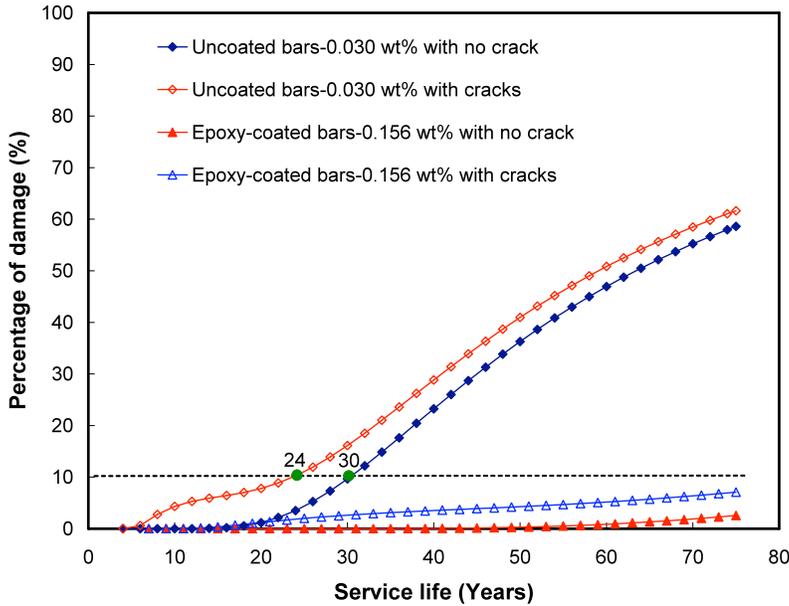
Figure 49. Model outputs for splash zone: damage function for the Atlantic Beach Bridge columns with 8% area affected by cracking. Threshold based on field specimens of the Ocean Isle Bridge: 0.150 wt%.

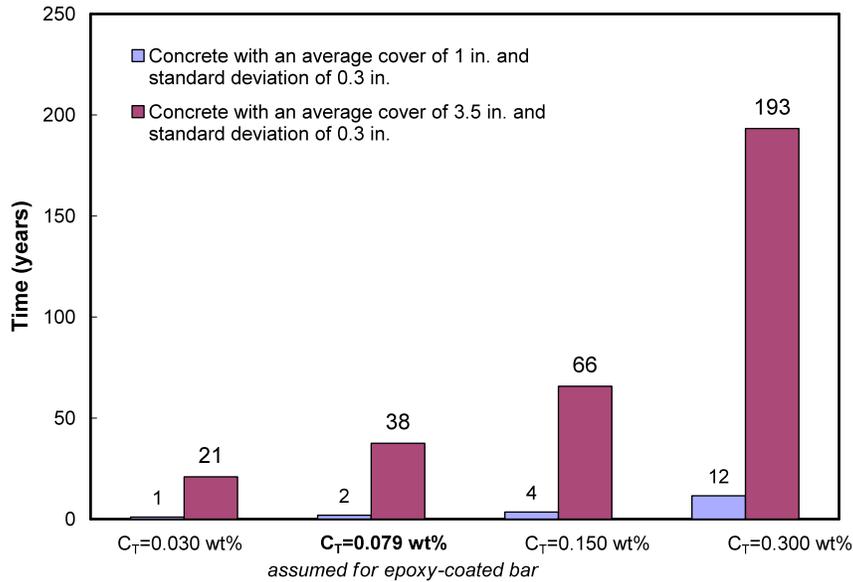
Figure 50. The effect of concrete cover on time to 10% reinforcement corrosion (Based on diffusion and surface chloride data from the splash zone of the MacKay River Bridge.)
