CONDITION SURVEY OF OLDER WEST VIRGINIA BRIDGE DECKS CONSTRUCTED WITH EPOXY- COATED REINFORCING BARS

Final Report

December 22, 2009

Wiss, Janney, Elstner Associates, Inc.

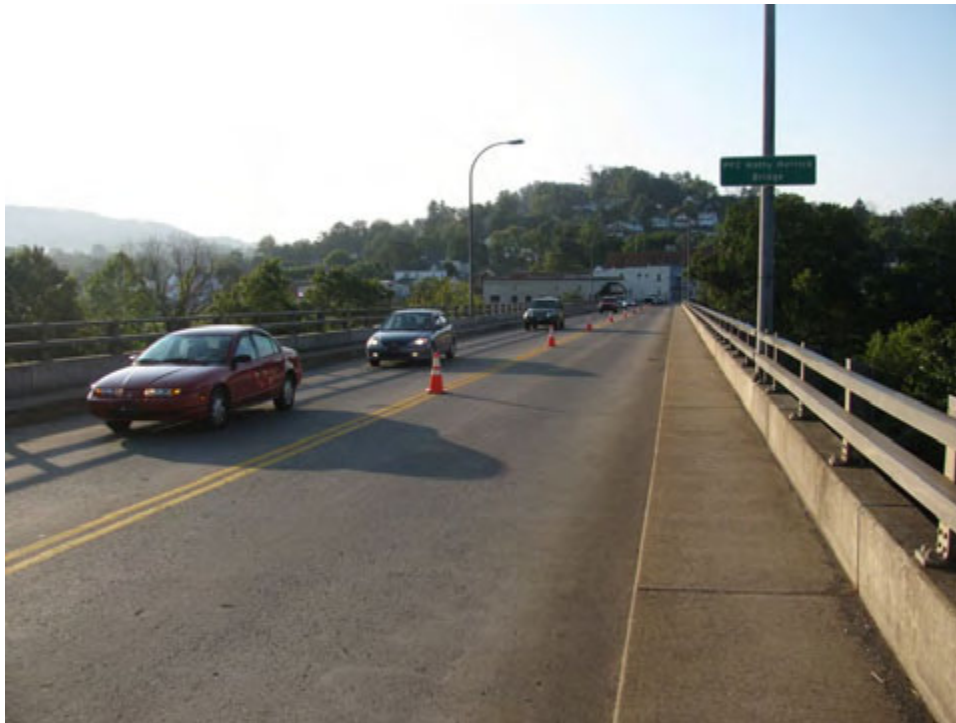
Figure 20. Bridge No. 2930.

The six bridge decks inspected during this study, which included three interstate highway bridges, one interstate overpass and two urban bridges, were in good to excellent condition with the exception of two spans of Bridge No. 2930, which, as learned during this investigation, were reinforced with uncoated black bar. The ECR reinforced decks exhibited less than 0.15 percent corrosion-induced deterioration by area in each case. The deterioration that was observed on the ECR decks was concentrated at cracks and at the construction joints.

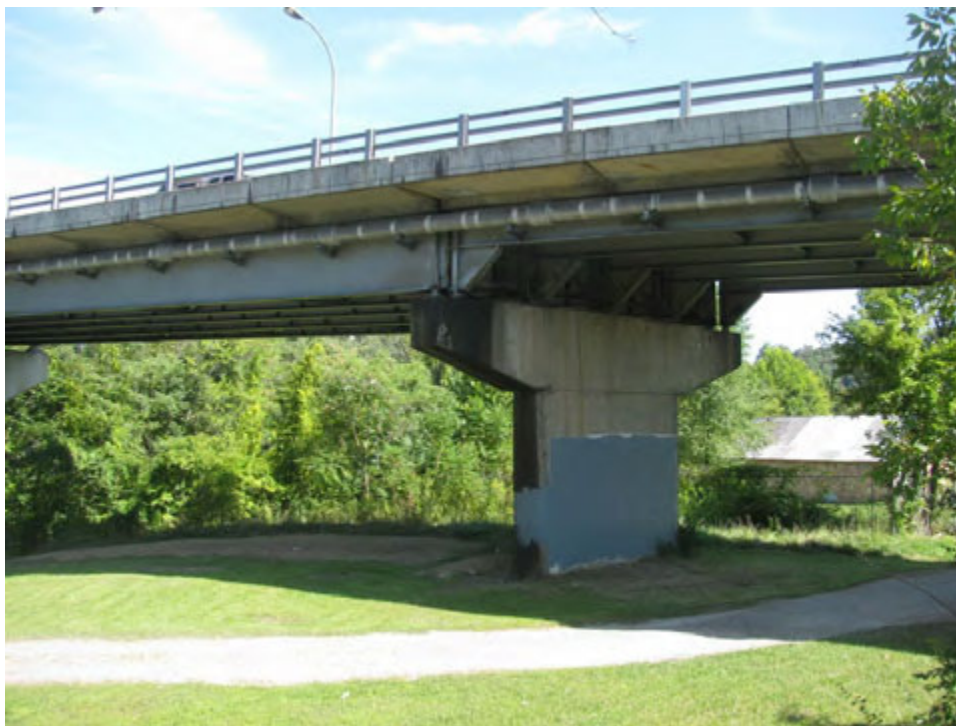
Figure 21. West side of Pier 4 of Bridge No. 2930.

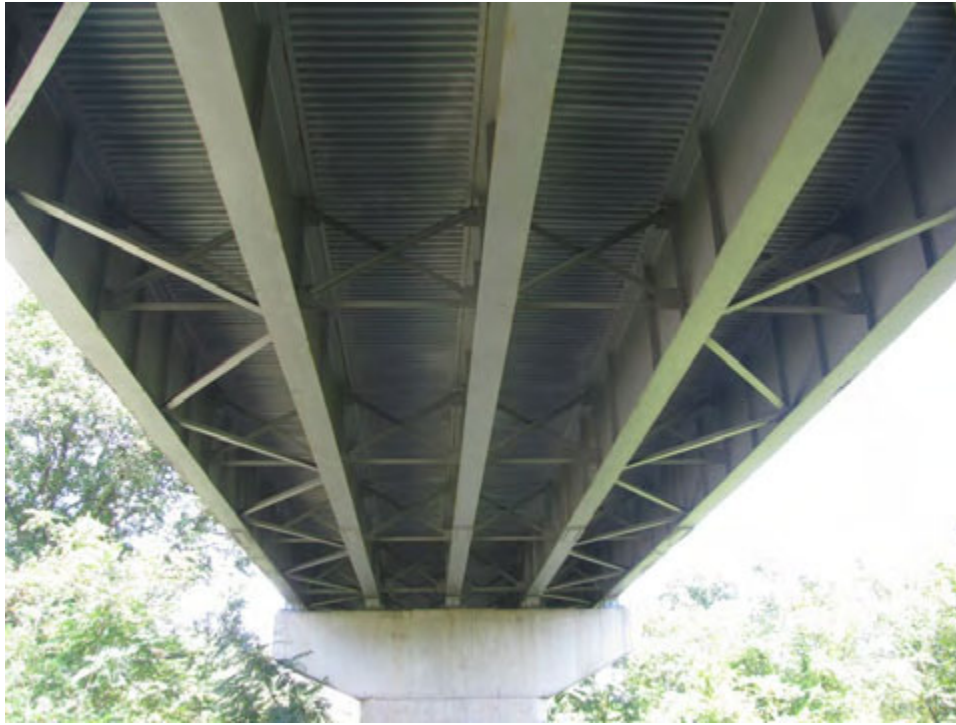
Figure 22. Stay-in-place forms in Spans 1-4 of Bridge No. 2930.

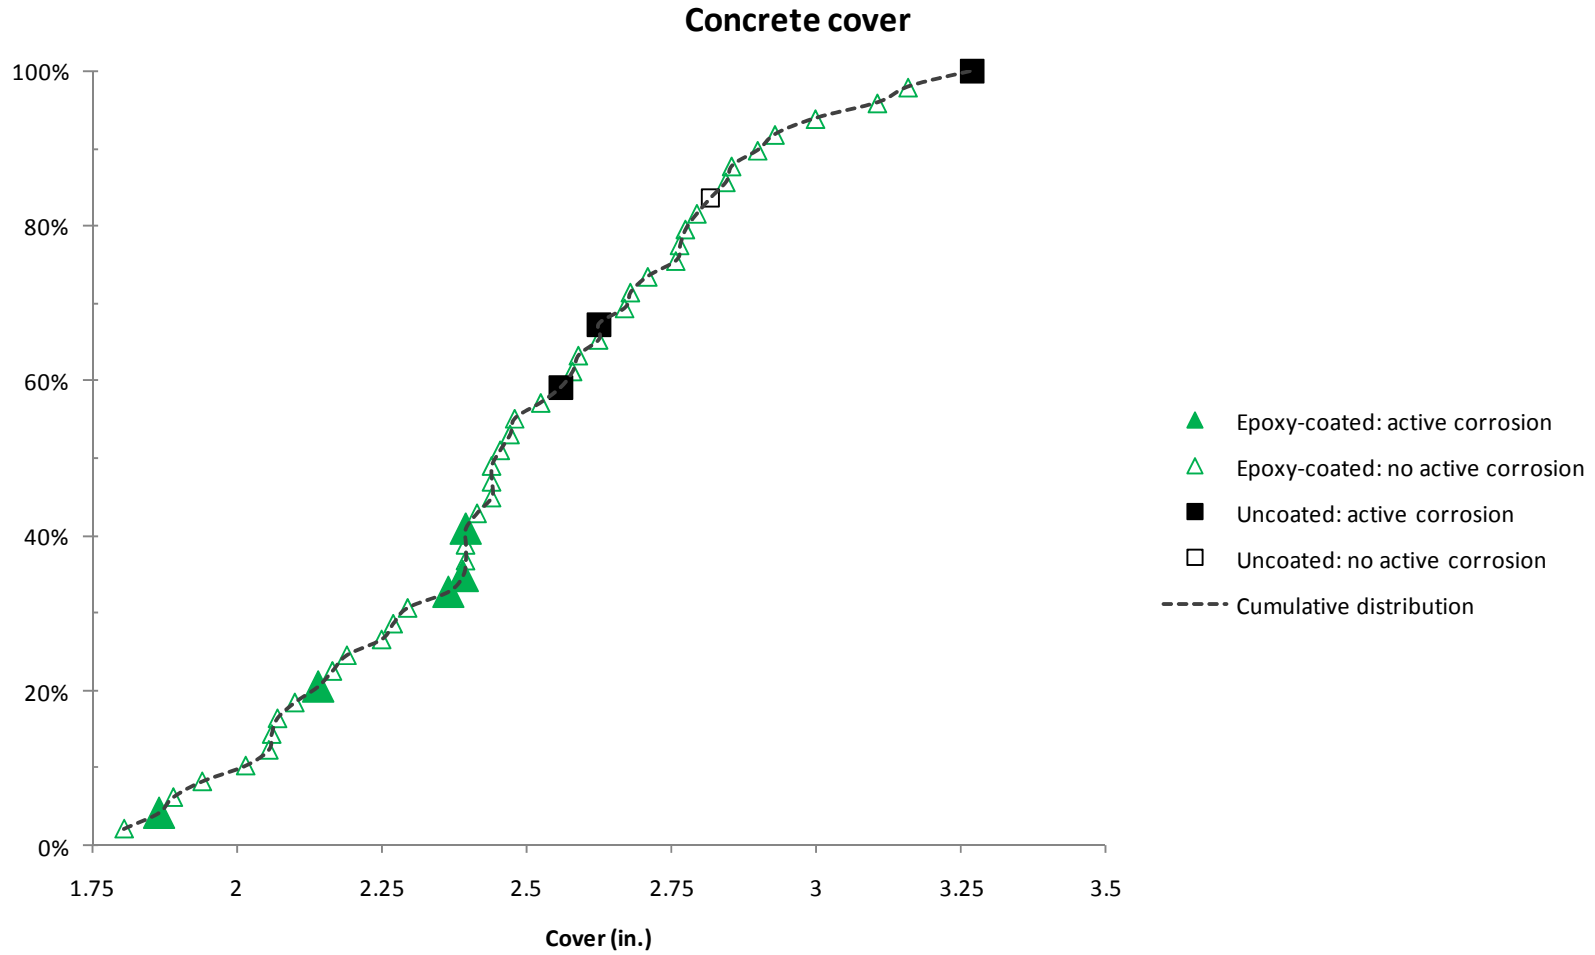
Figure 27 shows the distribution of bar depth measured for each bar segment. The measured bar depth ranged from 1.8 to 3.3 in. and appears to have had little effect on determining whether corrosion is present on the bar segment.

Figure 27. Distribution of cover depth above bars for cores from all bridges.

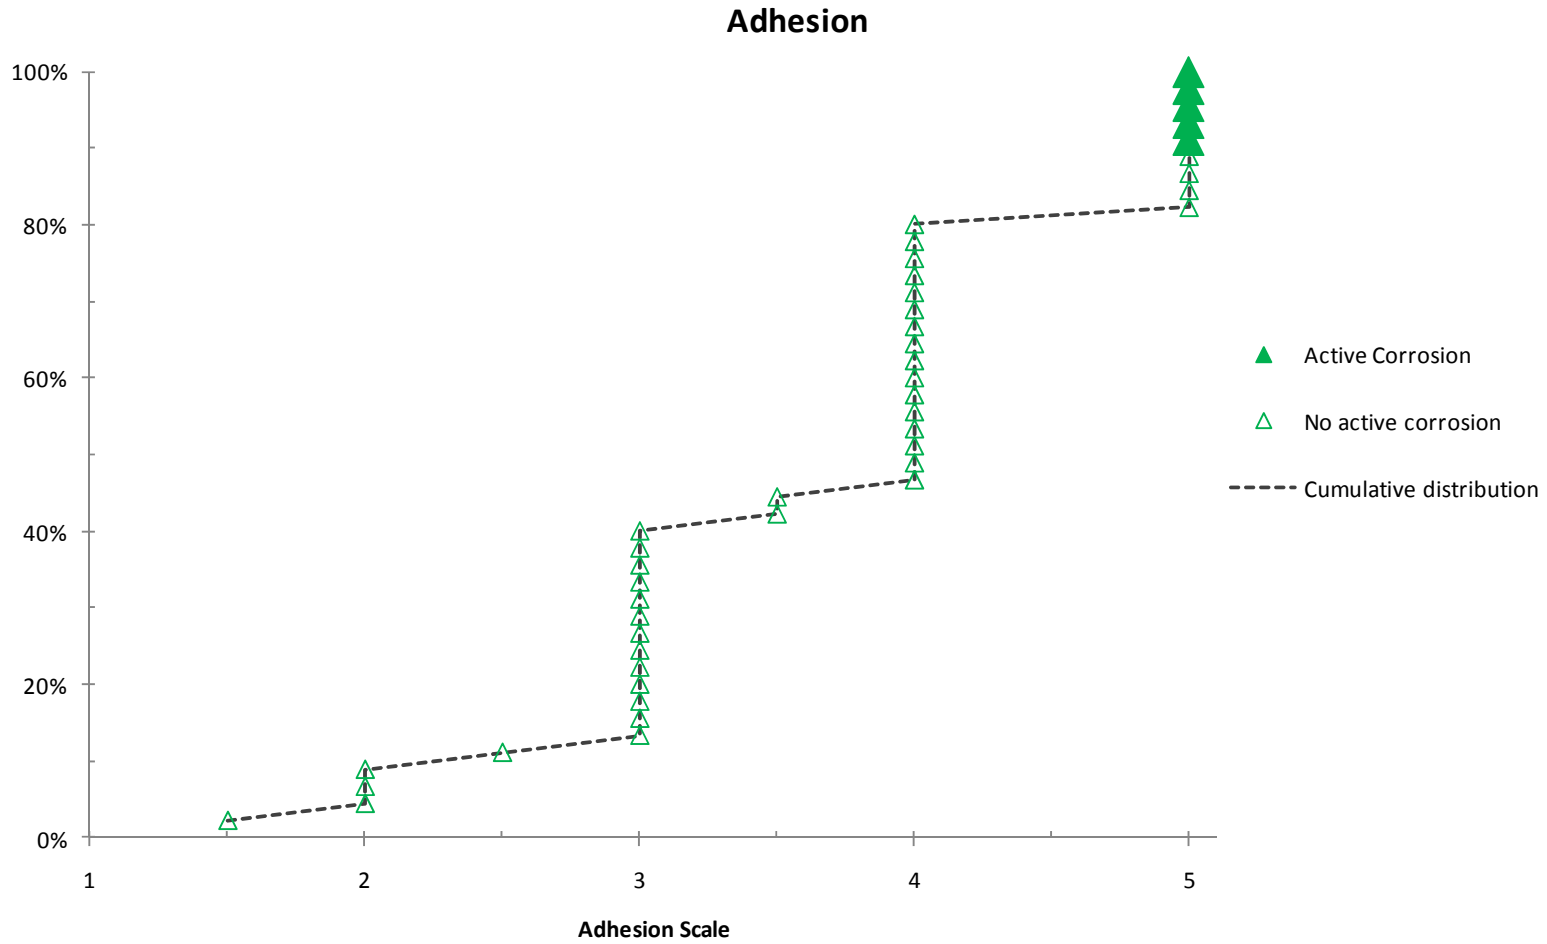
The distribution of coating adhesion is shown in Figure 28. Few ECR segments had an average adhesion rating of less than 3, which would be indicative of a well bonded coating. However, no segments that were judged to be actively corroding had an adhesion rating other than 5. However, this may not reflect a link between corrosion and coating bond, but it is likely that the loss of coating adhesion resulted from the development of corrosion product on the steel surface.

Figure 28. Distribution of epoxy-coating adhesion measured on bars in cores sampled from all bridges.

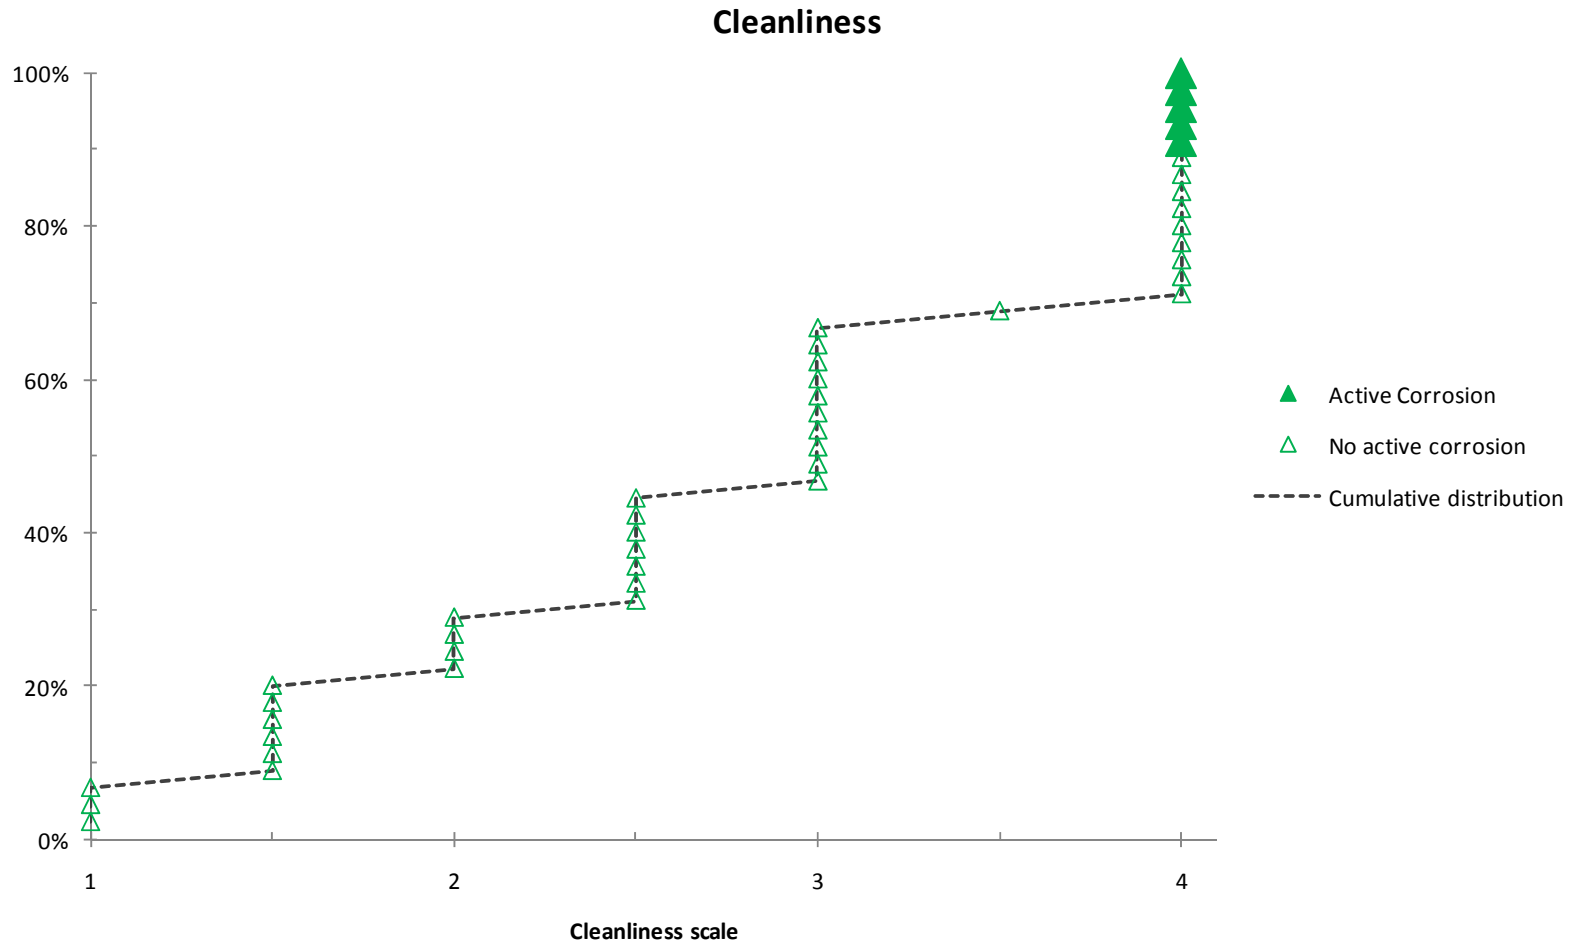
The distribution of backside cleanliness is shown in Figure 29. The backside cleanliness varied widely among the sampled bar segments. The backside cleanliness rating of all corroding bars was 4, but a number of other bars were identified without active corrosion where the backside cleanliness rating was also 4.

Figure 29. Distribution plot of epoxy-coating cleanliness measured on bars in cores sampled from all bridges.

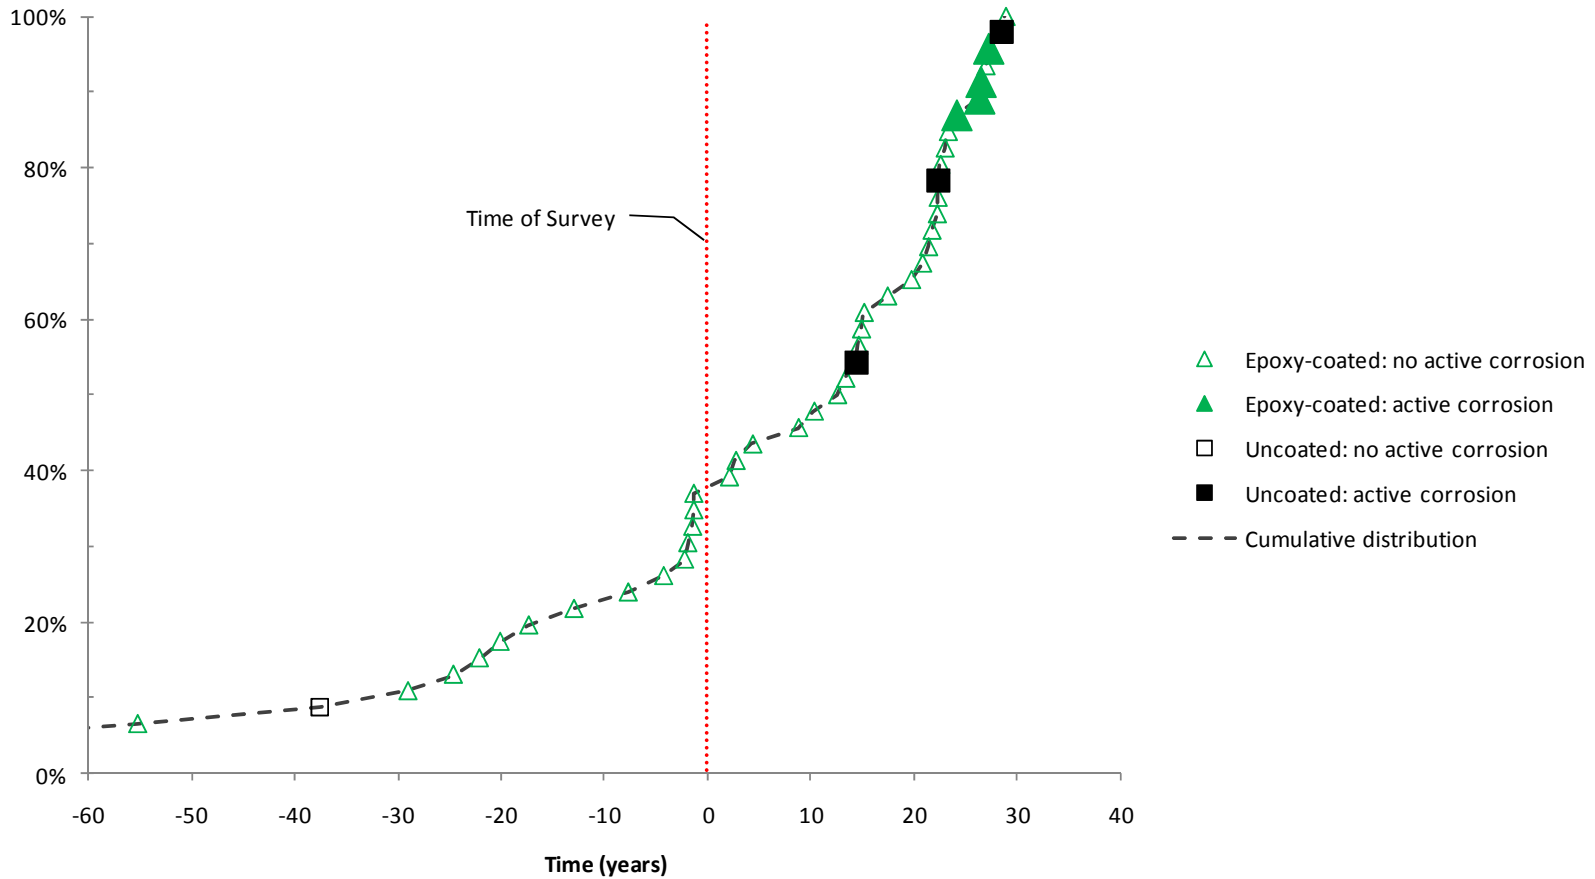
Again using the Fick's Law solution at each core location, the age of the bridge at which the chloride concentration at each bar segment exceeded 0.035 percent by weight of concrete was determined. This was subtracted from the current ages of each bridge to give the time for each bar segment since the chloride concentration at that bar reached the uncoated bar corrosion threshold. The distribution of these times for each bar segment is given in Figure 32. The ECR segments exhibiting active corrosion are among those bar segments that have been exposed to chloride concentrations above the uncoated bar threshold for the longest period of time, exceeding 20 years in all four cases. It is notable that, for these segments, while delaminations were present, concrete surface spalls were not. Some ECR segments examined have been exposed to chloride concentrations higher than the uncoated bar threshold longer than 20 years without active corrosion.

Figure 32. Plot of time since reaching uncoated bar corrosion threshold (0.035% by weight of concrete) at bar depths from all bridges. (A negative value implies that the bar has yet to reach the threshold.)

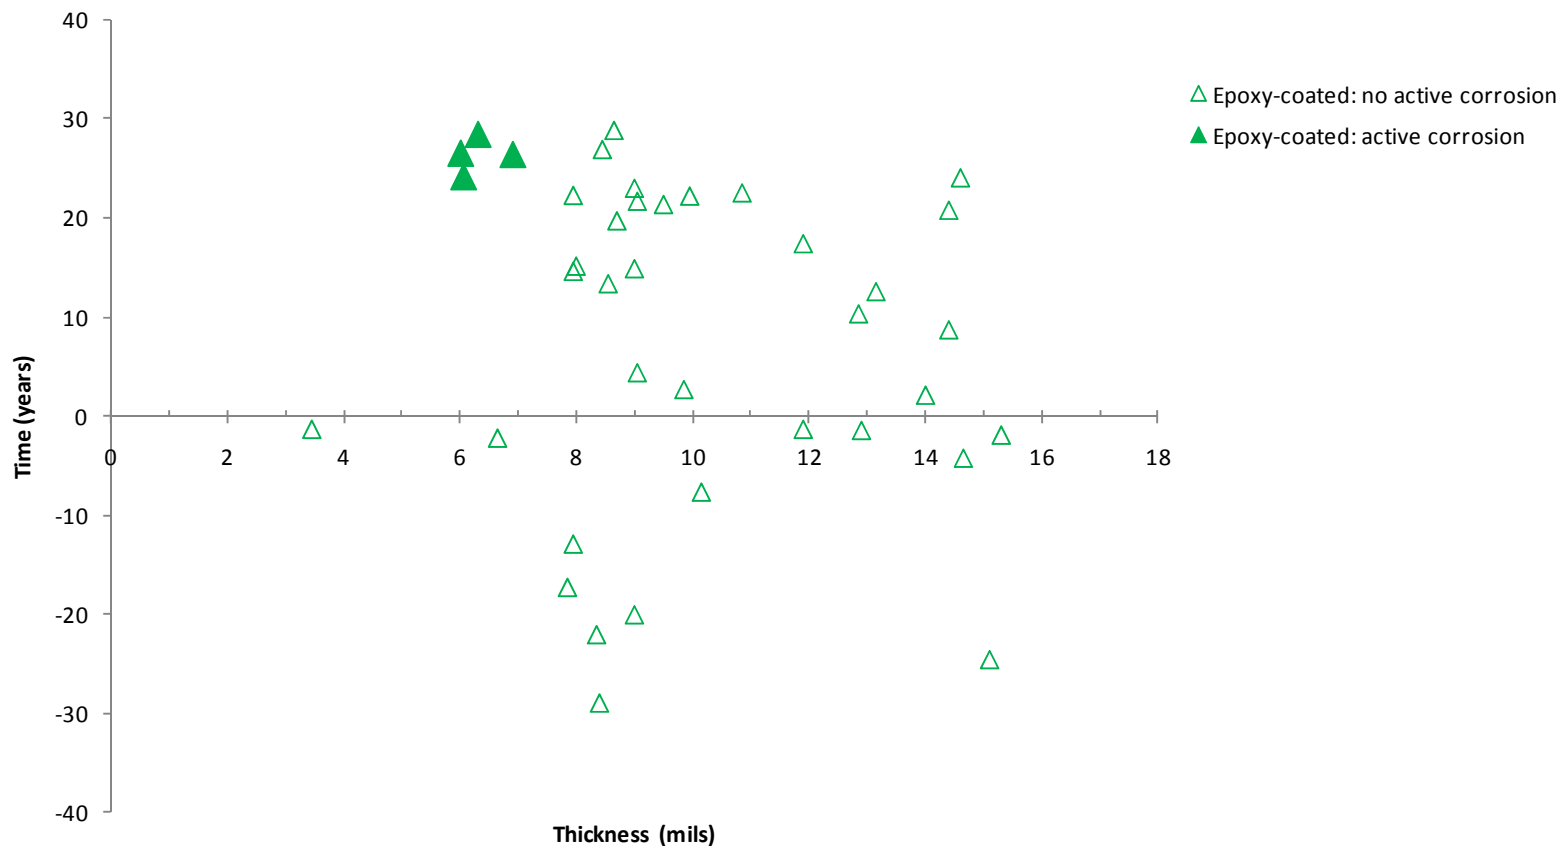
To further explore the possible impact of exposure time, the time since chloride concentration exceeded uncoated bar threshold is plotted versus coating thickness in Figure 33. This plot suggests that, for this sample set, those bars where the coating was thinnest were also the same bars that first saw chloride thresholds greater than the uncoated bar threshold. Therefore, while chloride concentrations above threshold are necessary for corrosion to occur, thin coating may be the primary cause of corrosion of these bars and the length of exposure time may not be the determining factor in the presence of active corrosion on these bars.

Figure 33. Time since chloride concentration exceeded uncoated bar threshold versus epoxy coating thickness on bars from all bridges.

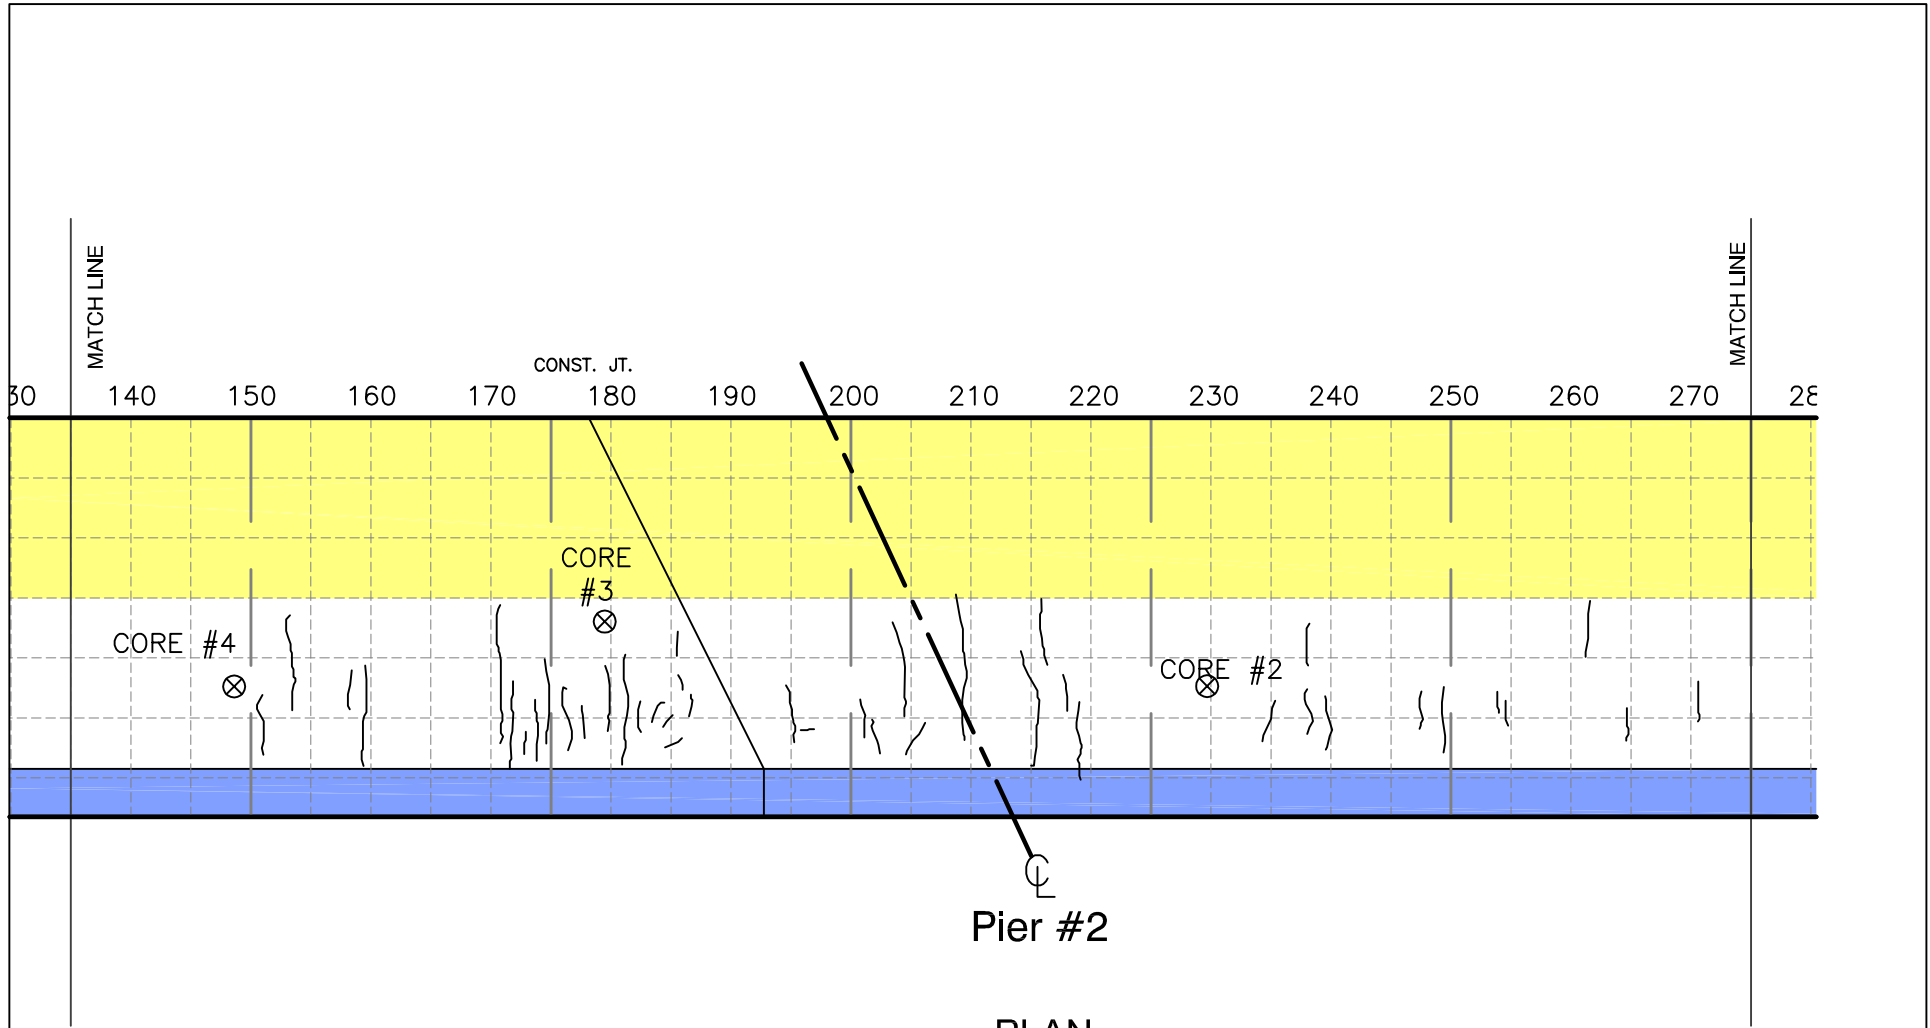
WJE Job No. 2007.1402
 Date: 9/3/09
 Recorded by: JSL
 Sheet No: 1 of 3

West Virginia Bridge Deck Evaluation
WV No. 2953 NBI No. 17A076
