*Review of Papers —*

# **CORROSION RESISTANCE**

**Of Epoxy-Coated Reinforcing Bars**  
**in Florida Bridges**

**During the past 30 years, many papers have been published regarding the performance of epoxy-coated reinforcing bars in Florida. Several researchers have used these structures as a reason to not specify epoxy-coated reinforcing in marine environments. In 2010, two papers were published by the University of South Florida and the Florida Department of Transportation which demonstrate that in appropriate concrete, epoxy-coated reinforcing bars can be used for a 100-year design life. This document summarizes that work.**

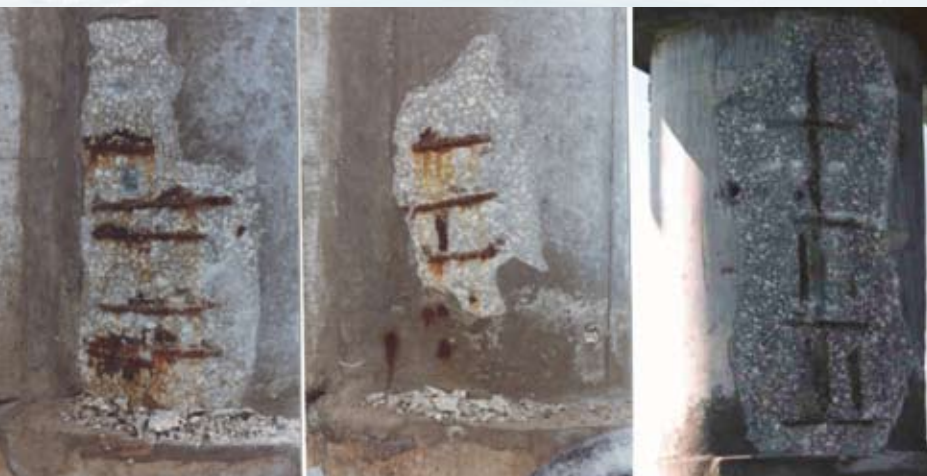
The five bridges that exhibited early age distress were classified in the two papers as Group 1. When spalls were found, they were of the order of 3 sq ft. Typical spalls are shown in **Figure 1**.

Figure 1: Typical spalls observed in bridge piers<sup>(1)</sup>.

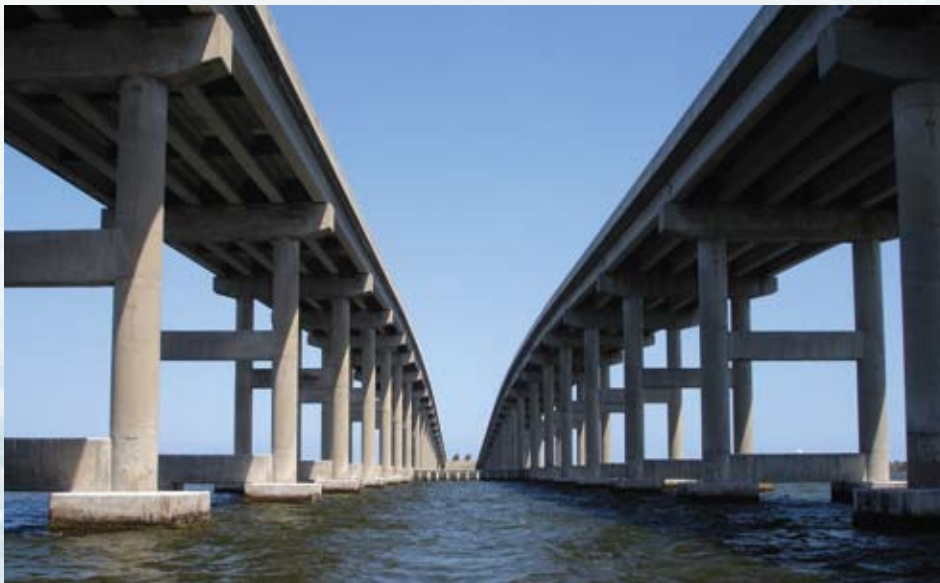
Additional research is recommended to address this specific issue; however, for companion bridges in Melbourne, Florida (**Figure 4**) containing epoxy-coated or uncoated bars, corrosion damage has been observed in the structure containing uncoated bars, while no distress was observed in the structure containing epoxy-coated bars.

Figure 4: Companion bridges containing either black (left) or epoxy-coated bars (right) in Melbourne Florida.
