# Service Life Extension of Northern **Bridge Decks** containing Epoxy-Coated Reinforcing Bars

## Bridge Decks Studied

Extensive condition assessments were conducted on 17 bridge decks in seven northern states: Iowa, Minnesota, New York, Ohio, Pennsylvania, Virginia, and Wisconsin. The bridge decks in Iowa had epoxy-coated reinforcing bar in the top and bottom mats. All other bridge decks had epoxy-coated reinforcing bar in the top mat only. The bridge decks varied in age from 9 to 27 years.

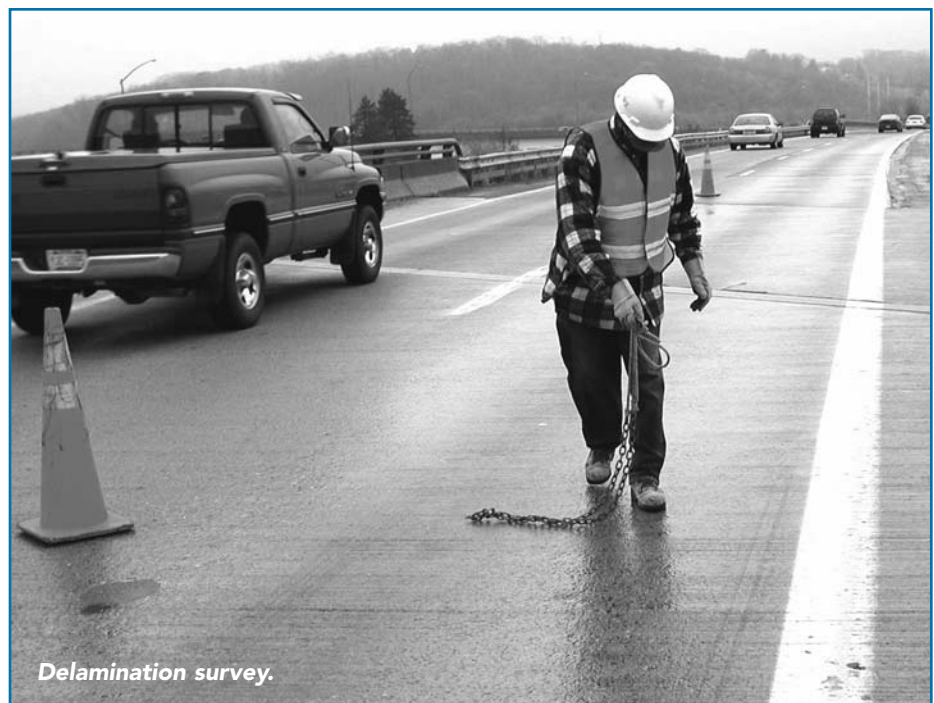
**At right: Delamination survey using chain dragging methods.**

Delamination survey.

The first item in the overall condition assessment was a detailed visual examination and delamination survey performed on each bridge deck. (photo below) The damage level of each deck was calculated as the ratio of the total damaged surface area located in the inspected deck area (including spalls and delaminations) to the total surface area inspected. The crack density (ft/ft<sup>2</sup>) was calculated by dividing the measured total length of the identified cracks by the total surface area.

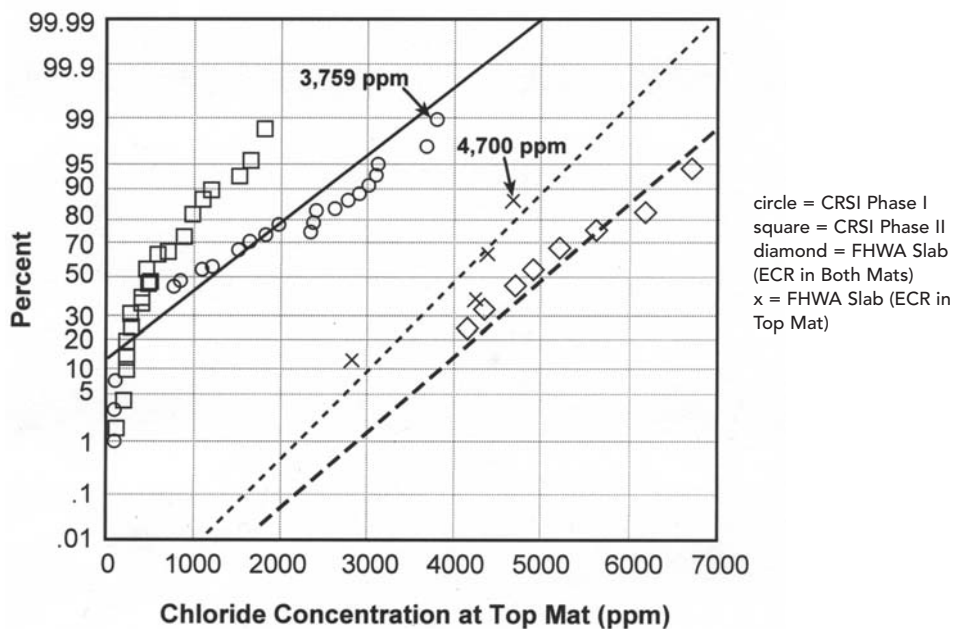
**Figure 2**

Figure 2 shows a compilation of measured chloride concentration for the bridge decks analyzed in this study, along with data from a long-term laboratory study for FHWA that had an epoxy reinforcing bar rating of 1 (no corrosion) and having low corrosion current densities ( $< 0.2 \mu\text{A}/\text{cm}^2$ ). Because the FHWA slabs were exposed to a 96-week Southern Exposure regime (cyclic wetting with 15 percent NaCl solution prior to 5 years of natural weathering), the chloride concentrations were much higher than the ones found for this study.

### CHLORIDE CONCENTRATIONS OF BRIDGE DECKS IN STUDY

Based on the chloride data analysis, a chloride concentration of 1,185 ppm (the mean value of  $C_{th}$  from the

data set) was considered a representative  $C_{th}$  of epoxy-coated reinforcing bars in bridge decks with coated bars in the top mat only. However, it was not possible, based on the data available, to derive a statistically significant value of  $C_{th}$  for epoxy-coat-

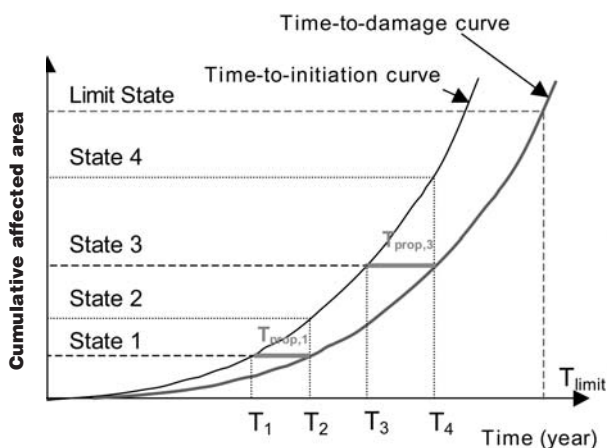
Figure 3

A statistical model was developed based on the field and laboratory data to predict the service life of bridge decks. The prediction model is based on Tutti's conceptual model, as shown in Figure 3, and can be expressed as:

$$T_d = T_{init} + T_{prop} \quad (1)$$

### SERVICE LIFE PREDICTION MODEL

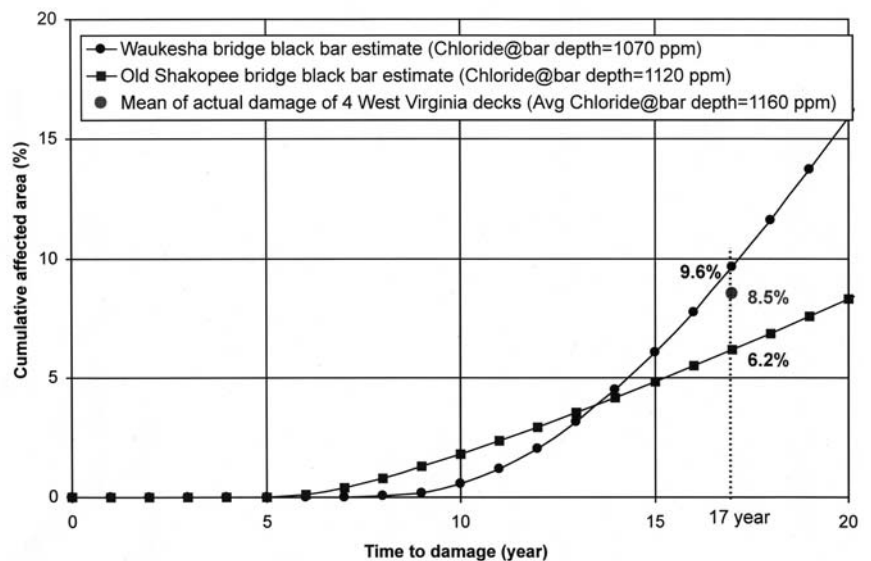
Figure 4

### COMPARISON OF MODELED AND FIELD DATA

For purposes of model validation, the model results for uncoated bar cases from two bridge decks (Waukesha, Wisconsin and Old Shakopee, Bloomington, Minnesota) were compared against the West Virginia data. Good agreement between the modeled and field data was found (as shown in Figure 4).

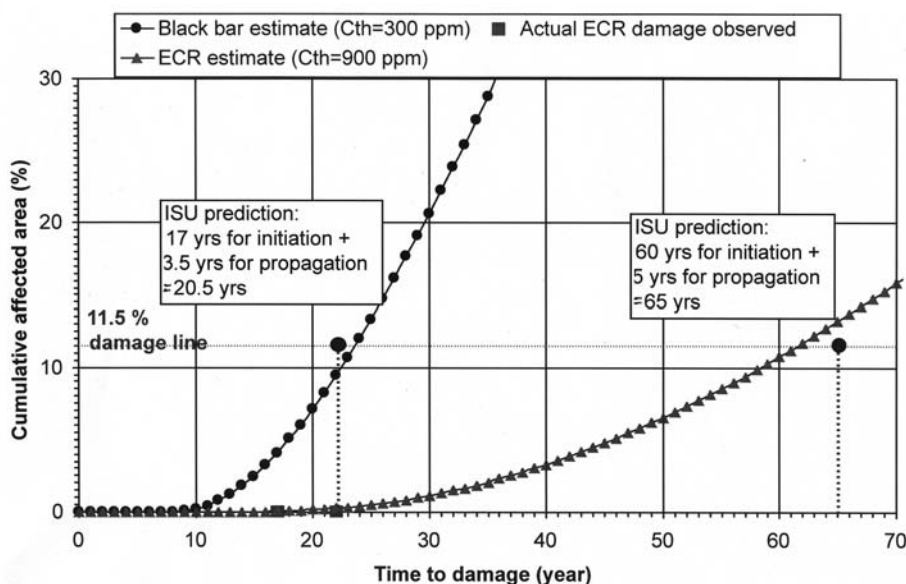
Figure 5

For comparison purposes, the bridge deck from Botetourt County, Virginia, was selected for modeling because it had similar mean depth of cover and was projected to have comparable damage to uncoated bars. Using chloride threshold values assumed by ISU (900 ppm for epoxy-coated reinforcing bars and 300 ppm for uncoated bars), the Botetourt County bridge deck was modeled; results are shown in Figure 5.

### BOTETOURT BRIDGE PERFORMANCE COMPARED TO PREDICTIONS

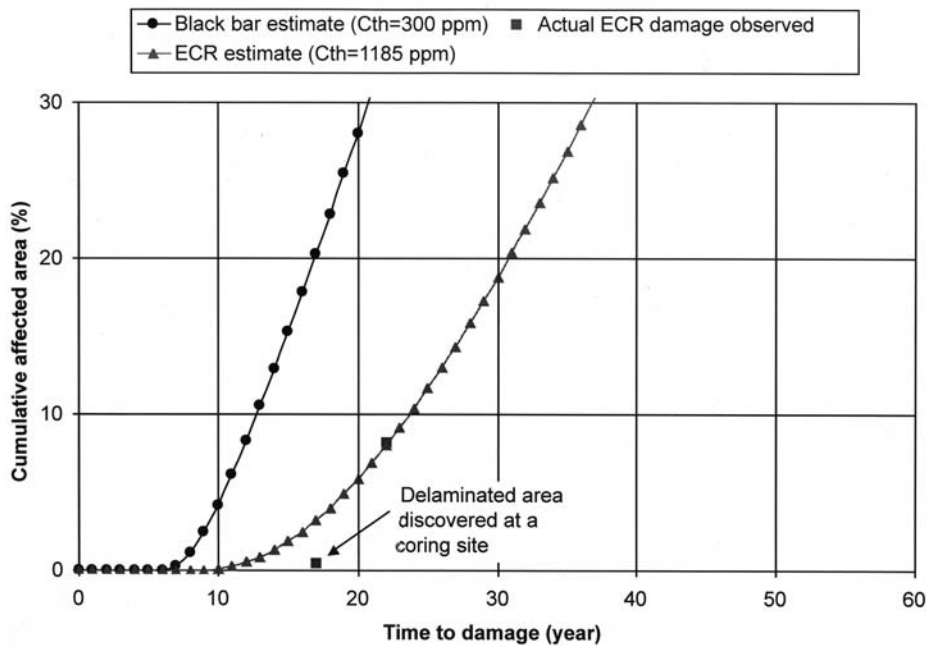
Figure 6

The bridge deck in Blacksburg, Virginia, exhibited the worst physical damage (8.2 percent of the surface area of the deck contained spalls and delaminations) among the decks investigated in this study.

As shown in Figure 6, the prediction model indicates that if uncoated

bars had been used to construct this bridge deck, the deck would have exhibited corrosion damage on about 20 percent of the deck after 22 years in service – well beyond serviceability – compared to the actual damage of 8.2 percent.

## BLACKSBURG DECK PERFORMANCE COMPARED TO PREDICTIONS

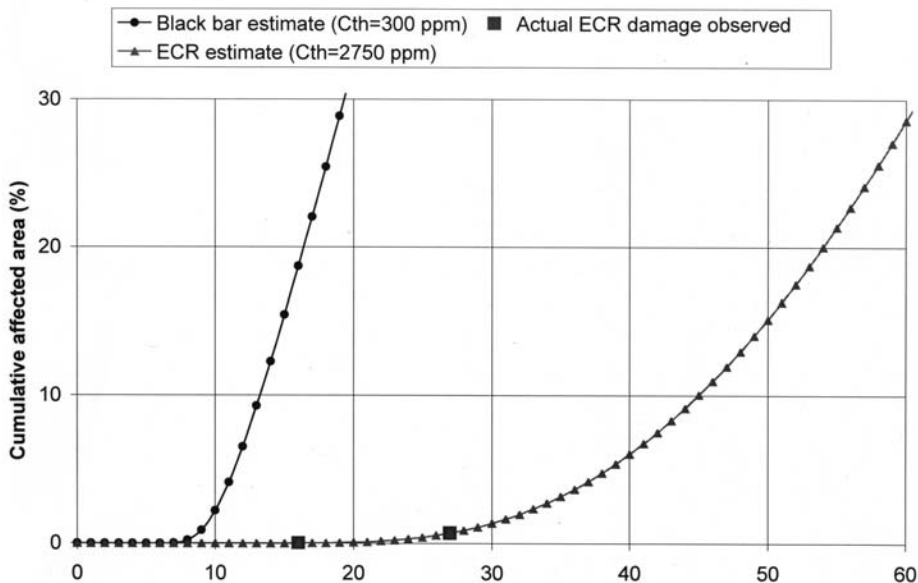
Figure 7

The bridge deck in Mahoning, Ohio had a high level of chloride contamination and a shallow media depth of concrete cover over the top mat of reinforcing bar.

The prediction model (shown in Figure 7) indicated that if uncoated reinforcing bar was used, the bridge deck would have exhibited corrosion damage on about 57 percent of the deck after 27 years of service. For prediction of the service life of the bridge deck using epoxy-coated reinforcing bars, a value of 2,750 ppm was assigned to the chloride threshold  $C_{th}$  to make the modeled values correspond with the observed damage level of 0.7 percent at 27 years.

## MAHONING DECK PERFORMANCE COMPARED TO PREDICTIONS
